Buzzards Bay

*National Estuary
Program*

December 21, 2005

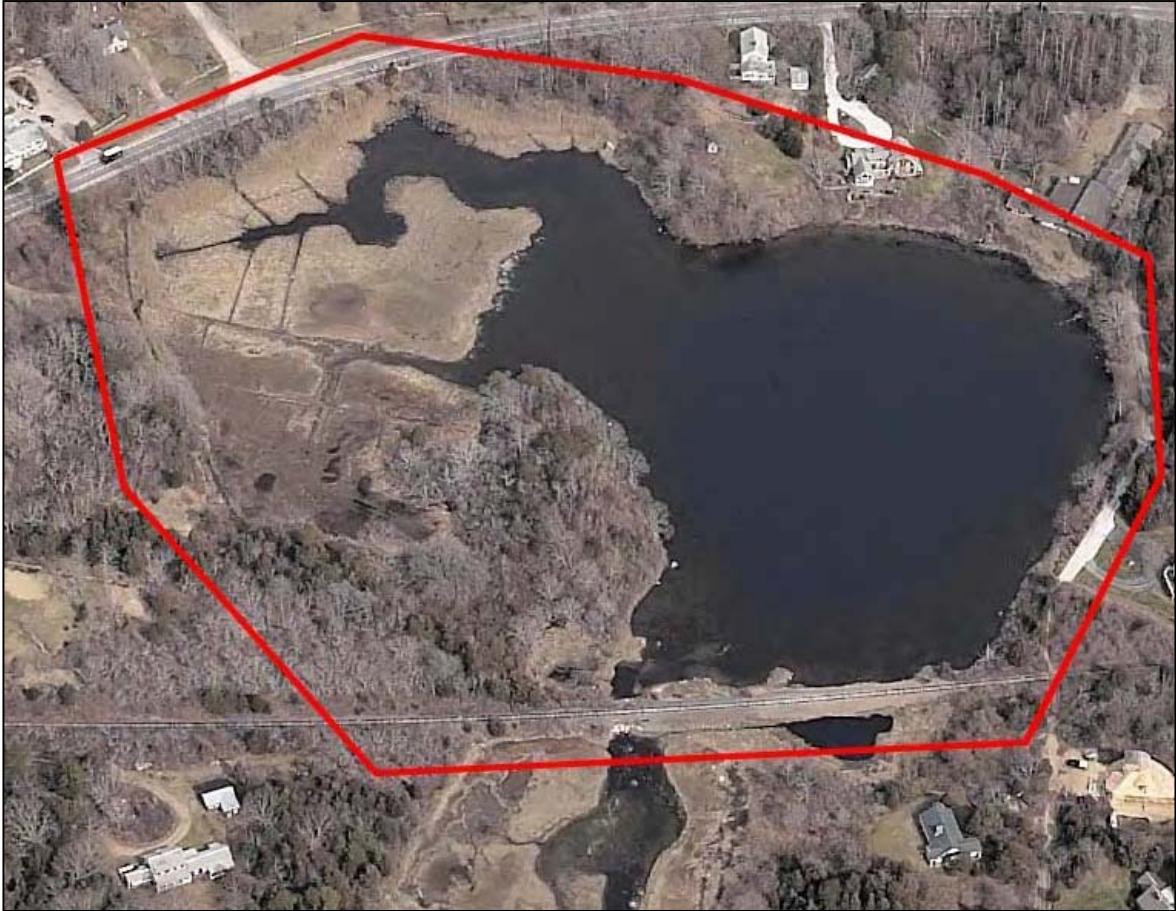
Figure 3. Oblique aerial photograph of Restriction FA17 at Oyster Pond, red outline is approximate area affected by tidal restriction.

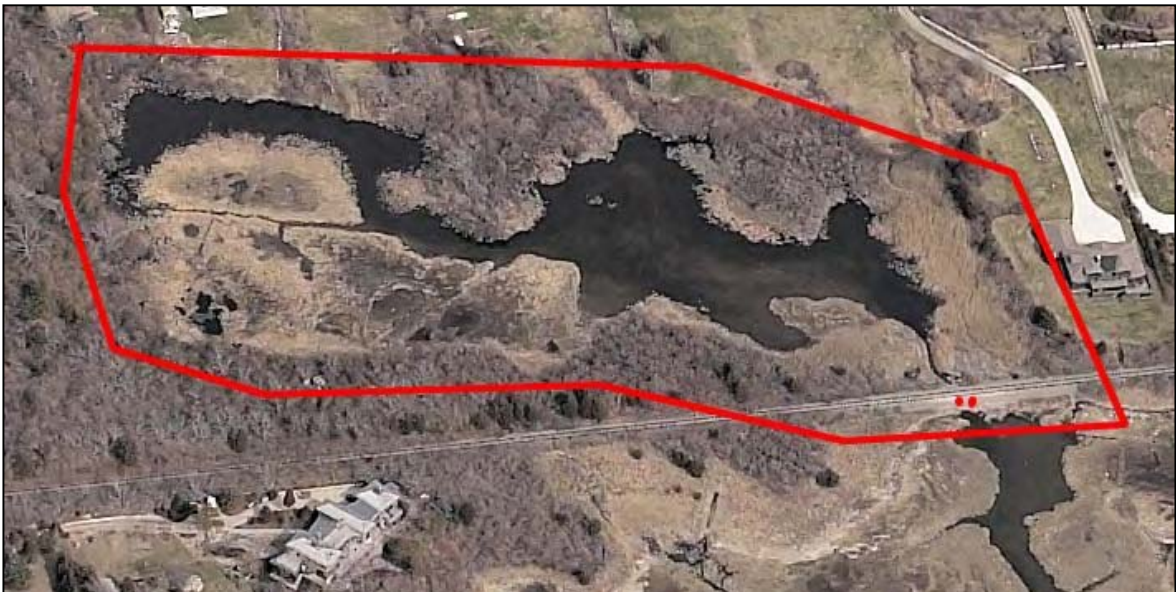
Figure 4. Oblique aerial photograph of restriction pipes FA28 and FA28A.

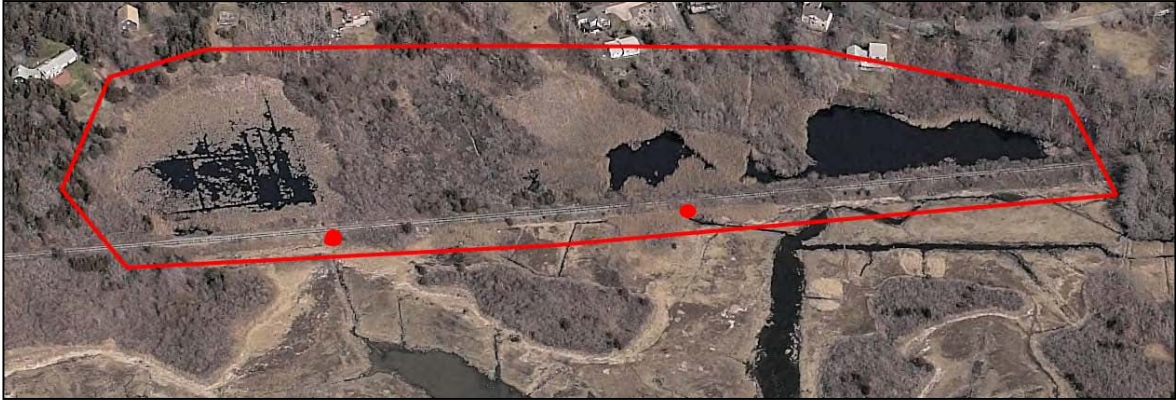
Figure 5. Oblique aerial photographs of Restriction FA20 (left) and FA21 9 (middle) south of Quahog Pond in Great Sippewisset Marsh.

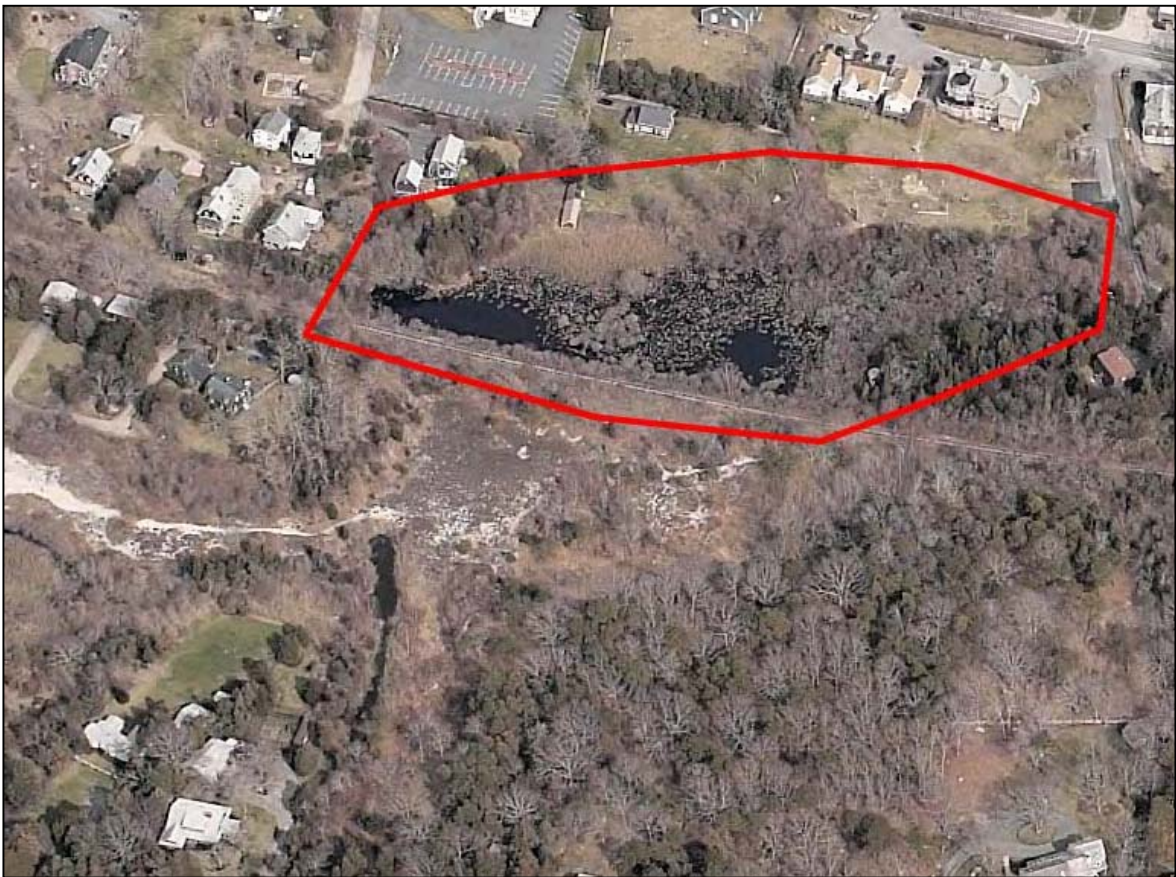
It is also worth stressing that some tidal restrictions caused by the bike path should not be restored. The long flooded area west of the tracks in the vicinity of Nonamesset Road near Snug Harbor in West Falmouth should be left as is. The lack of drainage from either poor designs or lack of maintenance long ago created a small freshwater wetland and pond at that site, and these wetlands should be preserved.

Figure 6. Oblique aerial photograph of an old tidal restriction behind Nonamesset Rd, near Snug Harbor caused by the railroad track construction. This site was not included in the Buzzards Bay NEP tidal restriction atlas because of the extensive fill seaward of the railroad tracks, and because the inland side of the tracks appears to be a well established freshwater wetland.

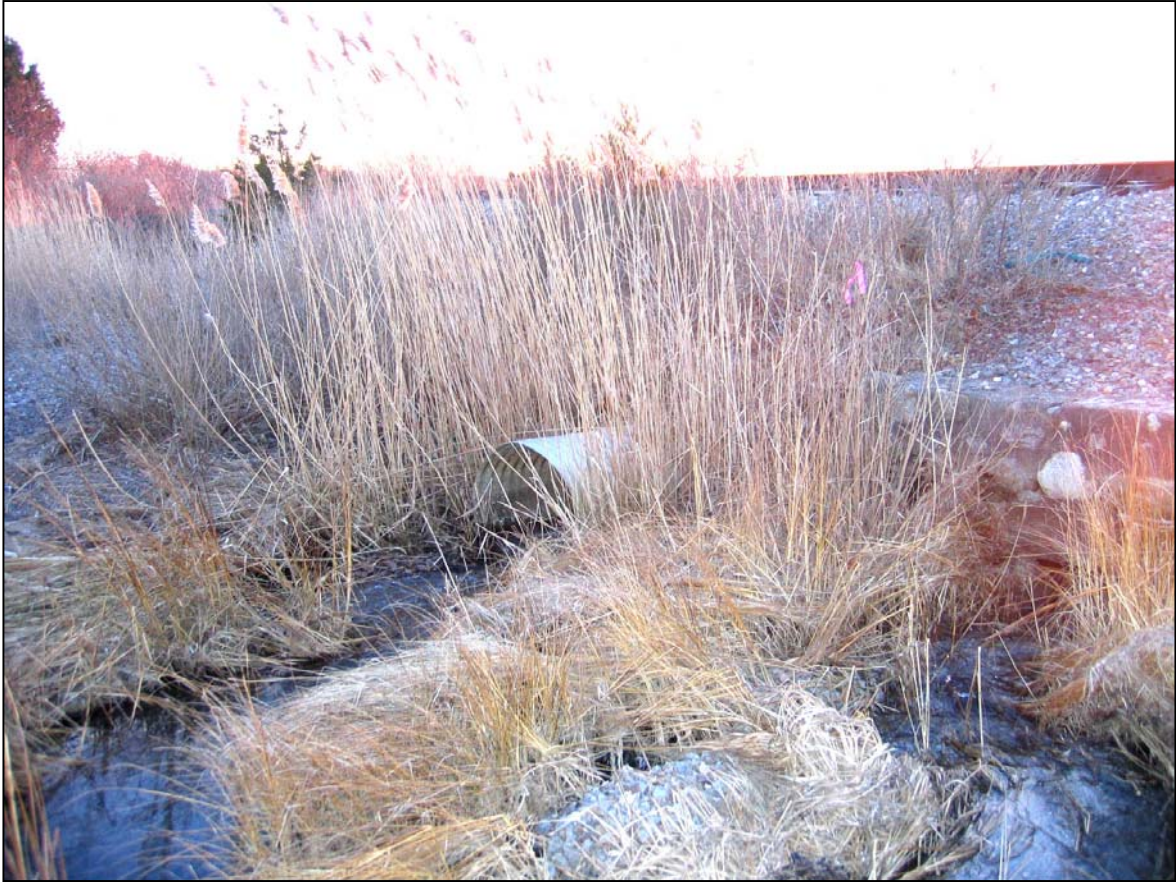
Among the tidal restrictions caused by the rail line, the restriction that appears to warrant the most consideration is the double pipe system identified as FA28 and FA28A, shown in figures 7, 8, and 9. The railway track is at its lowest elevation here, in part because it was built in a salt marsh, and also because the marshland may have subsided somewhat. This area is subject to storm flowage and, as shown in figure 9, the spring tide and storm surge wrack lines are just 1 foot below the top of the tracks. Hurricane Bob washed out the track bed here in 1991 and stone ballast was washed landward creating a stone debris field that remains in the marsh (figure 8). This stone ballast could be removed as part of a salt marsh restoration. The railway bed is narrow here and appears to be eroding. Attempting to stabilize this area for the bike path may require filling in portions of the salt marsh. To avoid additional salt marsh fill, a large box culvert or even an elevated wood bridge could restore tidal flushing of the eastward marsh and solve a difficult bike path crossing through the salt marsh.

Figure 7. Photo of the landward side of the tracks at tidal restrictions FA28A and FA28 in Great Sippewisset Marsh. The old stone box culvert (right) is filled with boulders and track ballast stone. The metal pipe (FA28A left), probably installed after Hurricane Bob damage, was improperly sized and not at the correct elevation. A 400 square foot wetlands fill caused by a debris field of ballast from the Hurricane Bob washout begins to the left in this photo.

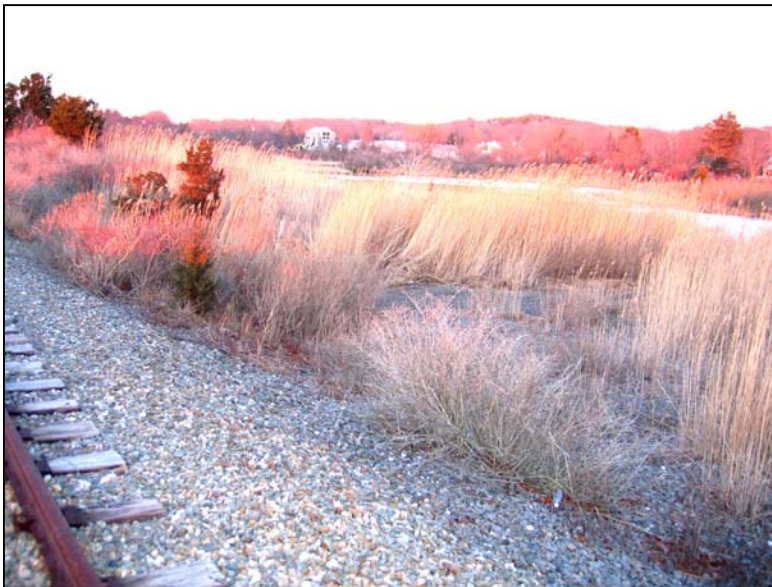
Figure 8. Old stone debris field washed into and left in the landward marsh as a result of Hurricane Bob near restrictions FA28A and FA28 in Great Sippewisset Marsh.

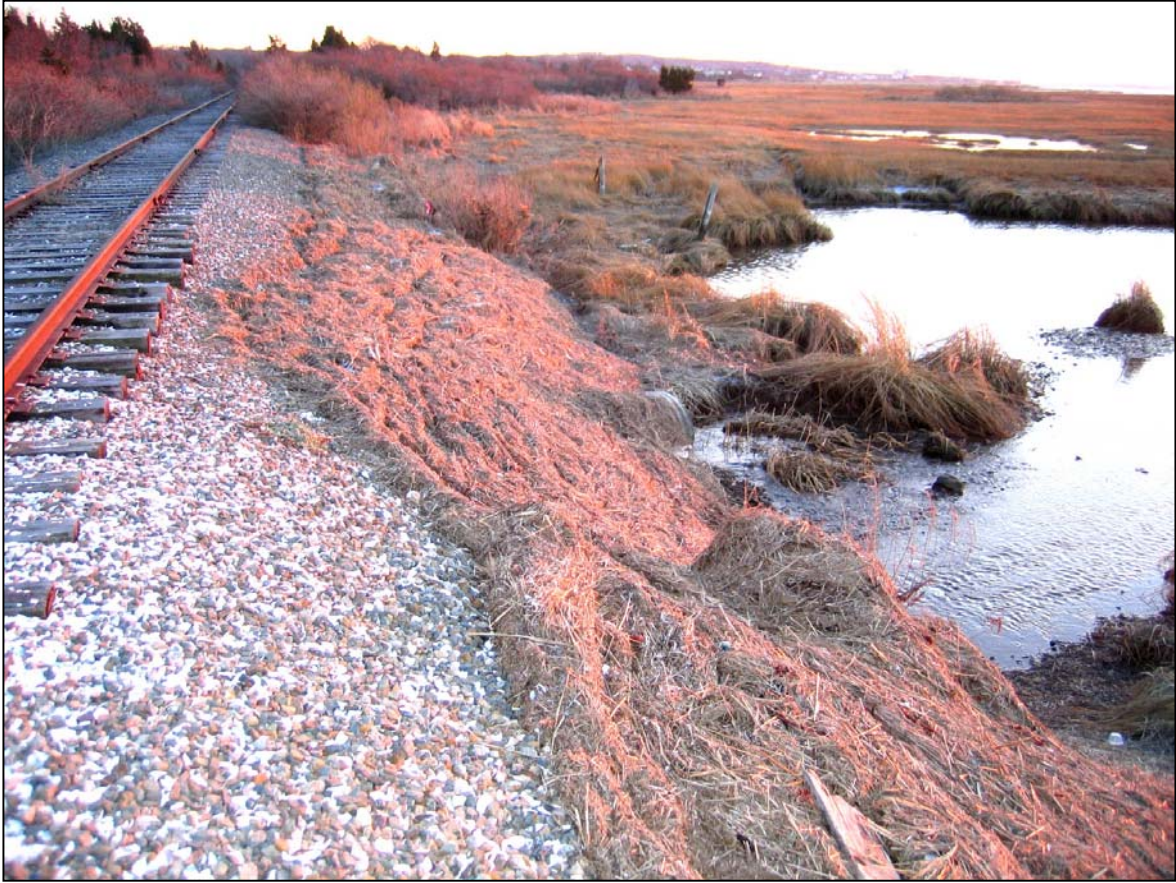
Figure 9. Spring high and storm surge wrack lines on the westward face of the tracks at restriction FA 28 and FA28A (pipe just visible center). The railway bed is at its lowest elevation in this location, and appears to be eroding on the seaward face.
