Atlas of
Tidally Restricted Salt Marshes
in the Buzzards Bay Watershed
Massachusetts

June 2002

Buzzards Bay Project National Estuary Program

Study Purpose

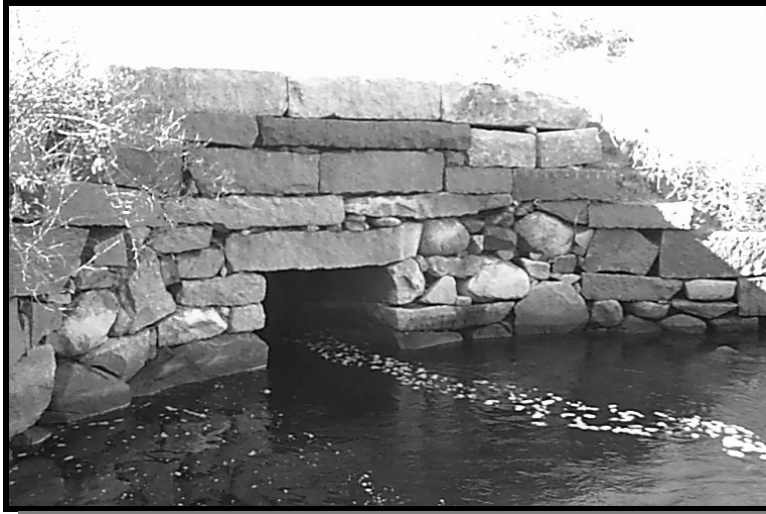
Figure 3. Tidal Restriction Site MT10 Old access to beach, Mattapoisett

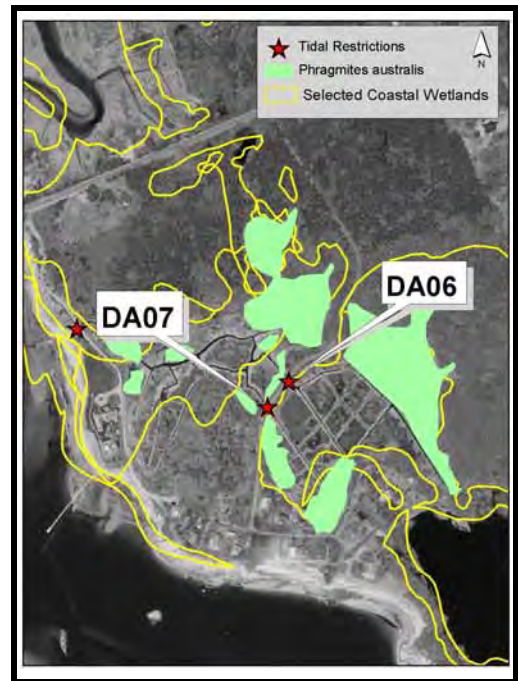
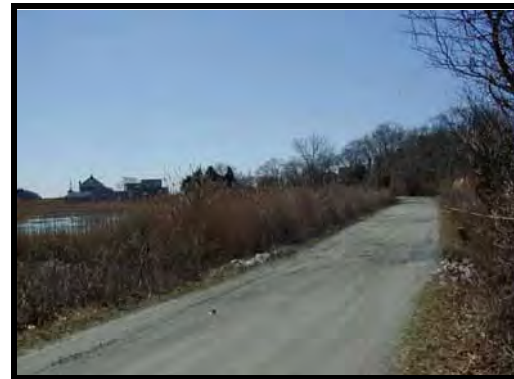
The major restriction to this marsh system, DA08, will be replaced with a larger culvert in the near future as part of a GROWetlands project. As there are some low lying developed areas above DA06 and DA07, further study may be warranted prior to initiating further remediation efforts at this marsh. Due to the fact that the driveway is not paved and the culverts are not far below the road surface, these restrictions would be easy to fix. DA07 is partially buried in mud.

Gravel road passing over restriction DA06

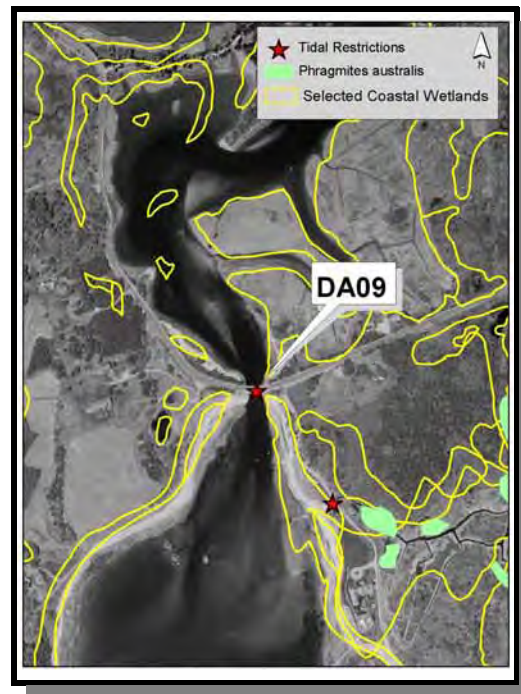
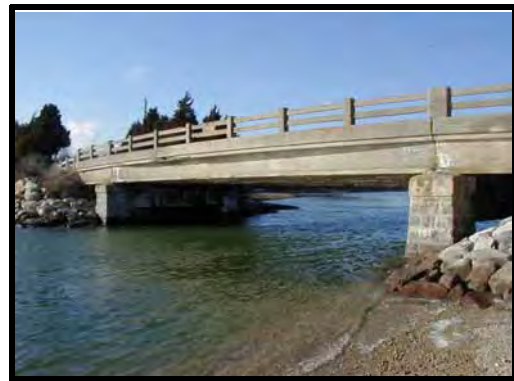
Tidal restriction DA09 is the Little River Bridge in Dartmouth (see map on page 80). Located at the mouth of Little River, this bridge has cracks and spalling in many areas and may need reconstruction in the future.

Bridge condition: poor
Road width: 25 feet
Restriction length: 50 feet
Acres of wetlands affected: 181.3 acres
Acres of *Phragmites* present: 11.3 acres

The plunge pool created by tidal scouring is a favorite spot for illicit bridge jumping. Although this site scored high for a number of reasons, further study would be required to determine if upstream impairments are caused by this restriction, and whether dredging of the channel or widening of the bridge during construction would mitigate these impacts.

South side of bridge looking upstream

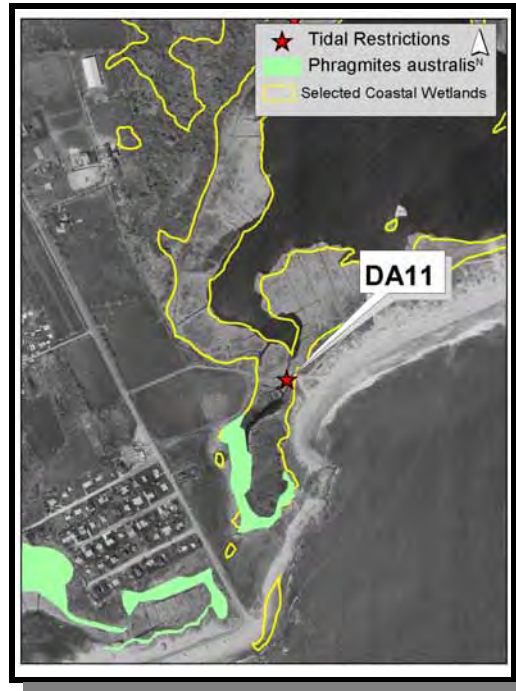
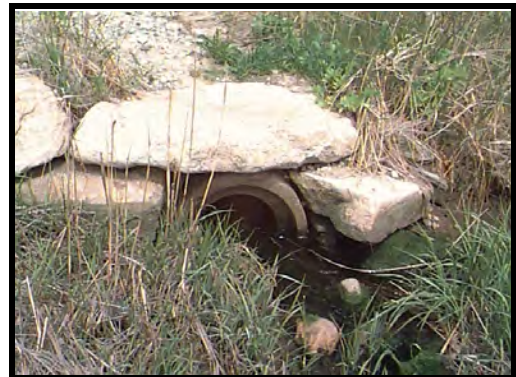
Culvert condition: poor
Road width: 12 feet
Culvert length: 14.4 feet
Acres of wetlands affected: 6.3 acres
Acres of *Phragmites* present: 2.2 acres

North side of culvert

The Buzzards Bay Project has initiated discussions with the Massachusetts Audubon Society and the Town of Dartmouth concerning the replacement of the undersized culvert with two 24" culverts.

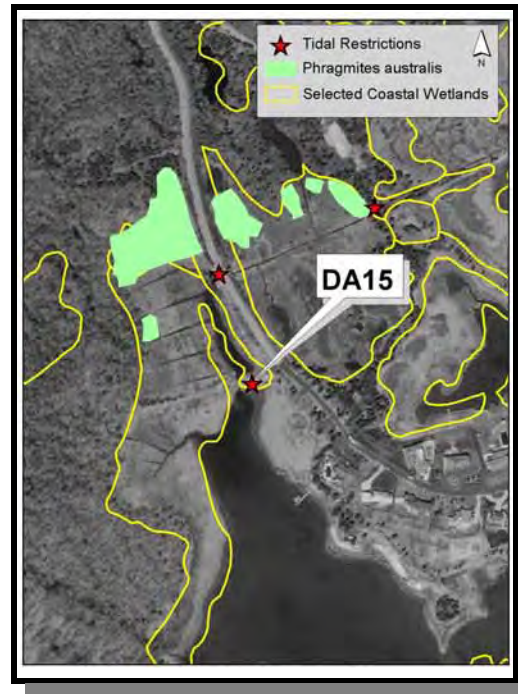
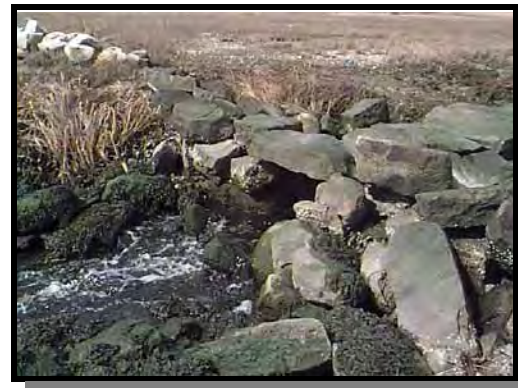
Old stone box culvert

The replacement of the existing stone path with a footbridge would increase the tidal flow yet still allow pedestrian access to the property.

Note: This restriction was remediated by the Town of Dartmouth in May 2002.

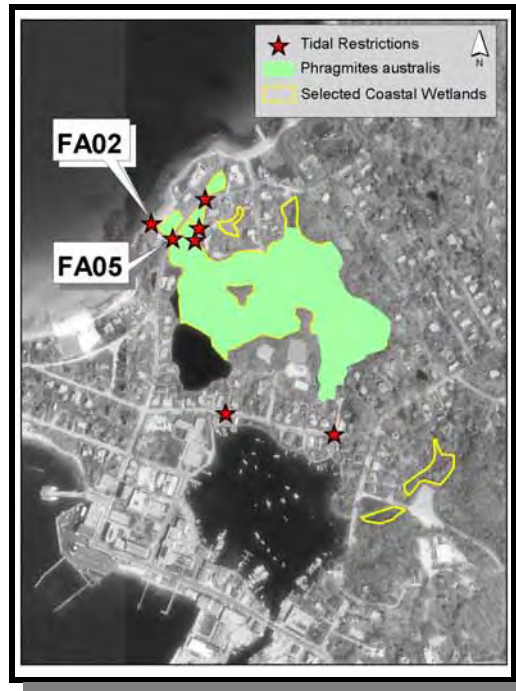
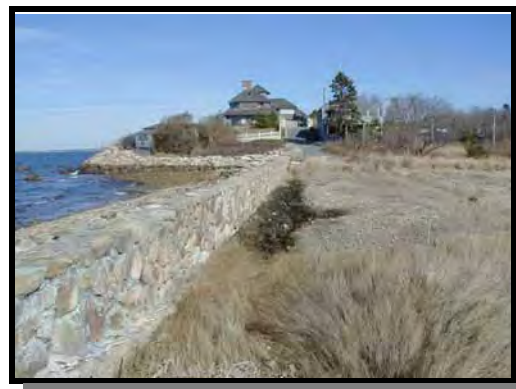
Culvert condition: culvert not visible
Stone wall width: 3 feet
Estimated culvert length: 24 feet
Acres of wetlands affected: 14.8 acres
Acres of *Phragmites* present: 14.8 acres

View of rock wall

Due to the low lying areas, this site should be investigated to determine if a self regulating tide gate is needed. The impacted marsh is the same area affected by FA03, FA04, FA05, FA06, FA40, and FA41. A study that looks at all restrictions affecting this marsh system is recommended.

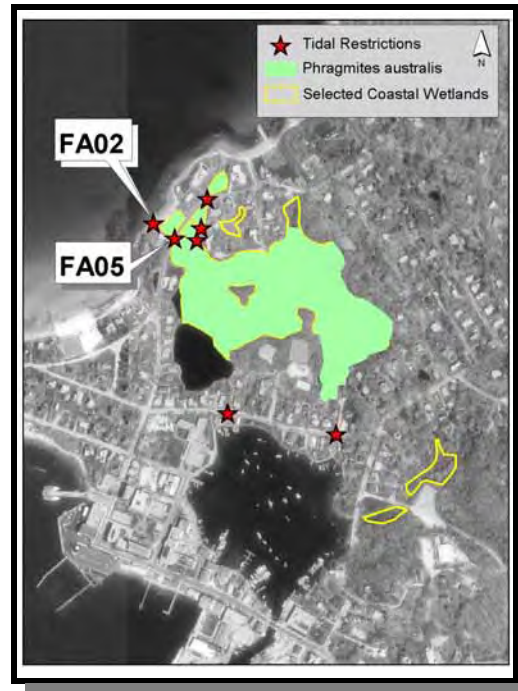
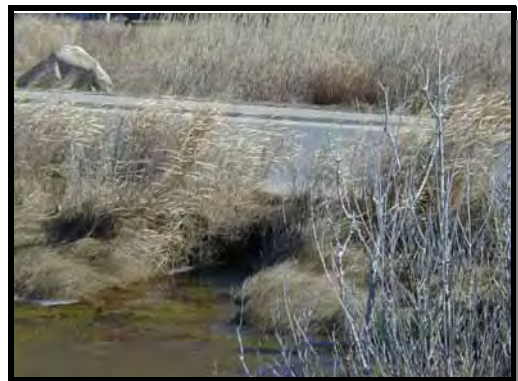
Restriction site FA05

There is a lot of *Phragmites* on the upstream side of this culvert. The culvert has filled in on the east side with soil and is not visible, as it is covered by rocks. A larger culvert is required. The impacted marsh is the same area affected by FA02, FA03, FA04, FA06, FA40, and FA41. A study that looks at all restrictions affecting this marsh system is recommended.

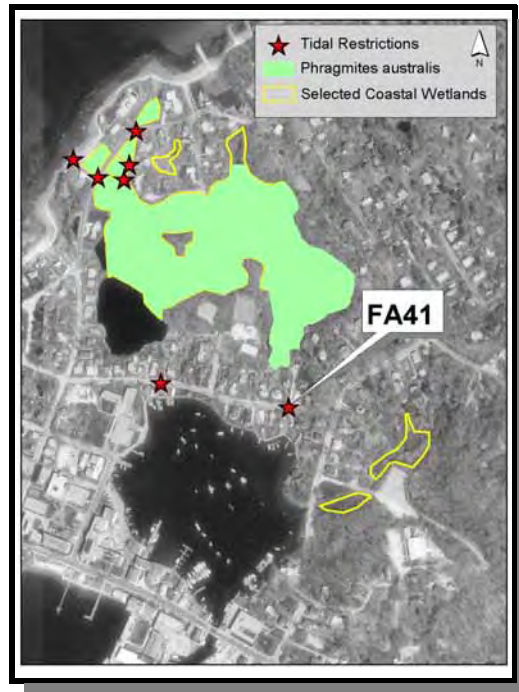
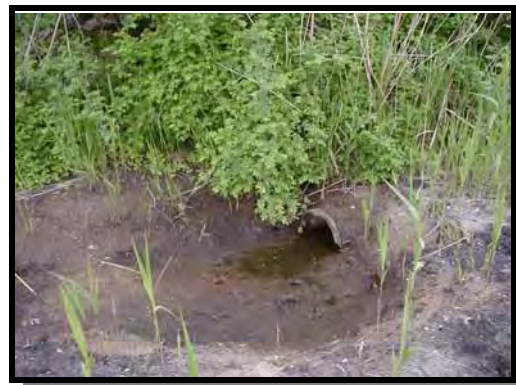
Culvert condition: poor
Road width: 20 feet
Culvert length: 30 feet
Acres of wetlands affected: 15 acres
Acres of *Phragmites* present: 15 acres

The culvert is 95% blocked at the Eel Pond end and not visible. In the spring of 2002 the culvert was broken during the reconstruction of the home on the Eel Pond side and covered over without being replaced. The length of the culvert and density of development will provide challenges to restoration. The impacted marsh is the same area affected by FA02, FA03, FA04, FA05 FA06, and FA40. A study that looks at all restrictions affecting this marsh system is recommended.

Mill Pond side of culvert

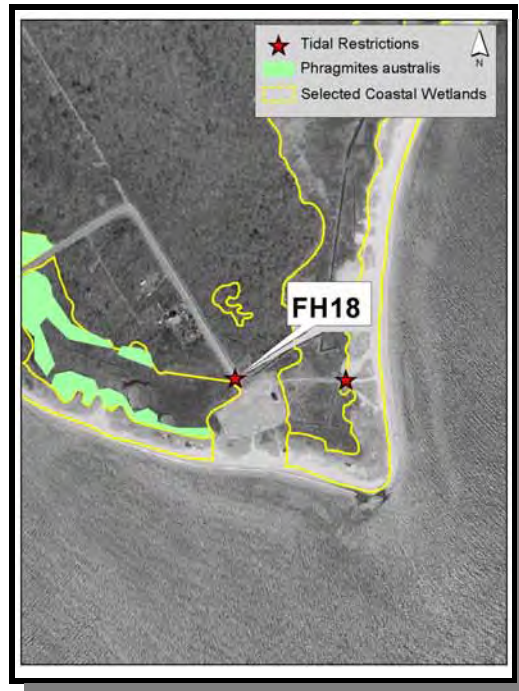
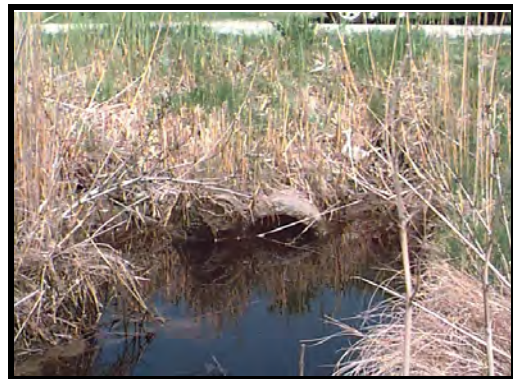
Downstream view

This site has generated interest among several state agencies. The ditch through the upland to FH18 should also be reshaped to handle an increased flow when the culvert is replaced with a larger one.

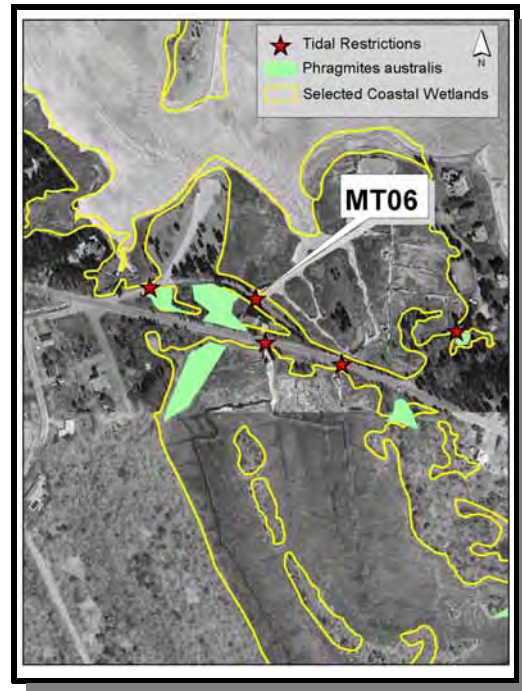
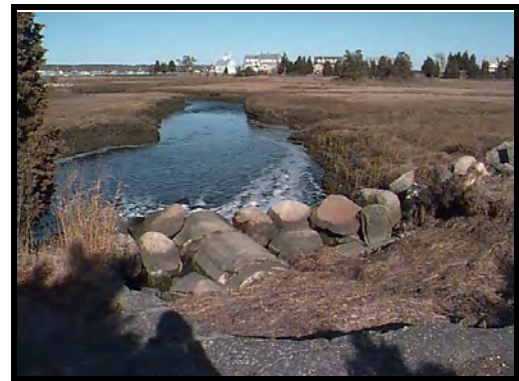
Culvert condition: poor

This culvert is broken in many places. Additionally, the road is broken up and two-thirds washed away. This site has been selected as a GROWetlands project. The Massachusetts Wetlands Restoration Program has secured an engineering firm to study the site.

Downstream side

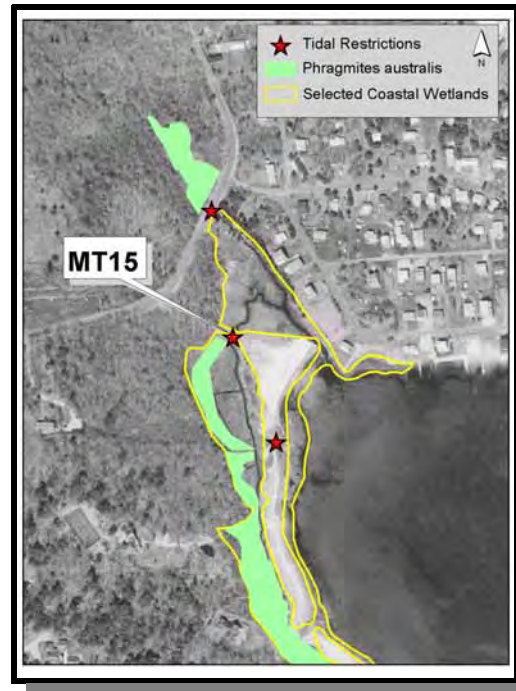
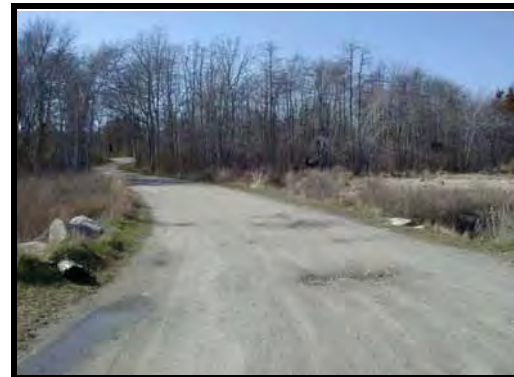
Due to the lack of paving and utilities and the shallow culvert depth, this culvert would be easy to replace. There has been somewhat of a breach in the barrier beach to the south at MT17, which allows tidal waters to the same wetland.

Entrance road to beach

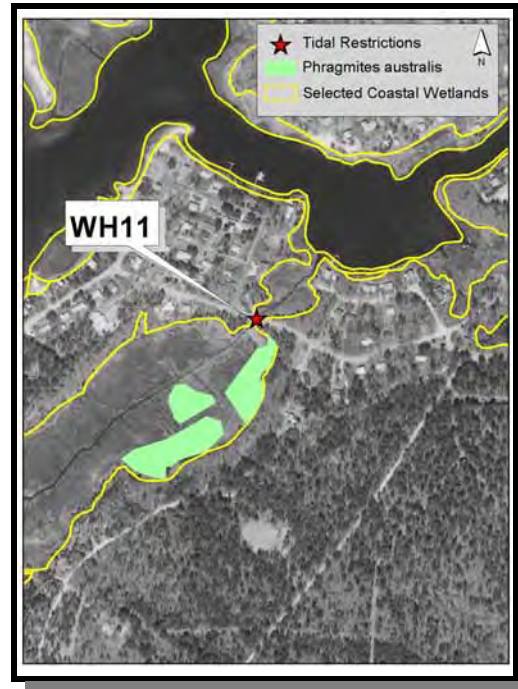
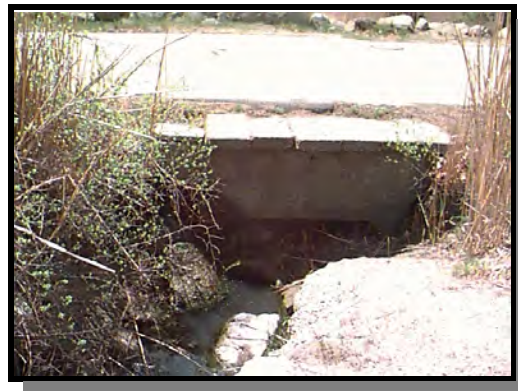
Tidal restriction WH1 I

There is a water main bleeder pipe discharging at the culvert which lowers the salinity in the area. Sediment washing off the road and low velocity through the culvert have caused sand to accumulate. Dredging of the ditch, along with installation of a larger culvert would be needed to improve flushing.

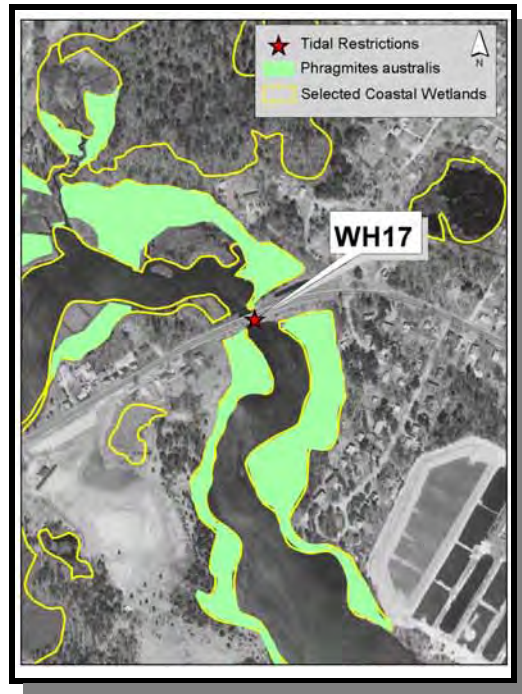
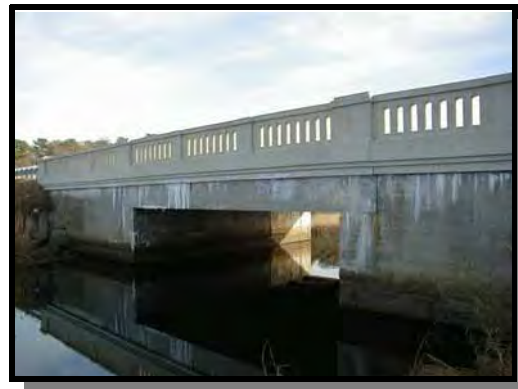
This opening is very small for the size of the river. The river supports a herring run as well as sea run brown trout. Increased flushing may also improve water quality impairments caused by the wastewater treatment plant.

North side of bridge

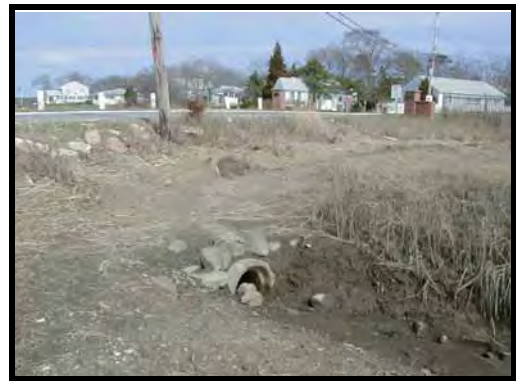
Due to the shallow culvert depth, this would be an easy culvert to replace. The location of any utilities (gas, water, and sewer are present in the street) could add appreciably to the final costs.

East end of pipe
