ATLAS OF

TIDALLY RESTRICTED SALT MARSHES

IN THE
BUZZARDS BAY WATERSHED
MASSACHUSETTS

JANUARY 2001
DRAFT FINAL

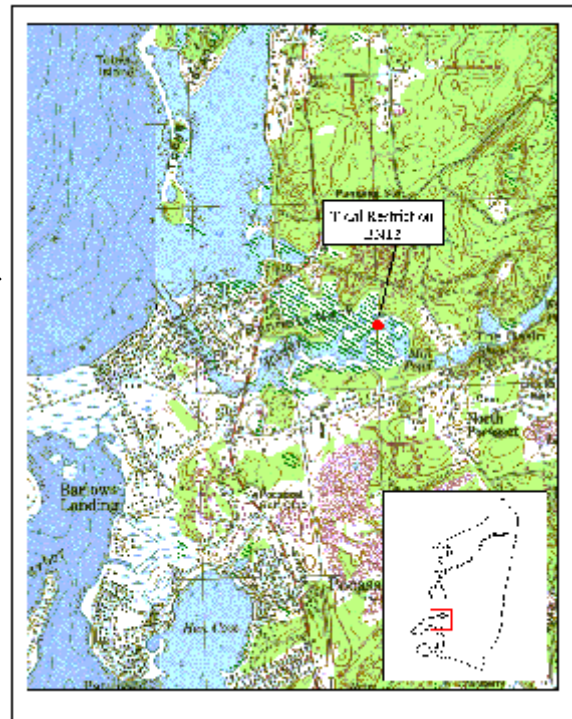
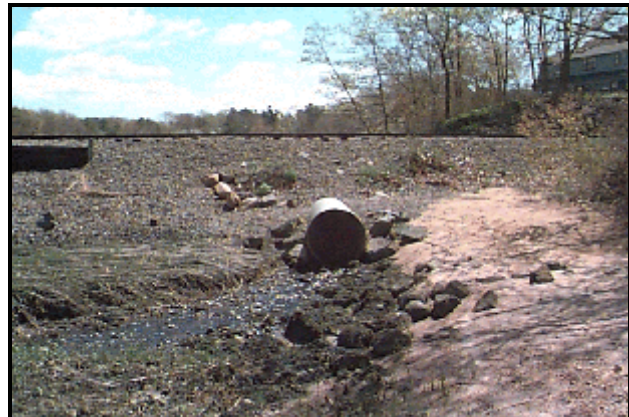
Tidal Restriction BN12b

Restriction BN12 is the result of two culverts located under a railroad track. The first, an aluminum culvert appears fairly new and is at a slightly lower elevation than the second culvert. The second culvert is made of concrete and is badly damaged. The surrounding wetlands include an anadromous fish run and it is also mapped as habitat for rare & endangered species by the Natural Heritage & Endangered Species Program. Both the restriction and affected wetland are on private property.

The restrictions consist of two circular culverts, one 48" diameter corrugated aluminum and one 30" concrete culvert. The culverts are located under a twenty foot wide railroad track. There is an existing tide gate which is stuck 4" open, and consists of a rotting board on rusting hinges.

- Culvert condition - aluminum - good, concrete - poor
- Restriction width - 2.7 feet
- Restriction length - 12 feet
- Channel width - unknown
- Acres of wetlands affected - 46.20
- Acres of *Phragmites* - 0

This site is one of a number of restrictions in the Towns of Bourne and Falmouth caused by the old railroad track bed. Culvert replacement under the railroad bed will require participation and permission of the Massachusetts Department of Transportation.

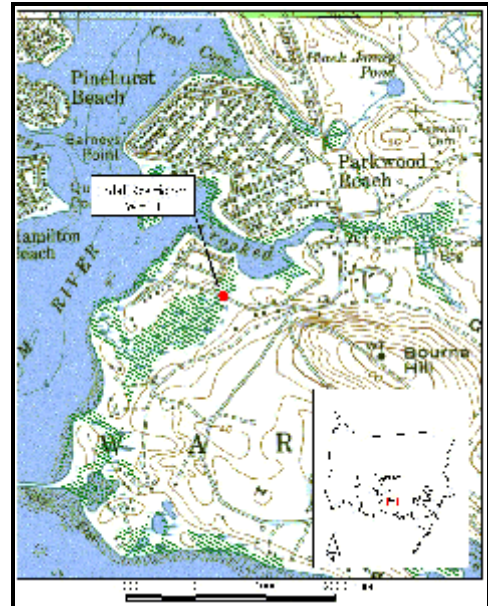
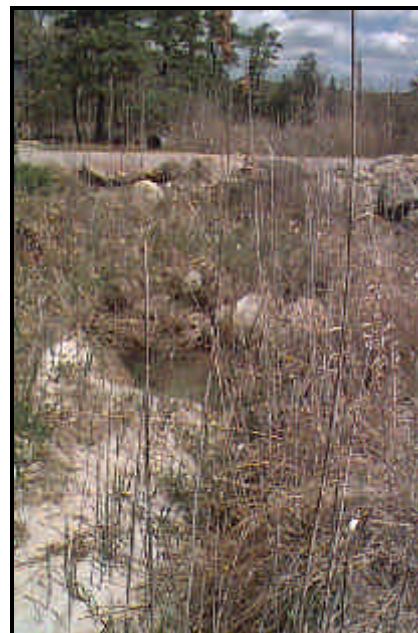
Tidal Restriction WH11

- Culvert condition - fair
- Restriction width - 1.5 feet
- Restriction length - 36 feet
- Channel width - 3 feet
- Acres of wetlands affected - 29.0
- Acres of *Phragmites* - 8.6

A four foot open box culvert and expansion of the channel could benefit this site.

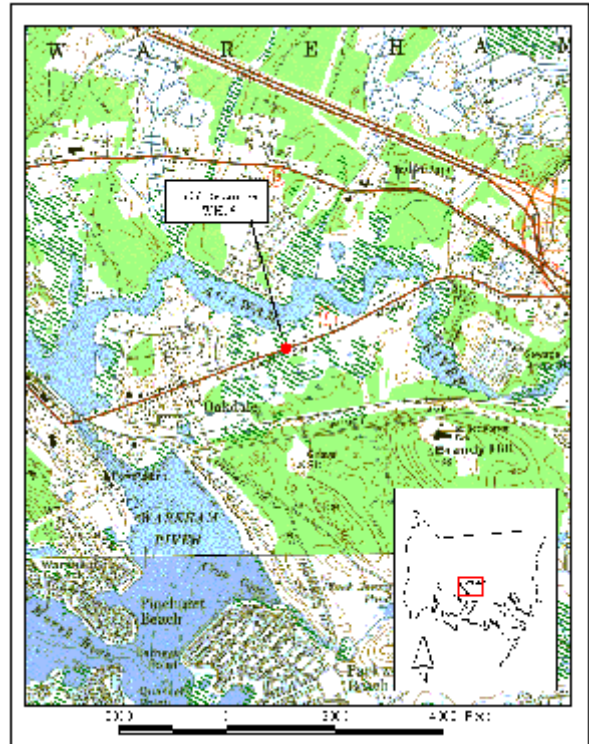
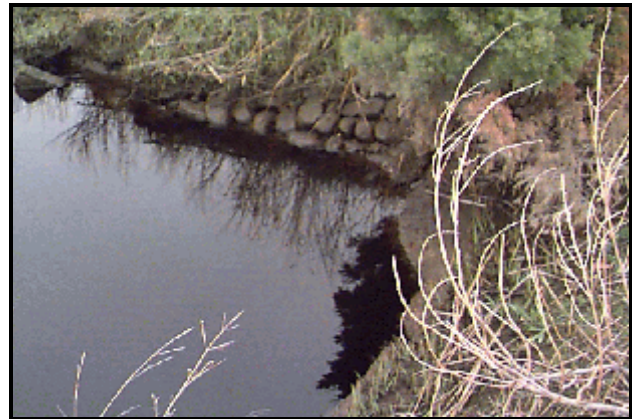
Tidal Restriction WH16

This restriction consists of a circular, 36" diameter, concrete culvert under a 36 foot wide, paved road. The headwalls on the structure are badly broken.

- Culvert condition - poor
- Restriction width - 3 feet
- Restriction length - 43.2 feet
- Channel width - unknown
- Acres of wetlands - 36.6
- Acres of *Phragmites* - 9.7

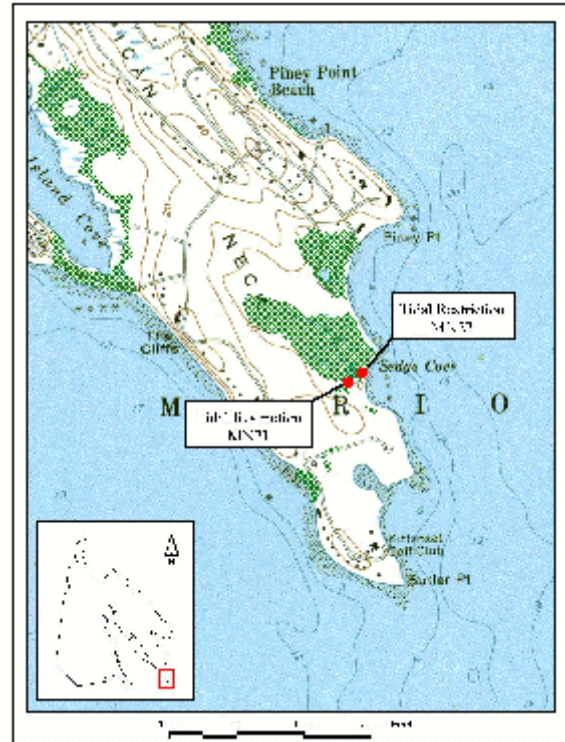
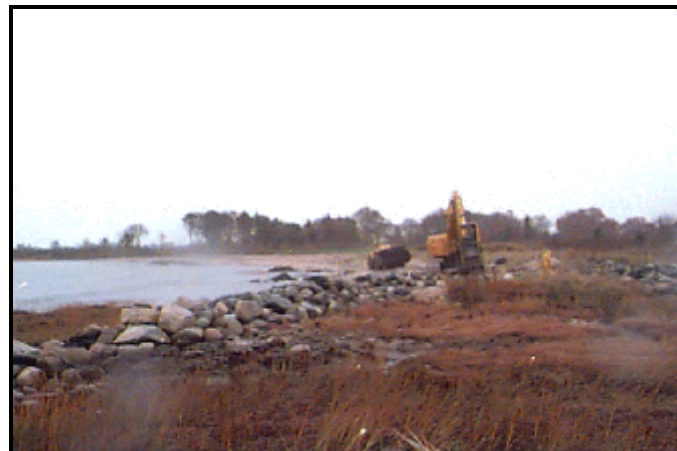
Removal of restriction MN22 (a stone wall across a salt marsh) during 1999.

This site was recently restored by the Kittansett Golf Club with technical assistance from the Buzzards Bay Project. At MN21, the culvert and a 50 foot length of stone wall was removed. At MN22, the 6 inch aluminum culvert under a dirt was replaced with three 12 inch culverts. This site was kept in the Atlas for reference purposes and because two other unremediated restriction also affect this marsh

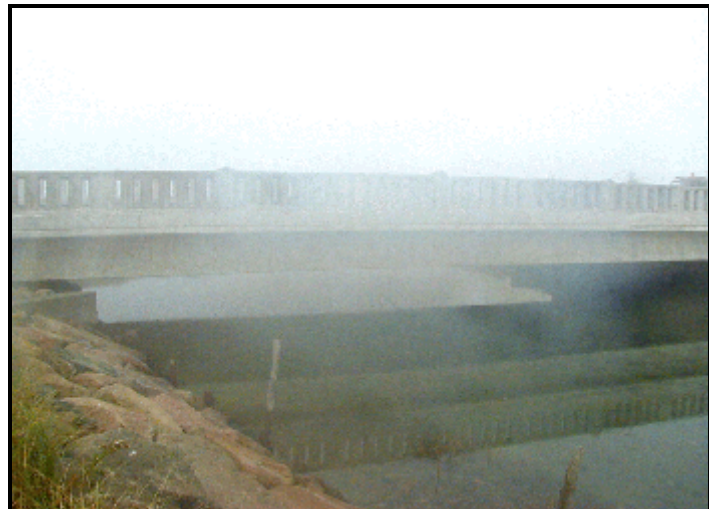
New Bridge at Old Silver Beach (FA23).

The bridge and foot bridge was recently reconstructed as a single bridge over the channel. Given this recent reconstruction, the only potential restoration at this site is channel dredging. The channel is very long and shallow, but it is unclear if dredging the channel under the road and to Old Silver Beach would result any benefit to this wetland system. This site is included in this report to acknowledge further study could be considered at this site.

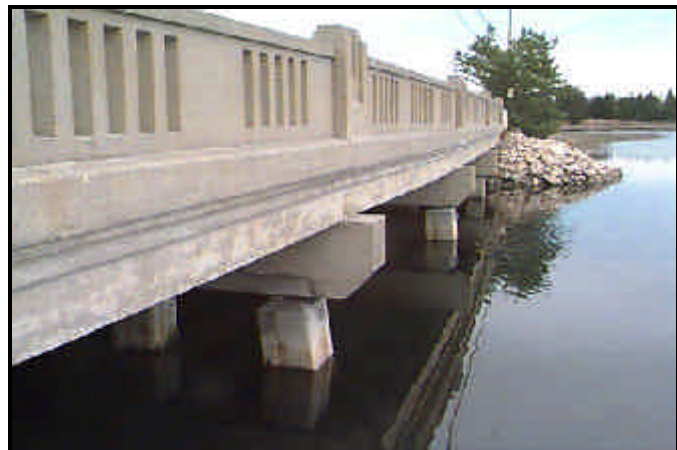
Close-up view of DA02

At this site, anecdotal information suggests the tidal circulation has diminished, and *Phragmites* cover has increased in recent years.

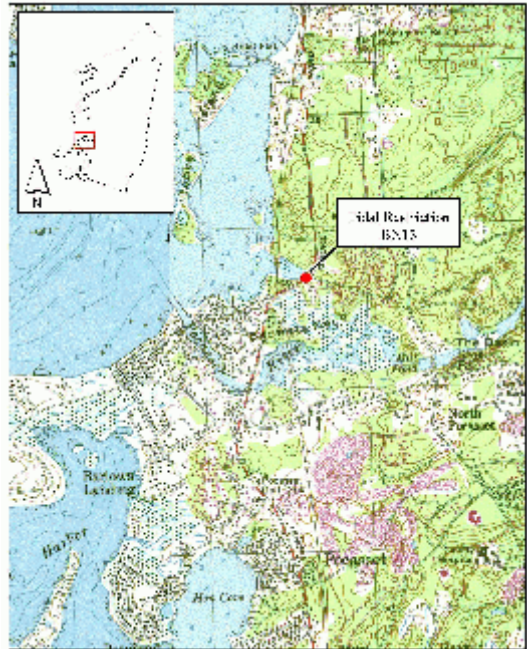
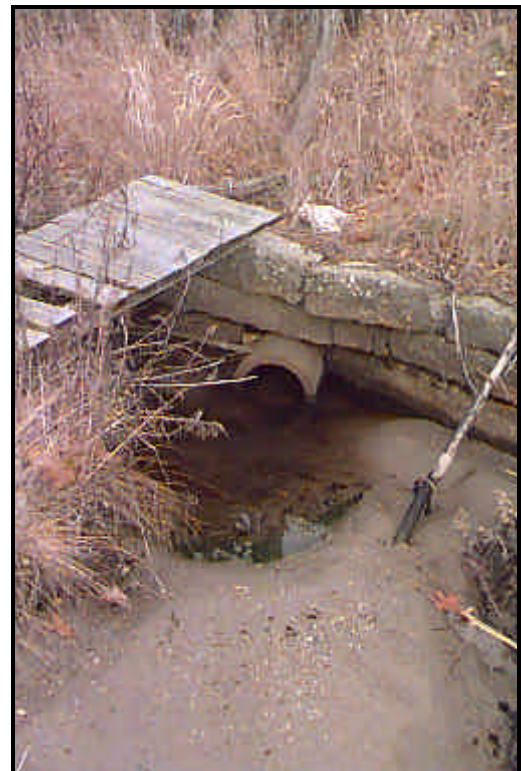
Tidal Restriction BN13

- Culvert condition - poor
- Restriction width - 2.7 feet
- Restriction length - 26.4 feet
- Channel width - 2 feet
- Acres of wetlands affected - 31.8
- Acres of *Phragmites* - 0.0

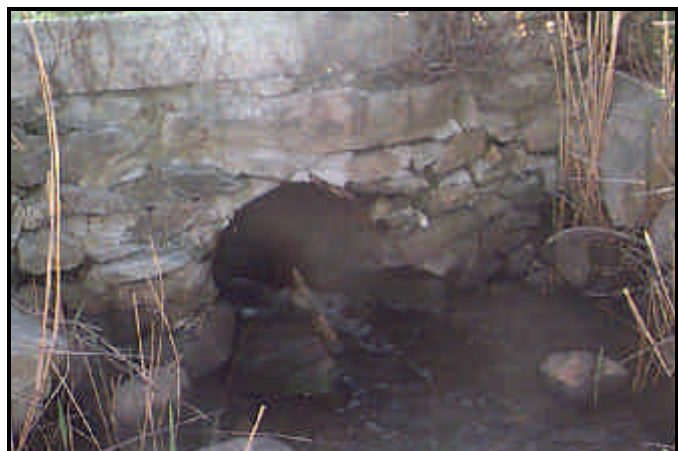
Cockeast Pond Restriction (WP01)

Restriction WP01 is a culvert under River Road at the edge of Cockeast Pond. The existing culvert has rusted through on bottom side. Historically this pond was fresh until the last culvert replacement after hurricane Carol in 1956. There is not sufficient salt water to establish *Spartina*. Species growing around the edge of the pond are *Phragmites* and narrow-leaved cattail, *Typha angustifolia*. The restriction is on town property. The restricted wetlands are privately owned and listed as habitat for rare & endangered species by the Natural Heritage & Endangered Species Program. The culvert is part of an anadromous fish run.

Restriction WP01 consists of a circular, 24 “ corrugated metal culvert under River Road. The road is 30 feet wide and paved.

Increased salt water flows to the pond may eliminate it as a breeding area for alewives. For this reason points were lost in the scoring for adverse impacts, and this site became ranked low. Instead of increasing tidal flow, it may be appropriate to further restrict tidal flow by elevating the culvert. This option is now being considered by the town and the Massachusetts Highway Department. It is included in this report because this site is a worthy freshwater remediation project.
