# Potential Habitat Restoration in the East Branch of the Westport River by Removal of Obstructions to Tidal Flushing at the Hix Bridge

Joseph E. Costa, PhD  
Buzzards Bay Project

Final  
October 10, 2000

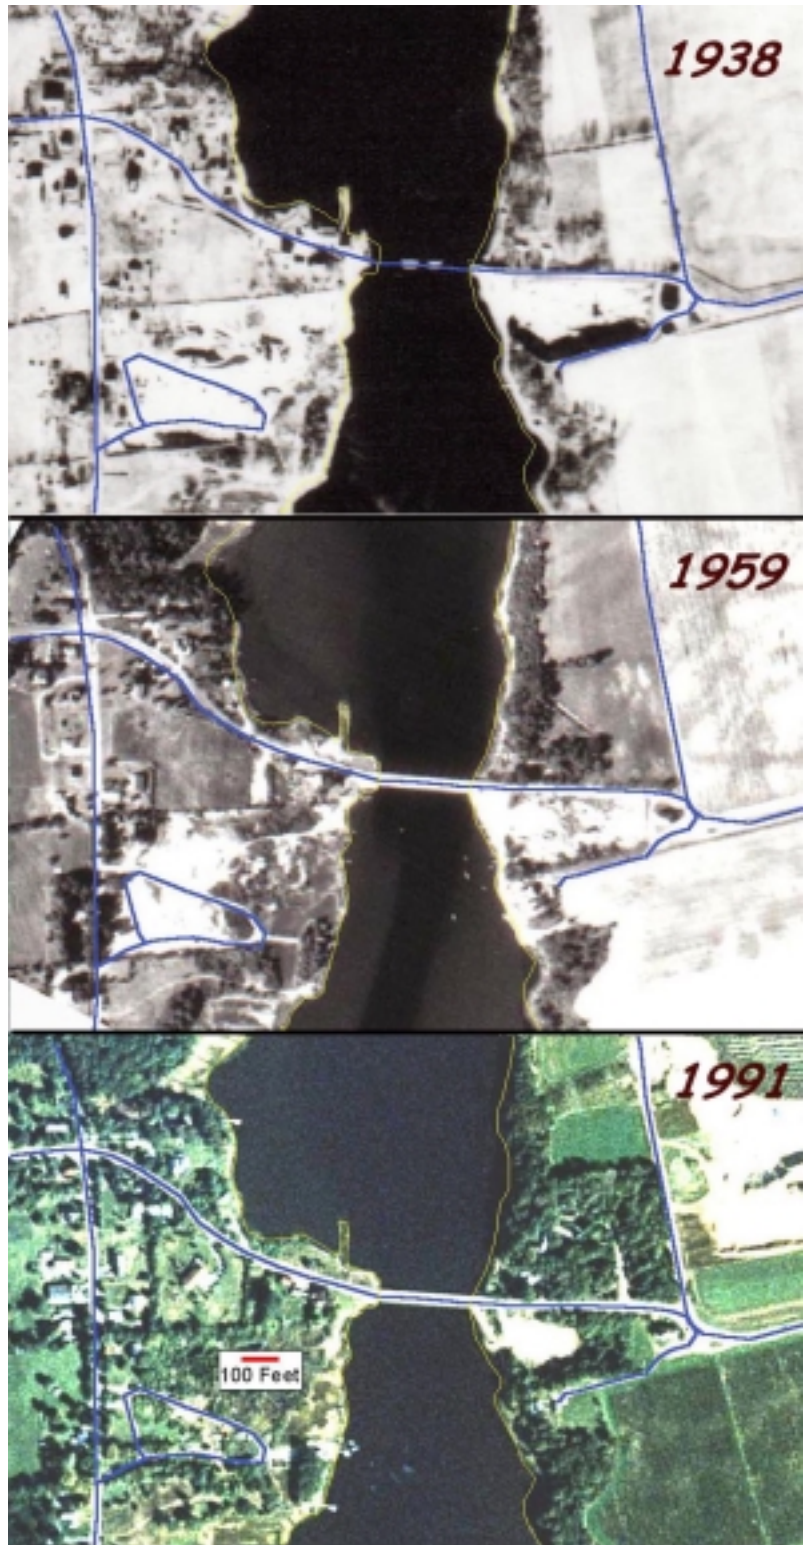
Figure 4 shows three aerial photographs of the site, including a photograph from December 1938, before completion of the existing bridge, and after the September Hurricane of 1938 (when the old bridge was damaged, and portions toppled into the river). These photographs show that little upland fill has been placed near the bridge, except at its western end, and that the boundaries of the river have changed little since 1938, except for some accretion on the eastern shore.

*Figure 4. Three aerial views of the Hix bridge dating from 1938, 1959, and 1991. Overall, river boundaries have been stable, but some filling and accretion may have occurred at the bridges west end, and along the eastern shore. The 1991 coastline is shown in each photograph.*

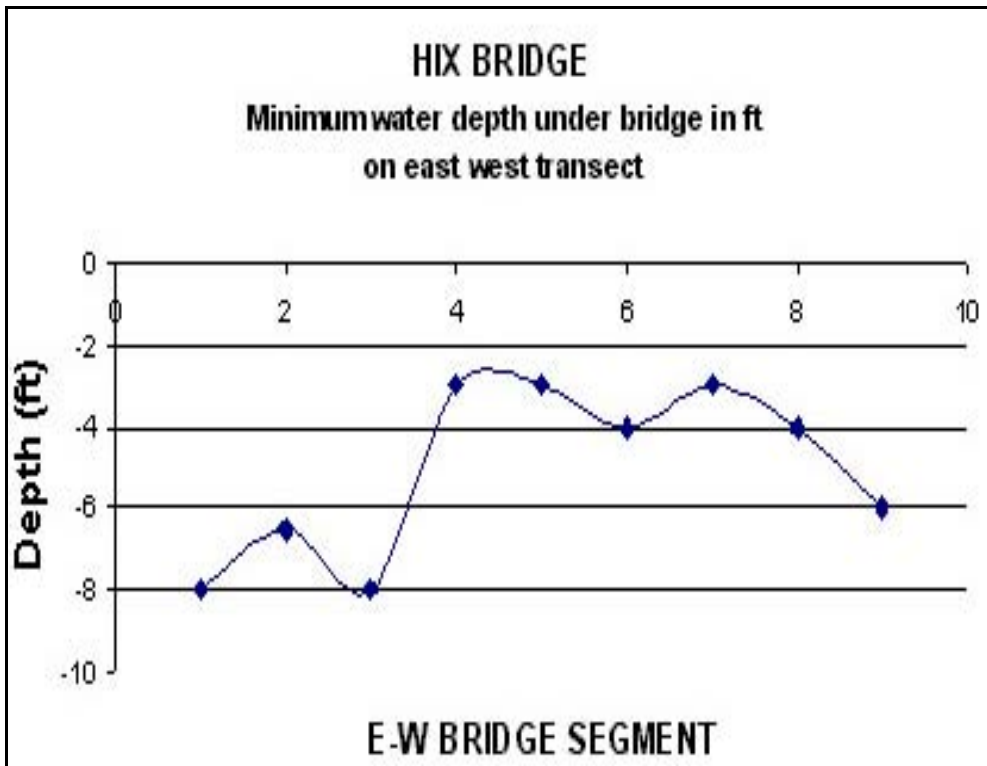
The depth of water under the bridge ranges from 3 feet mean low water (MLW) to 8 feet MLW (Fig. 5 and 6). Based on this bathymetric data collected by US EPA Narragansett, it has been suggested that fill was placed under the entire span of the bridge, especially since it is shallow for more than 2/3 of the bridge span. It has been contended that this fill may be restricting tidal flow and exacerbating pollution in the upper East Branch.

Figure 5. Depth under the Hix Bridge and to the north. Data courtesy of Ken Perez.

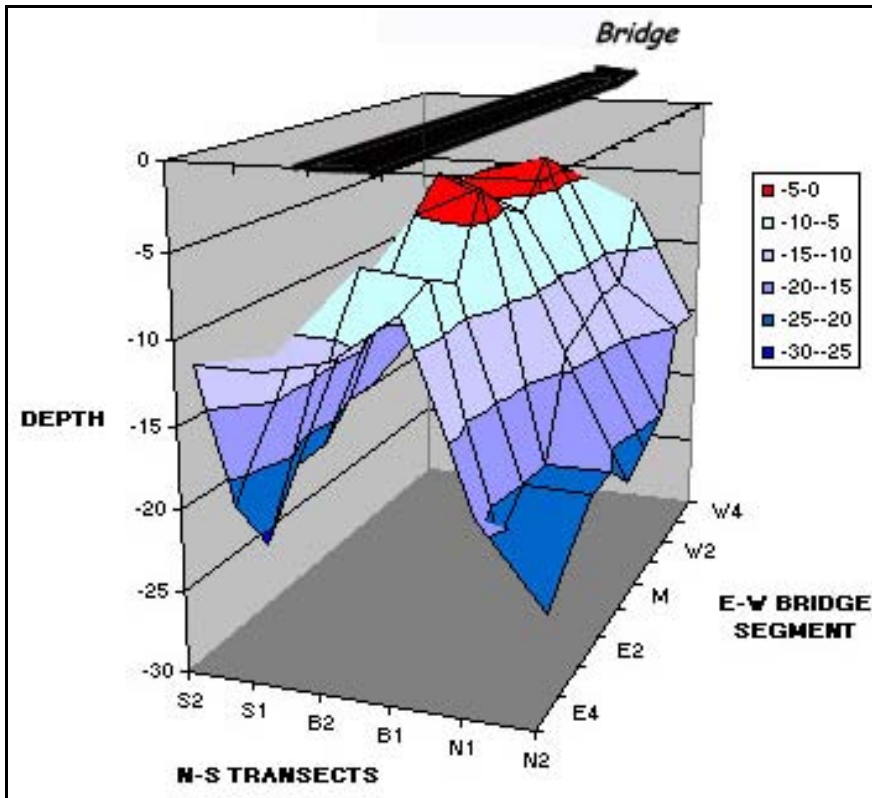
Evidence for this fill is also based on the additional underwater survey bathymetric data in Figure 6, which shows that the river depth exceeds 20 feet MLW on either side of the bridge. In contrast to the bathymetric data shown in Figs. 5 and 6, a bathymetric transect (Fig 7), and nautical chart bathymetric data (Fig. 8) north and south of the bridge show a natural channel of a depth of 7 to 9 feet MLW extending far north and south of the bridge. In fact, the deep areas north and south of the bridge (Fig. 7) are probably remnants of the earlier channel since these deep channels often occur in this type of estuary where the land forms a constriction.

Figure 6. Bathymetric Profile under the Hix Bridge based on EPA-Narragansett data. The data shows that there are deep areas on either side of the bridge.

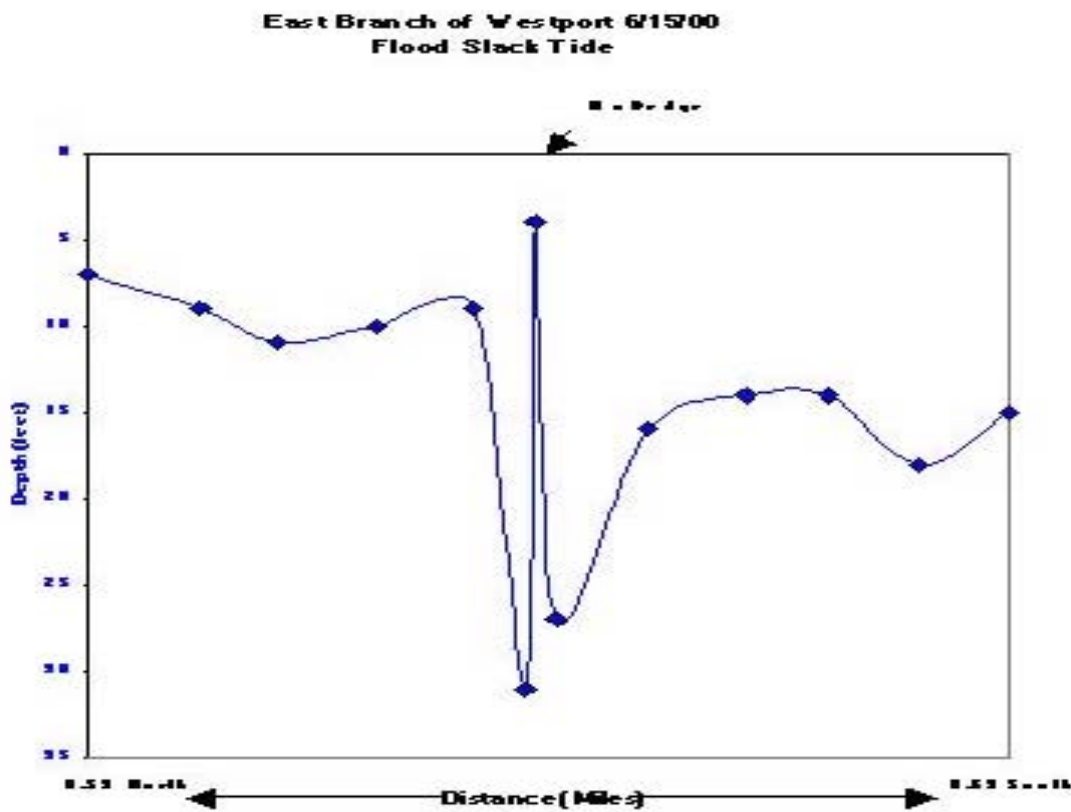
Figure 7. Mean river depth under the Hix Bridge and about 0.6 miles north and south. (Data courtesy of Ken Perez, USEPA.)

It is also possible that the hard fill under the bridge has caused scouring and removal of soft sediments on both sides as a result of strong tidal currents so evident in Figure 7.

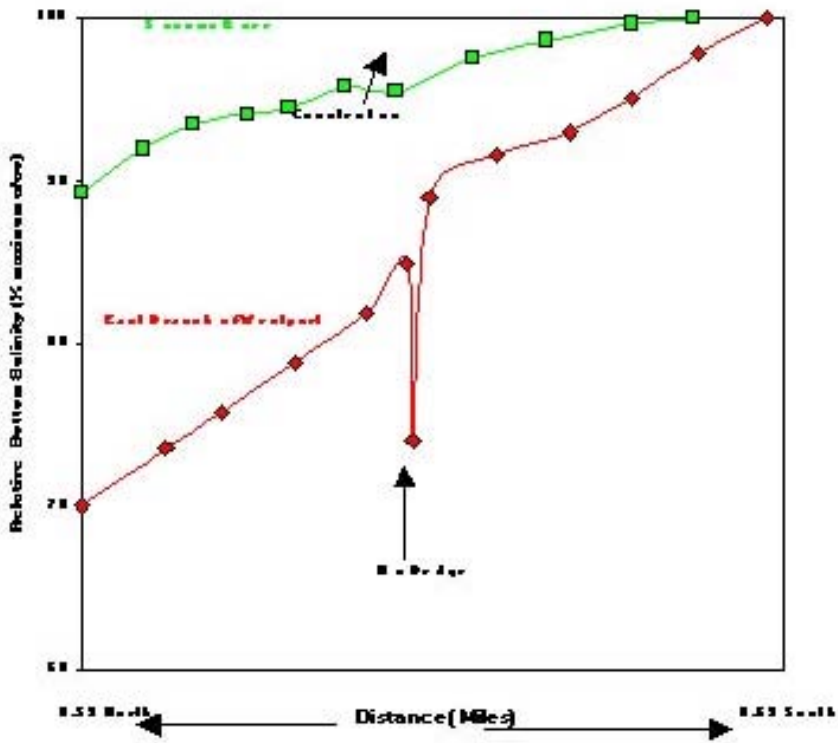
Figure 10 suggests that the sill barrier under the bridge alters surface salinity in a dramatic way compared to a comparable natural restriction in the Slocums River just a few miles to the northeast. This abrupt change in surface salinity is seen in ebb and flood tides (Figure 11).

Figure 10. Salinity transect north and south of the Hix Bridge compared to a similar natural constriction on the Slocums River.

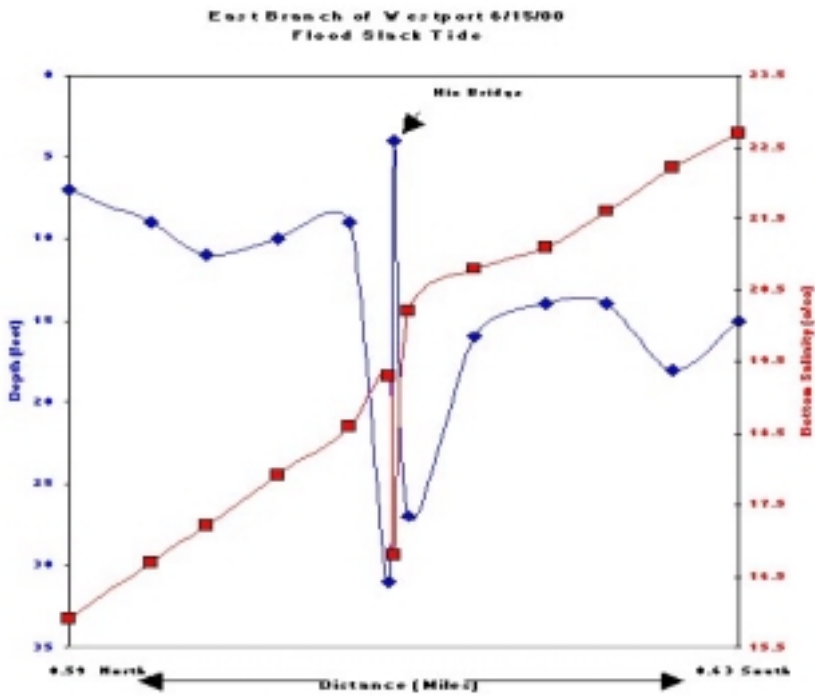
Figure 11. Comparison of salinity transect north and south of the Hix Bridge during ebb and flood tides.

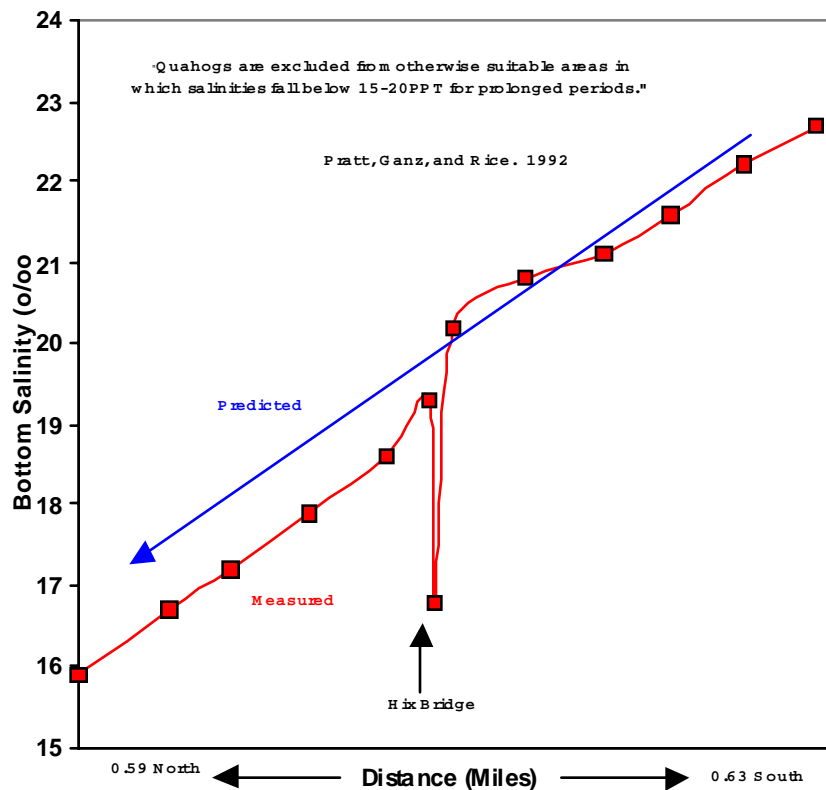
Figure 14. Prediction of salinity change with removal of tidal restriction

- Removal of the restriction is expected to increase salinity by about 1 ppt for more than a half mile north of Hix Bridge (Fig. 14). This may result in the expansion of quahog areas north of the bridge and a migration of oysters to the north. Will the salinity increases and tidal range be sufficient to reduce *Phragmites* populations?

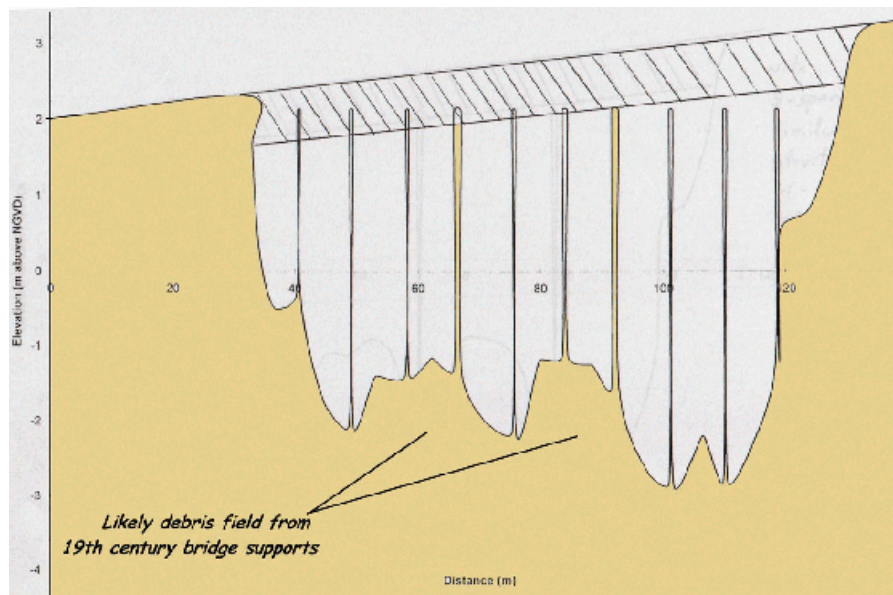
The fill present under the bridge includes large cut granite blocks. These are especially evident in the Western two-thirds of the span. These blocks are the remnants of the old bridge columns, which were knocked into the water, mostly on the north side, when the 1939 bridge was built, and from the 1938 hurricane.

The debris under and just north of the Hix Bridge restricts tidal flushing, which in turn lowers salinity north of the Hix Bridge. This lowered salinity may have contributed to the expansion and invasion of the Common Reed *Phragmites* into fringing salt marshes, eliminating valuable salt marsh habitat. Elimination of the tidal restriction will elevate salinities by at least 1 ppt, and possibly more near the surface. This increased salinity could contribute to the stabilization or possibly decline of the invasive *Phragmites* beds, and also may contribute to the expansion of soft shell clam and quahog populations north of the bridge.

Figure 15. Bottom profile under Hix Bridge from 1997 Hydraulic Report prepared by Lamson Engineering Corporation.

- How much of the old debris in Figure 15 should be removed, and how much will this work cost?

It is warranted to conduct at this time a more detailed evaluation of the cost and potential benefits or adverse effects from the removal of this fill.
