STUDY ON EEL POND IMPROVEMENTS

June 2005

Revised January 2006

Town of Mattapoisett
Board of Selectmen

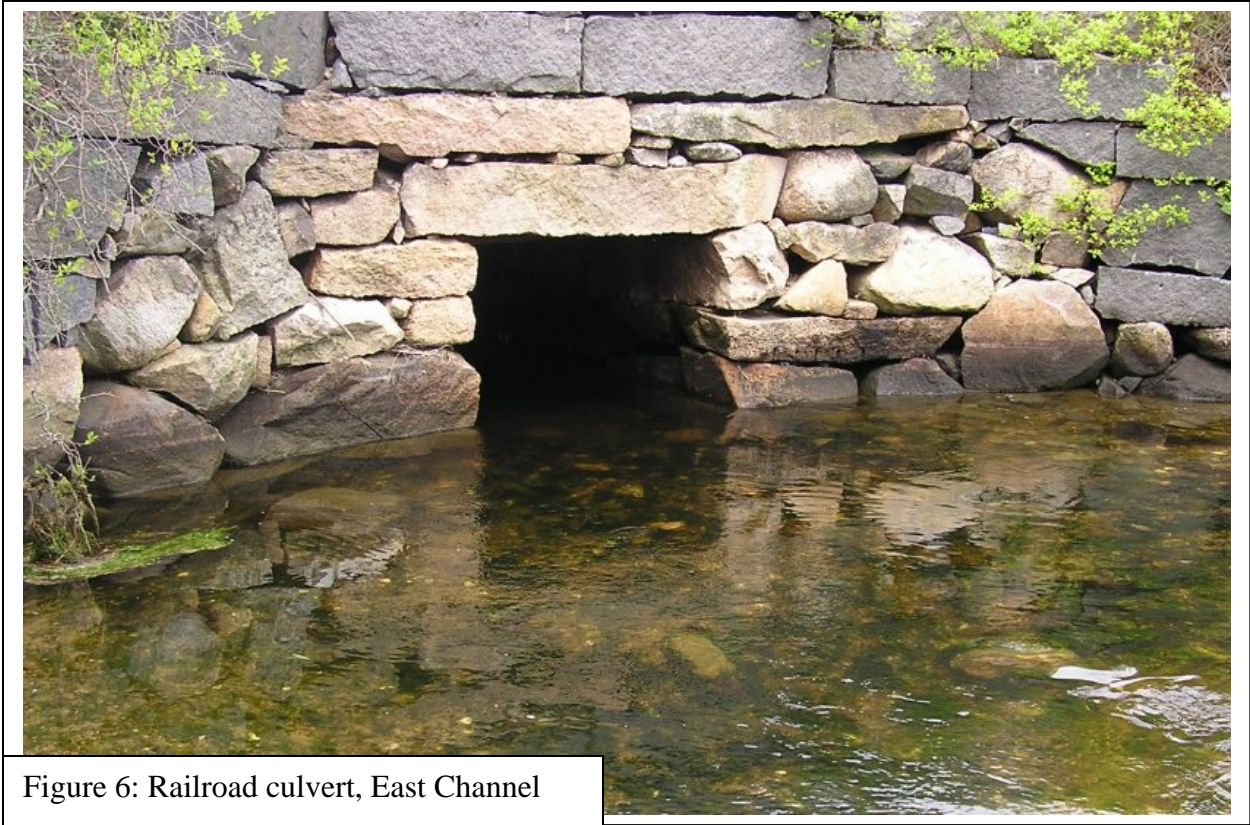
Figure 6: Railroad culvert, East Channel

2. It can also be noted that at the present time approximately 85% of the present tidal flow occurs through the West Channel, with the remainder of 15% flowing through the East Channel. This imbalance occurs for a number of reasons; however, two conditions are the primary cause: one is a restriction caused by the Rail Road Culvert, which measures only 5.0 feet wide by 5.5 high, with an invert elevation of +1.3 MLW (0.0 NGVD) (See Figure 6). The second restriction occurs all along the East Channel before it empties into Mattapoisett Harbor. The restriction is caused by the shallow, almost braided condition of the east channel (in general), which culminates near the harbor jetties where an area of large gravel that runs the width of the channel that is at approximately elevation +2.5 MLW (+1.2 NGVD), (See Figure 7).

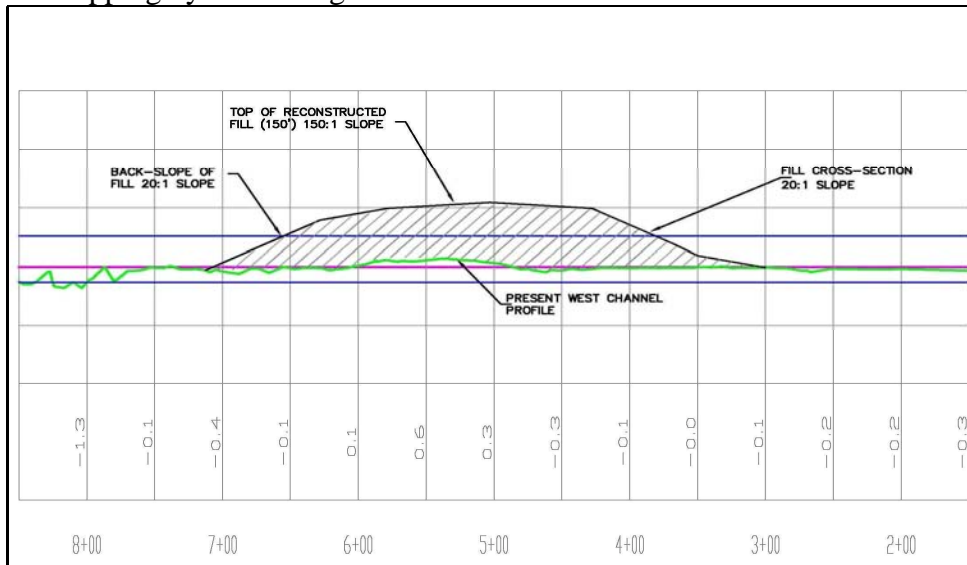
Figure 12: Profile of closing the West Channel

A Phase 2 program could also be instituted when funding becomes available to install a new culvert under the railroad embankment. The flow calculations that were used to size the culvert indicate that the culvert should be about 24 feet wide by 8 feet high, with an invert depth of -1.7 feet MLW (-3.0 NGVD). It should be noted that while smaller culverts would function well in most rainfall storm events, a 24 foot culvert would allow for a reasonably secure closure of the West channel, and would give reasonable assurance that erosion would be contained and the West channel would remain closed in the event of a barrier beach overtopping by storm surge.

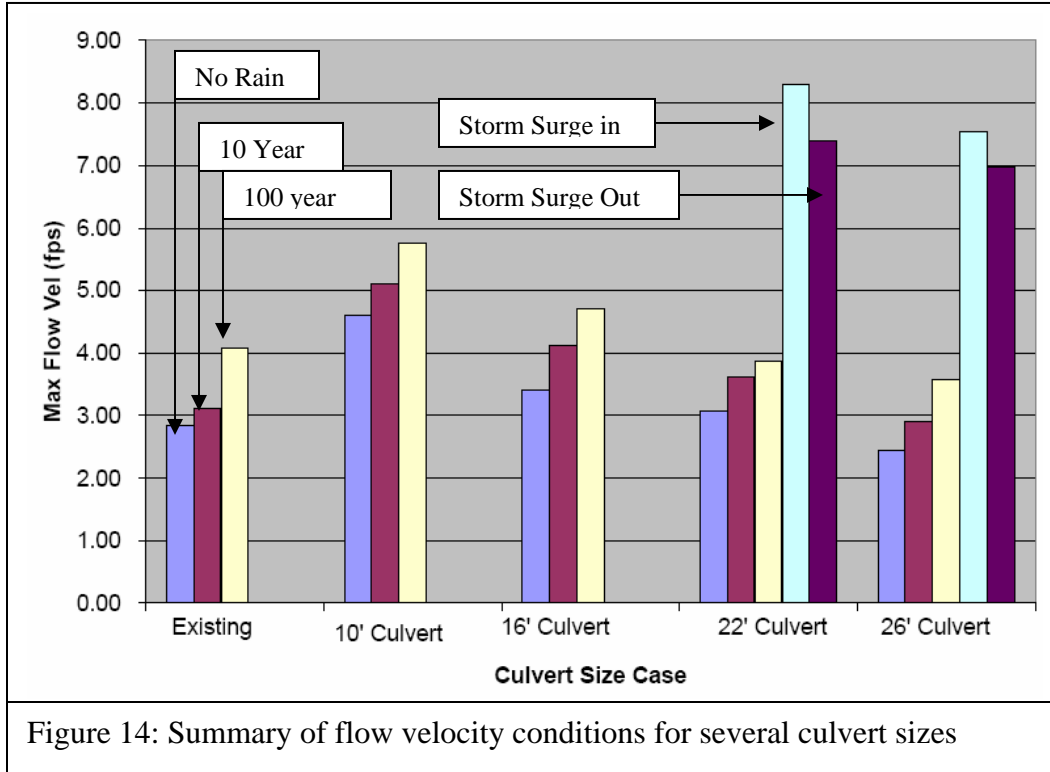
Table 5 is summarized in Figure 14, which provides an overview of the flow velocity conditions that would occur through a new culvert for a number of storm events with the West Channel blocked. The existing conditions are also provided for comparison.

Normal peak flow velocities through the existing railroad culvert with the West Channel open, range from between 2.8 and 3.2 feet per second, occasionally the flow could exceed 4.0 feet per second. This seems to have been a stable condition at the existing culvert for many years. Even so there is still evidence of scour at the openings, which leads one to the opinion that it is not prudent to change the culvert condition to exceed these flow values. It can be noted from the chart and the preceding analysis that dredging and closing the West Channel would require the enlargement of the existing railroad culvert. A number of hydrographs were computed using culverts that ranged in size from 10' (W) by 8' (H), to 26' (W) by 8' (H); each culvert was also checked for performance during a classic 10 and 100-year storm rainfall event. The tidal elevation and hydrograph charts are included as Exhibits 30 to 57. It can be ascertained by viewing these charts that a 10' x 8' culvert is too small for most rainfall storm events, as flow velocities and durations would increase considerably, also a 16' x 8' culvert shows only a slight increase. Under all rainfall "only" conditions the 20' x 8' and the 24' x 8' culverts showed reduced flow velocities, and considerably improved flushing of Eel Pond.

The deciding and most unpredictable condition of storm surge however rules out the 20' x 8' culvert, as flow velocities during a storm surge event could exceed 8 feet per second. To further demonstrate the severity of high flow velocities Figure 15 shows the water elevation difference from one side of a 26 foot culvert to the other, as well as the water level difference from the first small pond to the second. (The model used a 26-foot size culvert to account for the proposed 24-foot culvert in addition to the cross-sectional area of the existing culvert).

The conclusion of the culvert design study is that the minimum culvert size to be considered would be a 24' x 8' culvert, and that the culvert wings and inverts should be protected from scour. The rationale for a conservative design is substantiated by the need to protect the sewer main that is buried within the embankment during a storm surge event.

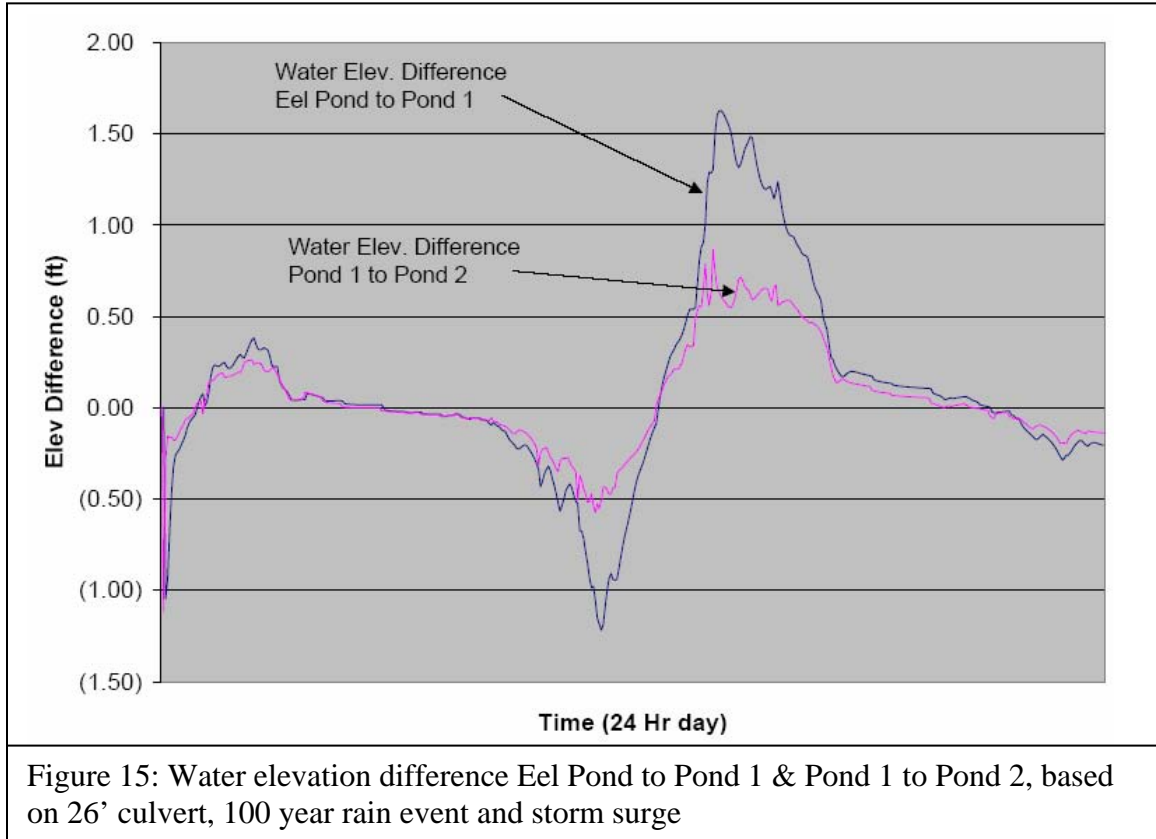
Figure 15: Water elevation difference Eel Pond to Pond 1 & Pond 1 to Pond 2, based on 26' culvert, 100 year rain event and storm surge

During the peak incoming surge the water elevation from one side of the culvert to the other will exceed one foot for a short time (this is not considered serious), however during the outflow of the storm surge the flows would reach such velocity that the water elevation from one side of the culvert to the other would exceed one foot for over 2 hours, and would exceed 18" for about 30 minutes. This is sufficient time for serious erosion to occur, thus it clearly indicates that the wing walls and invert of the culvert would need to be heavily armored. The lower line on the chart also shows considerable elevation difference between Pond 1 and Pond 2, indicating considerable flow velocities occurring in the channel between the two water bodies. This clearly indicates that the size of the planned dredged channel of 30' base width and -2.7 MLW (-4.0 NGVD), is also a minimal channel design, since a smaller channel would only cause more flow restriction during a storm surge event, and thus more potential for erosion damage.

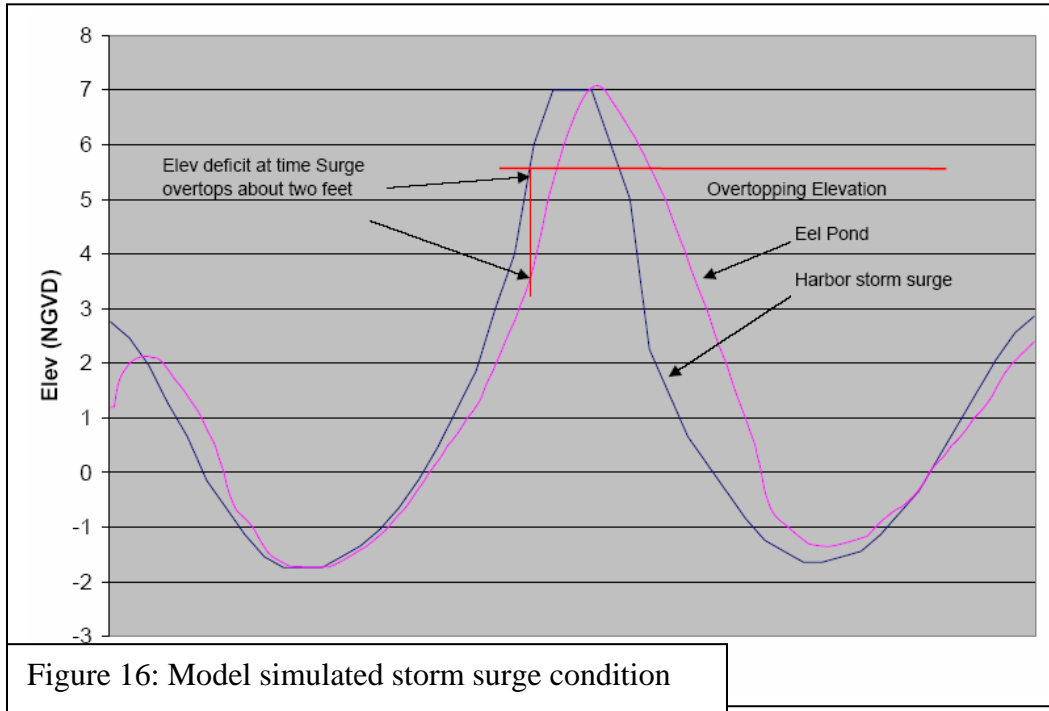
Also of concern is the erosion that would take place at the barrier beach and blocked West Channel as the overtopping occurred. Figure 16, which shows the water elevations in Eel Pond versus the Harbor elevations as the storm surge approaches. Note that at the point of overtopping, the water level in Eel Pond is about 2.5 feet lower than the Harbor. This condition while it will start as a trickle, will quickly increase in size, volume and velocity until the water level in Eel Pond matches that of the storm surge elevation. This will cause a condition that will quickly cause erosion to the West Channel plug and the beach crest, how much erosion takes place will depend on the amount of time that the water levels remain different between Eel Pond and the surge elevation. Historically, however the more severe erosion takes place as the surge recedes, as the erosion from the incoming surge usually creates gullies that become focus point of residual outflows. Again, the severity of erosion is proportional to the time that the water elevations remain different. A larger railroad culvert will reduce the time required for both transitions to take place, and thus will reduce the severity of the erosion.
