**BROAD MARSH RIVER  
STORMWATER REMEDIATION PROJECT  
1993 - 1998  
(DEP Project No. 93-01/319)**

final report

**DEP Project No. 93-01/319  
NONPOINT SOURCE PROJECT NUMBER: C9001214-93-1**

**final report  
July 3, 1998**

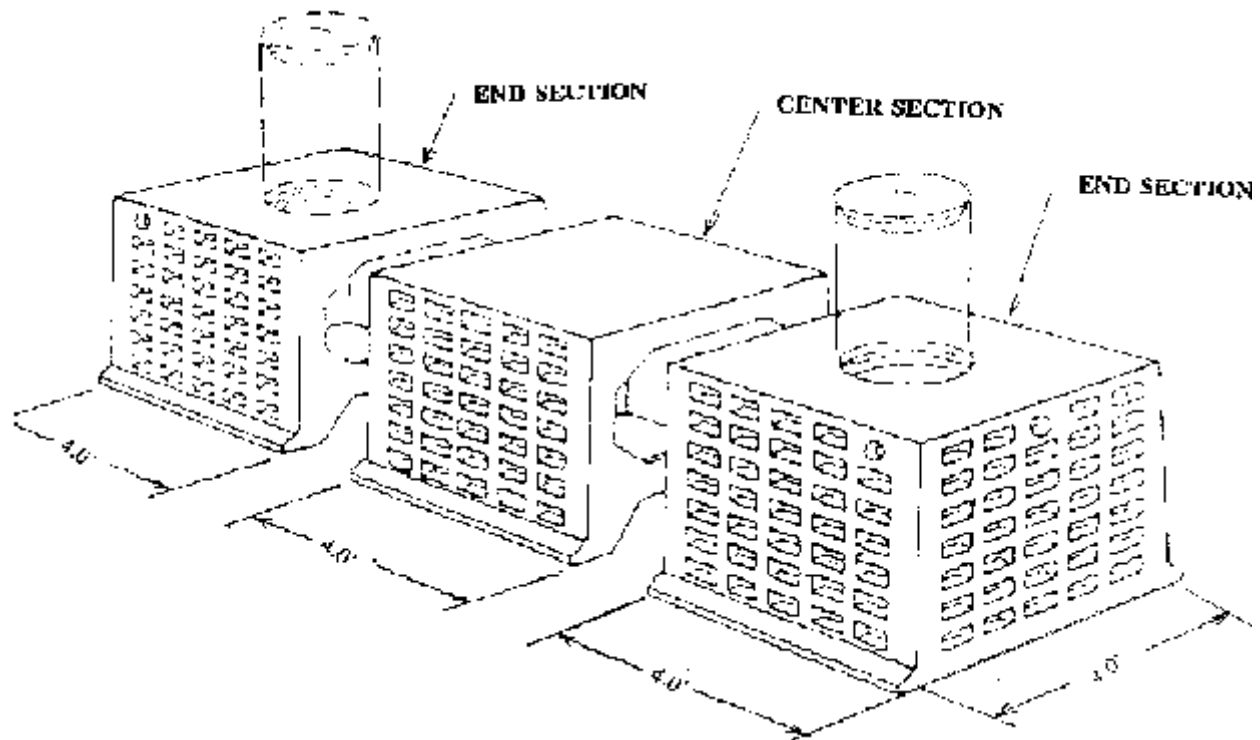
**Figure 4.** Precast galleys used at site.

types of infiltration structures, concrete leaching galleys and plastic infiltration chambers. The four by four galleys (Figure 4) were designed to be installed in areas with adequate separation to groundwater, Sites A, B, C, D, E, G, H, J, K and N (Figure 5).

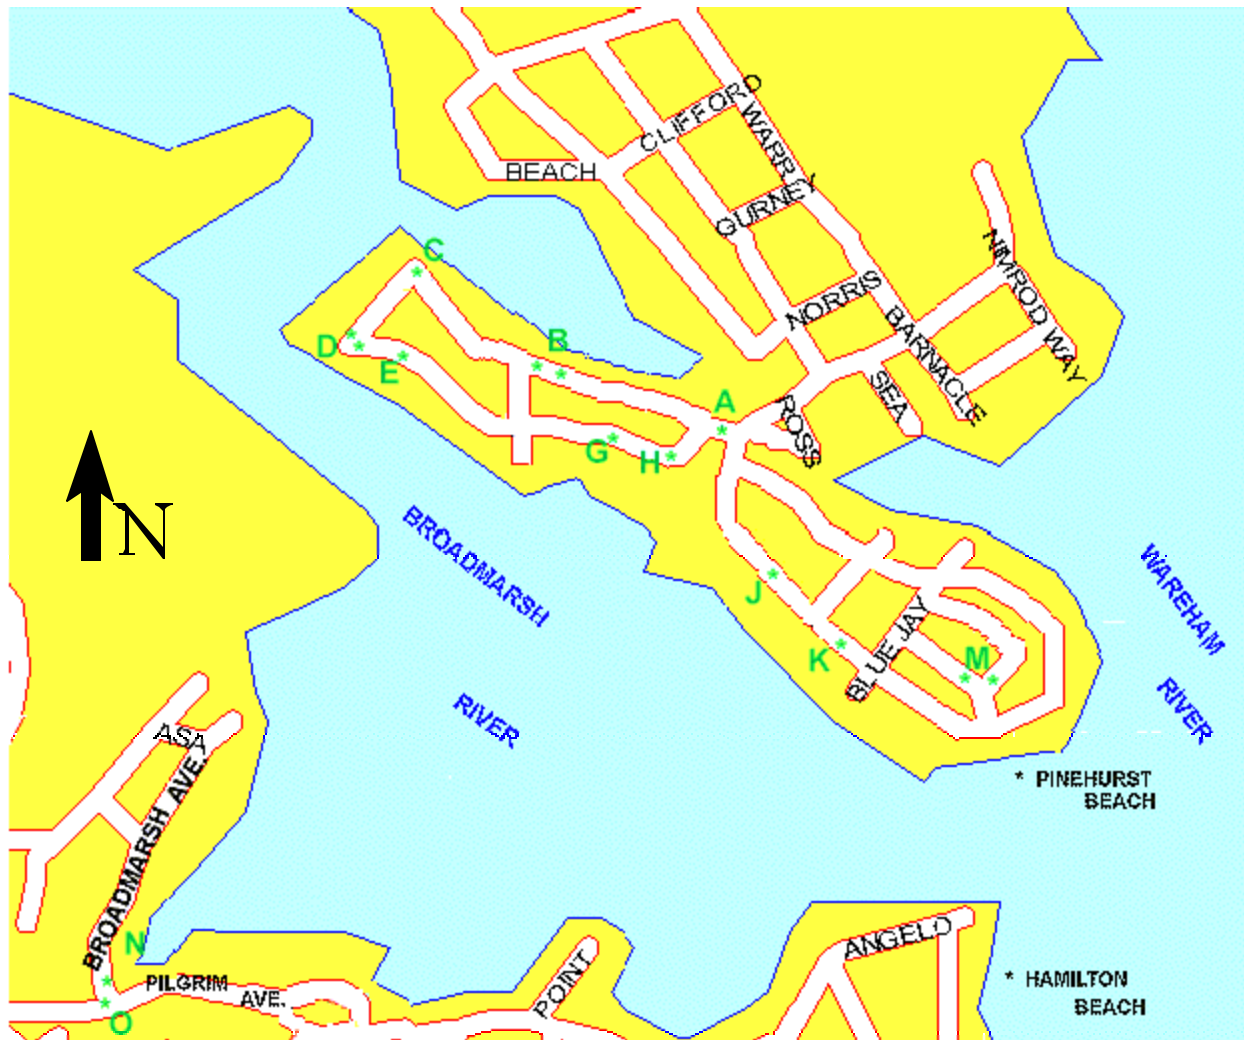
Figure 5. Location of precast galleys.

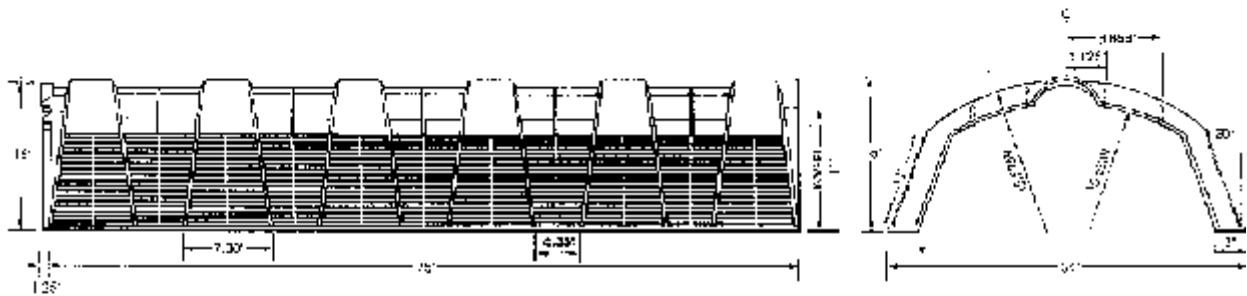
## THE HIGH CAPACITY INFILTRATOR® CHAMBER

SPECIFICATIONS	HIGH CAPACITY INFILTRATOR®
SIZE	3' x 6.25' x 1.53'
WEIGHT	30 lbs.
STORAGE	16.3 ft <sup>3</sup> (122 gal.)

**Figure 6.** Plastic chamber schematic.

The plastic chambers (Figure 6) were for use in areas with shallow groundwater, Sites F, L, and P (Figure 7). Two of the sites, M and O, have a combination of the galleys and plastic chambers. To provide adequate storage for the first half inch of runoff and provide adequate groundwater separation, some of the overflow pipes at the existing catch basins needed to be turned upwards with a 90-degree elbow (Figure 8). In addition, fifteen new catch basins were part of the design to accommodate utility lines. Based upon previous evaluations of infiltration basin BMPs, the approximate removal rate of stormwater bacteria is expected to be 80%.

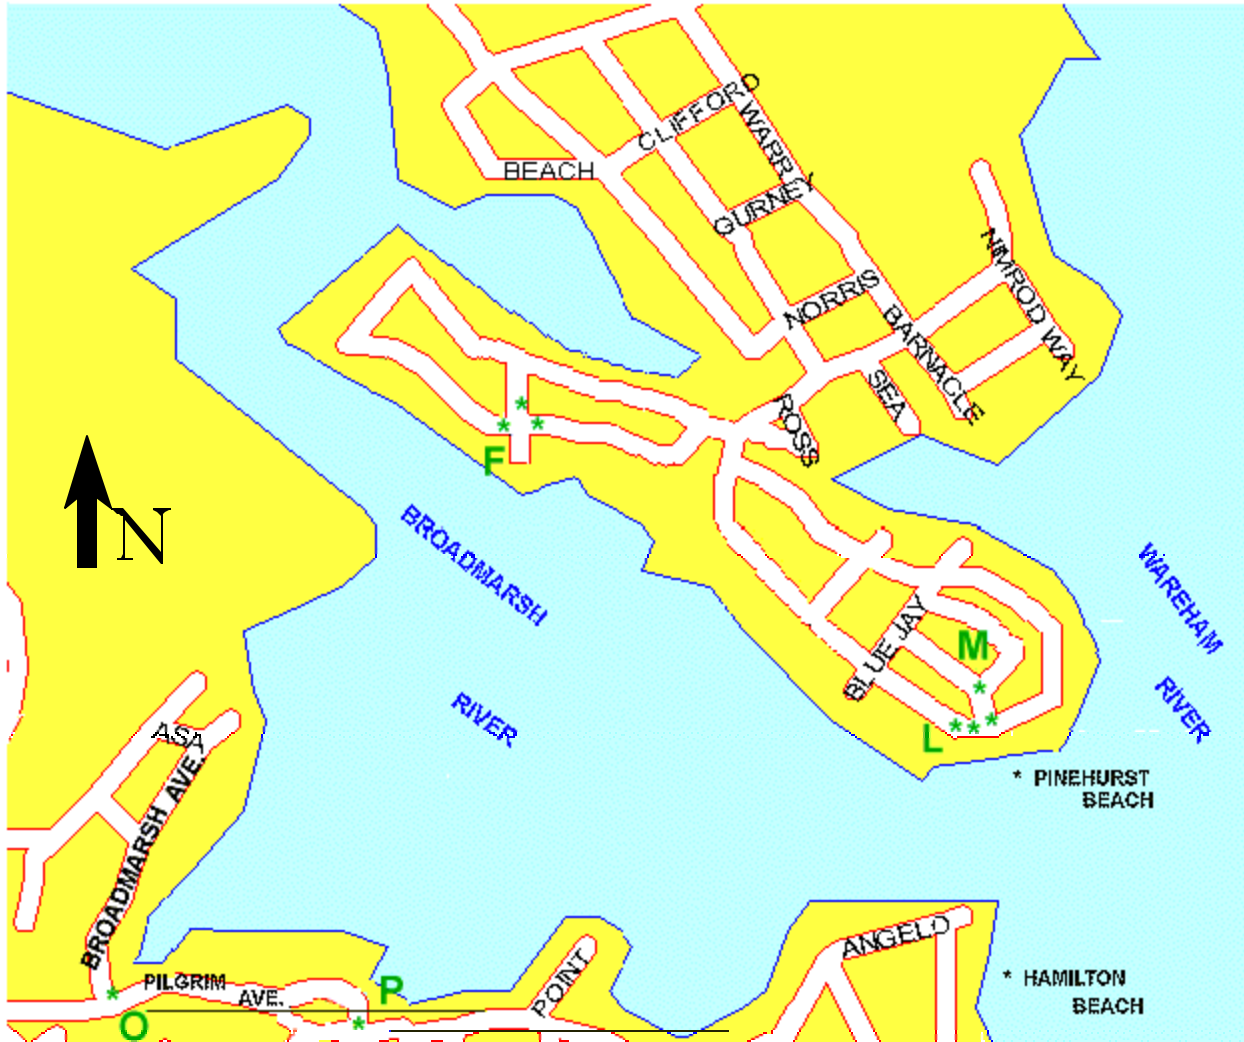
Figure 7. Location of plastic chambers.

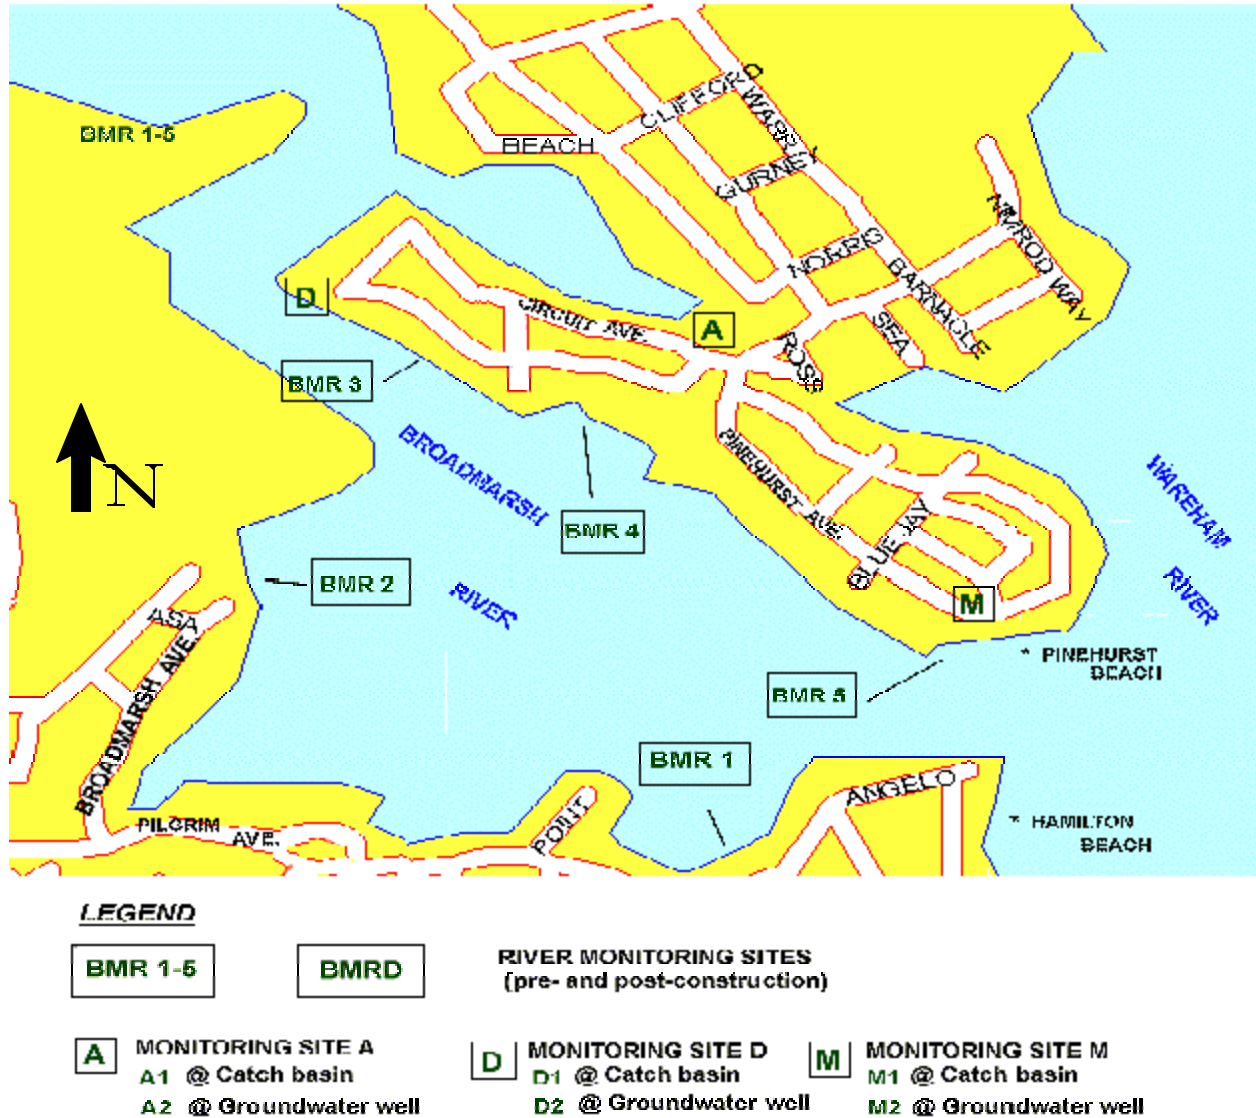
Figure 10. Location of infiltration monitoring stations.

As soon as construction was completed, the Division of Marine Fisheries began a visual inspection of the stormwater discharges (Figure 10). In August, DMF noticed that Sites N and O had stormwater

Monitoring of the infiltration structures during a rain begins with the sampling of stormwater at the catch basins. The catch basin grate is removed and the pretreatment sample collected (Sites A1, D1, and M1 - Figure 10). Following the catch basin samples, water samples are taken from the river (BMR1-5 and BMRD). The post-treatment samples are the final samples and are collected from the monitoring wells (A2, D2, and M2) using the bailers. Salinity and temperature are recorded for the river samples and the well samples.

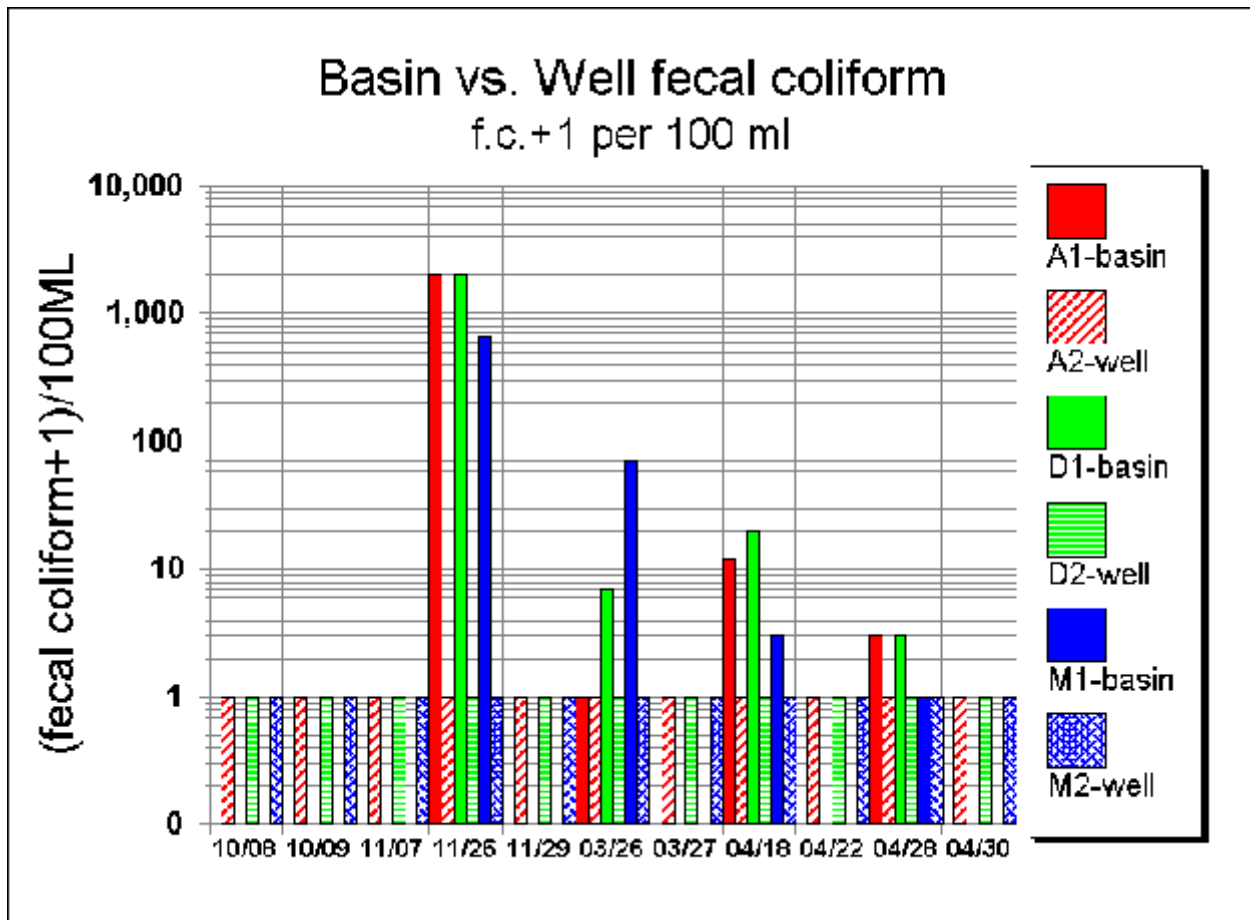
Figure 11. Comparison of well vs basin fecal coliform concentrations. Monitoring for 1996 to 1997.

The Buzzards Bay Project monitored three leaching basins and adjoining wells. These data are consistent with similar studies, namely that infiltration is a highly effective mechanism for eliminating fecal coliform discharges. As shown in Figure 11, even when fecal coliform levels reach 2000 fecal coliform per 100 ml in November of 1996, where there was 6.42" of rain over four days, 100% of the fecal coliforms are removed. In fact, only on one date was any fecal coliform ever observed in the well samples. In both cases the concentrations were only 1 per 100 ml. On April 18, 1997, fecal streptococci were monitored in the three wells and in stormwater in the infiltration basins. While infiltration is not as effective in removing fecal streptococci (Figure 12), probably because of the bacteria's smaller size, the percent reduction in the three basins nonetheless ranged from 51% to 98%.

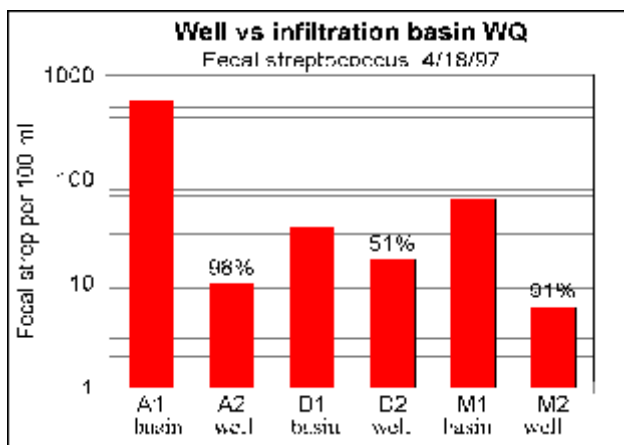
Figure 12. Fecal streptococcus in basin stormwater versus well groundwater concentrations. Percent contaminant reductions in well adjacent to infiltration basins are shown.

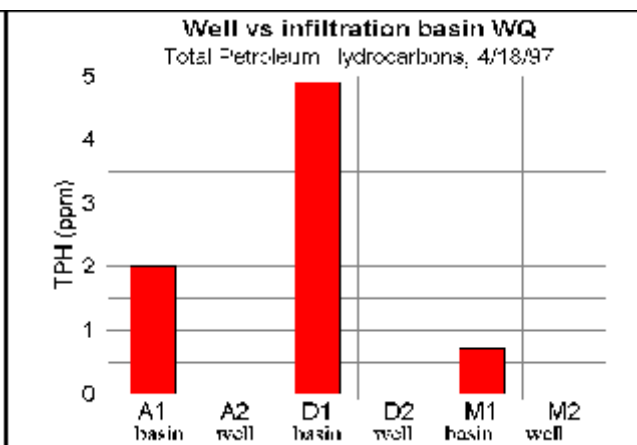
Figure 13. Total Petroleum hydrocarbons in basin stormwater versus well groundwater concentrations. All wells were below 0.5 ppm limit of detection.

Total Petroleum Hydrocarbons (TPH) were also measured on that date, and the wells were all below the 0.5 ppm detection limit for the analysis (Figure 13).

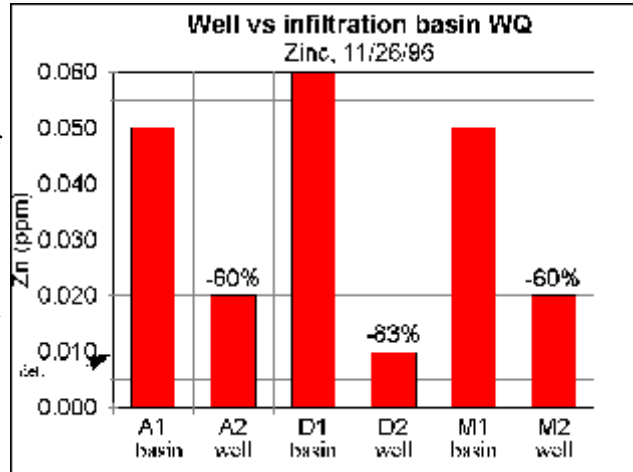
Figure 14. Comparison of infiltration basin and well samples showing percent removal of zinc. Detection limit was 0.5 ppm.

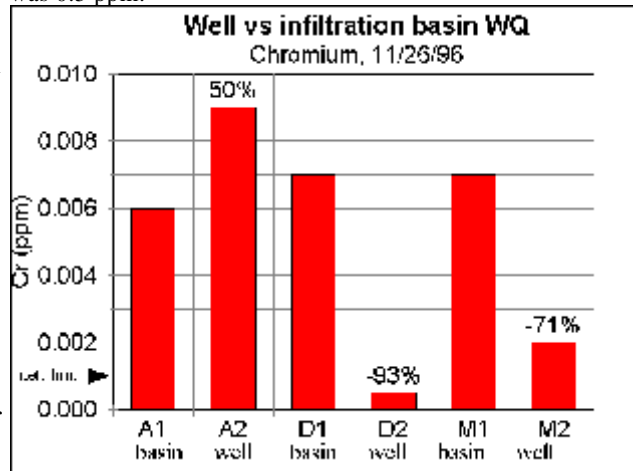
Figure 15. Comparison of infiltration basin and well samples showing percent removal of chromium. Detection limit was 0.5 ppm.

For other metals, even when elevated, removal results were not always consistent. For example, on 11/26/96, at the catch basins for sites D and M, chromium concentrations were 93% and 71% lower in the wells than in the catch basins, however chromium in well A2 was actually 50% higher than corresponding infiltration basin A1 (Figure 15).

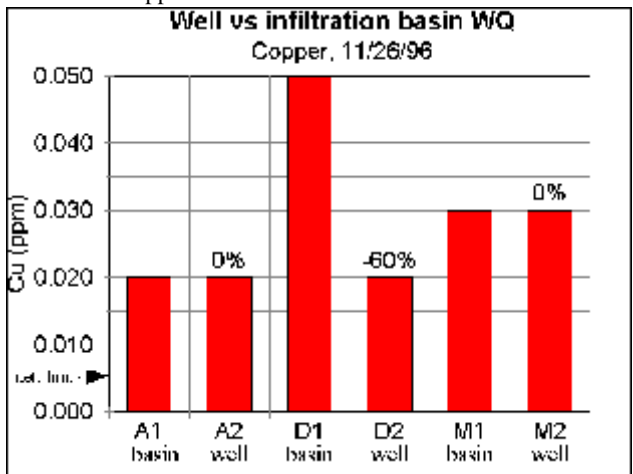
Figure 16. Comparison of infiltration basin and well samples showing percent removal of copper. Detection limit was 0.5 ppm.

The lack of change in some metals like copper and lead may reflect the fact that overall metal concentrations were very low at this site, close to the limits of detection (or in the case of lead, at the limits of detection) for the analysis used. The one site where copper showed a decline was at well-basin test site D, which had a copper concentration about double the concentrations observed at the other two sites. Thus, it is possible that these infiltration basins would be ranked more effective in a more urbanized area where metal concentrations are expected to be higher.

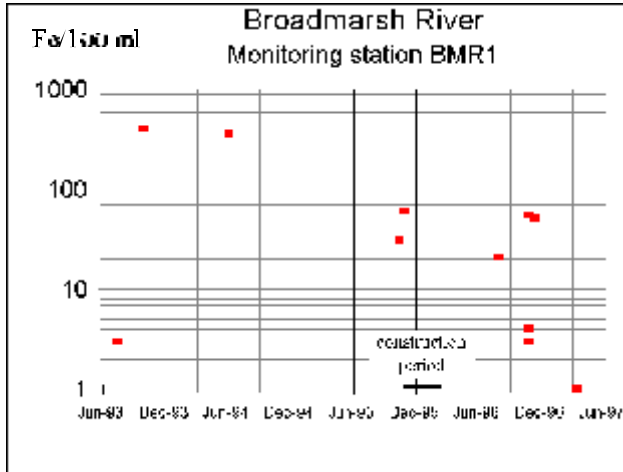
**Figure 17.** Broad Marsh River station 1 fecal coliform concentrations documented by Buzzards Bay Project.

For stations 1, 2, 3, and especially station 5, the October 1993 fecal coliform levels were consistently higher in fecal coliforms than the comparable August 1996 and March 1997 dates. Only at Station 4 was this trend not observed.

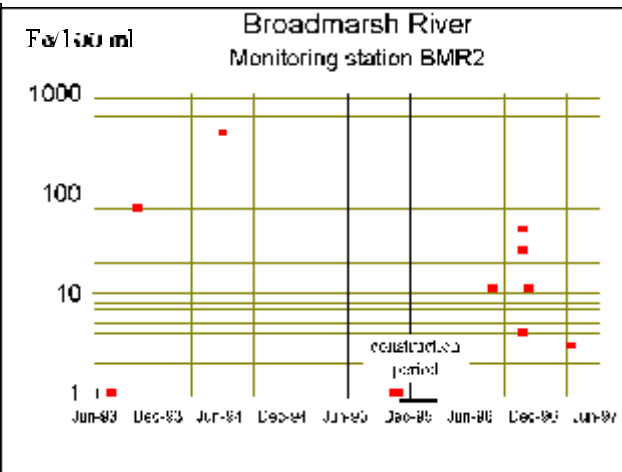
**Figure 18.** Broad Marsh River station 2 fecal coliform concentrations documented by Buzzards Bay Project.

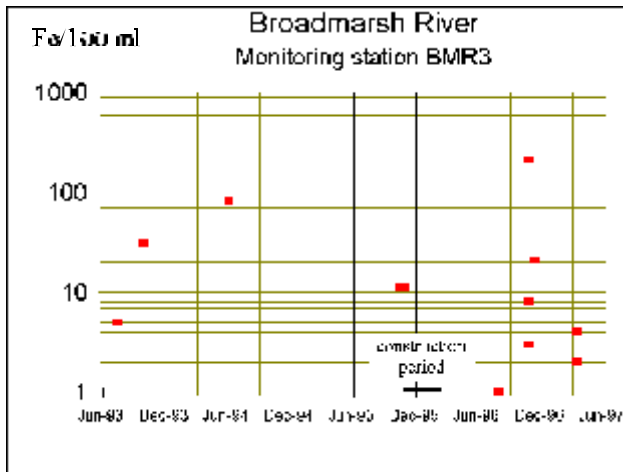
**Figure 19.** Broad Marsh River station 3 fecal coliform concentrations documented by Buzzards Bay Project.

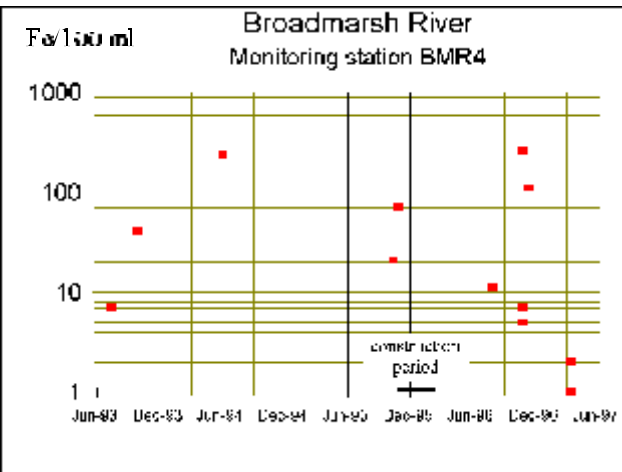
**Figure 20.** Broad Marsh River station 4 fecal coliform concentrations documented by Buzzards Bay Project.

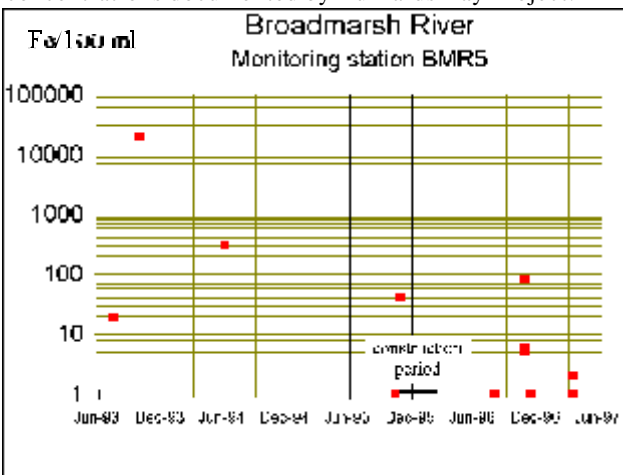
**Figure 21.** Broad Marsh River station 5 fecal coliform concentrations documented by Buzzards Bay Project.

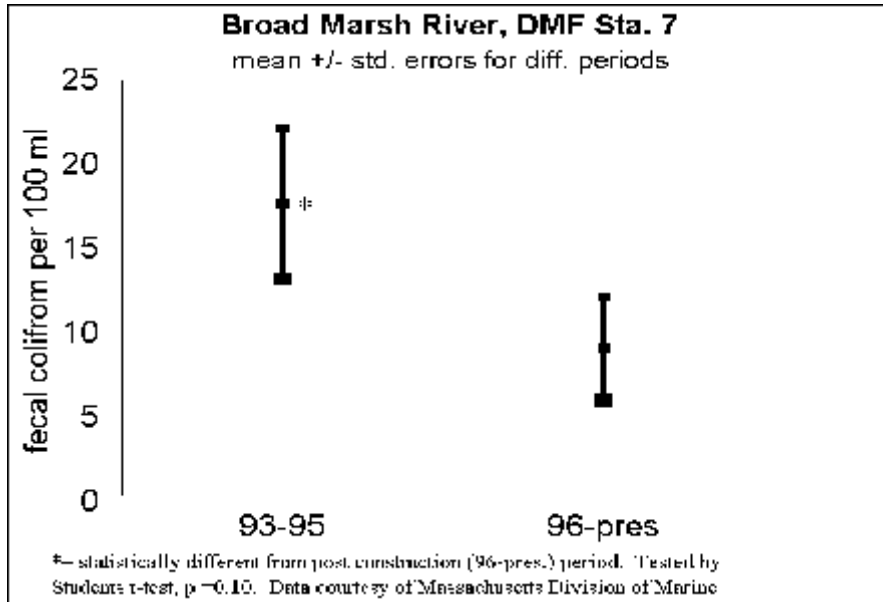
**Figure 23.** Student's t-test evaluation of preconstruction (93-95) and post-construction fecal coliform data from DMF. Data for all conditions included, Decline was significant.

As shown, Station 7, which was monitored since 1994 has shown a slight but statistically significant decline in fecal coliforms in the post construction period (Figs. 22 and 23). The Student's t-test results in Figure 13 were for a 1-tailed test with  $p < 0.10$  on untransformed data. The test was also performed on log-transformed data assuming that the data is lognormally distributed, and this test was also significant at the  $p < 0.10$  level (not shown). As is apparent from Fig. 22, background levels remain unchanged but clearly fewer

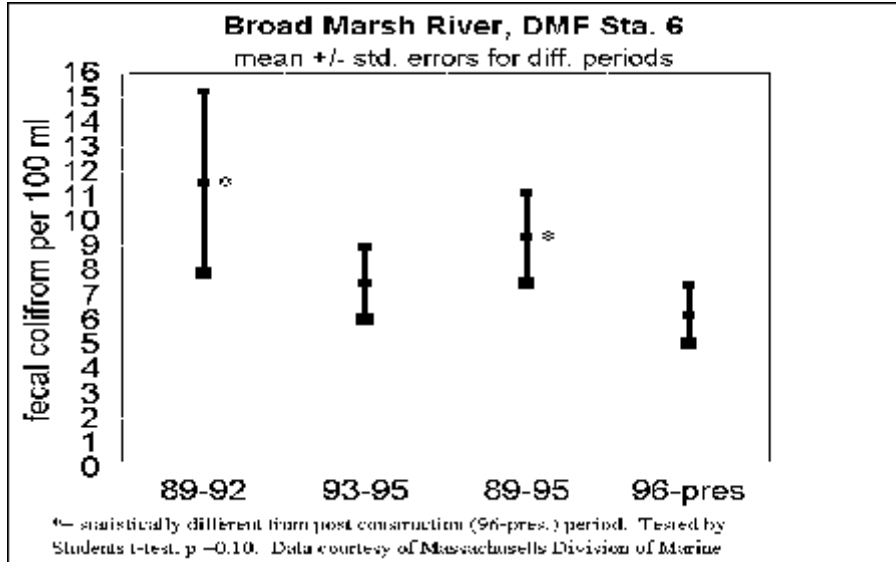
**Figure 25.** Means and standard errors of DMF fecal monitoring at Station 6 during different periods. The periods 89-93 and 89-95 were statistically higher than the post-construction period (96-present), but the period 93-95 was not statistically higher than the post construction period. Data for all rain conditions included.

The results from the upper embayment Station 6 (upstream of the stormwater treatment systems) are less clear. Background levels are somewhat lower at this site than Station 7, and during the period Station 7 was monitored (Fig. 24). Even the highs at Station 6 were considerably lower than Station 7 during the period Station 7 was monitored (1994 onward). Prior to 1994, fecal coliform concentrations appeared higher at Station 6 (Figure 25). A Students t-test found the 88-95 statistically higher than the post construction period (96 to present). The period immediately prior to construction (93-95) showed

somewhat higher fecal than post construction, but not significantly so. Overall it appears that upstream sources to Station 6 may have also changed and that the stormwater remediation project has had only modest impact on water quality at Station 6 which now has fecal coliform levels close to background and only once exceeded the shellfish bed standard of 14 fecal coliform per 100 ml since the stormwater treatment system was constructed.
