**BOUCHARD B120 RELEASE  
SHORELINE SEGMENT SUMMARY**

GeoInsight Project Number 3871-002

SEGMENT IDENTIFICATION: **W1B-12**

SEGMENT NAME: **Warren Point**

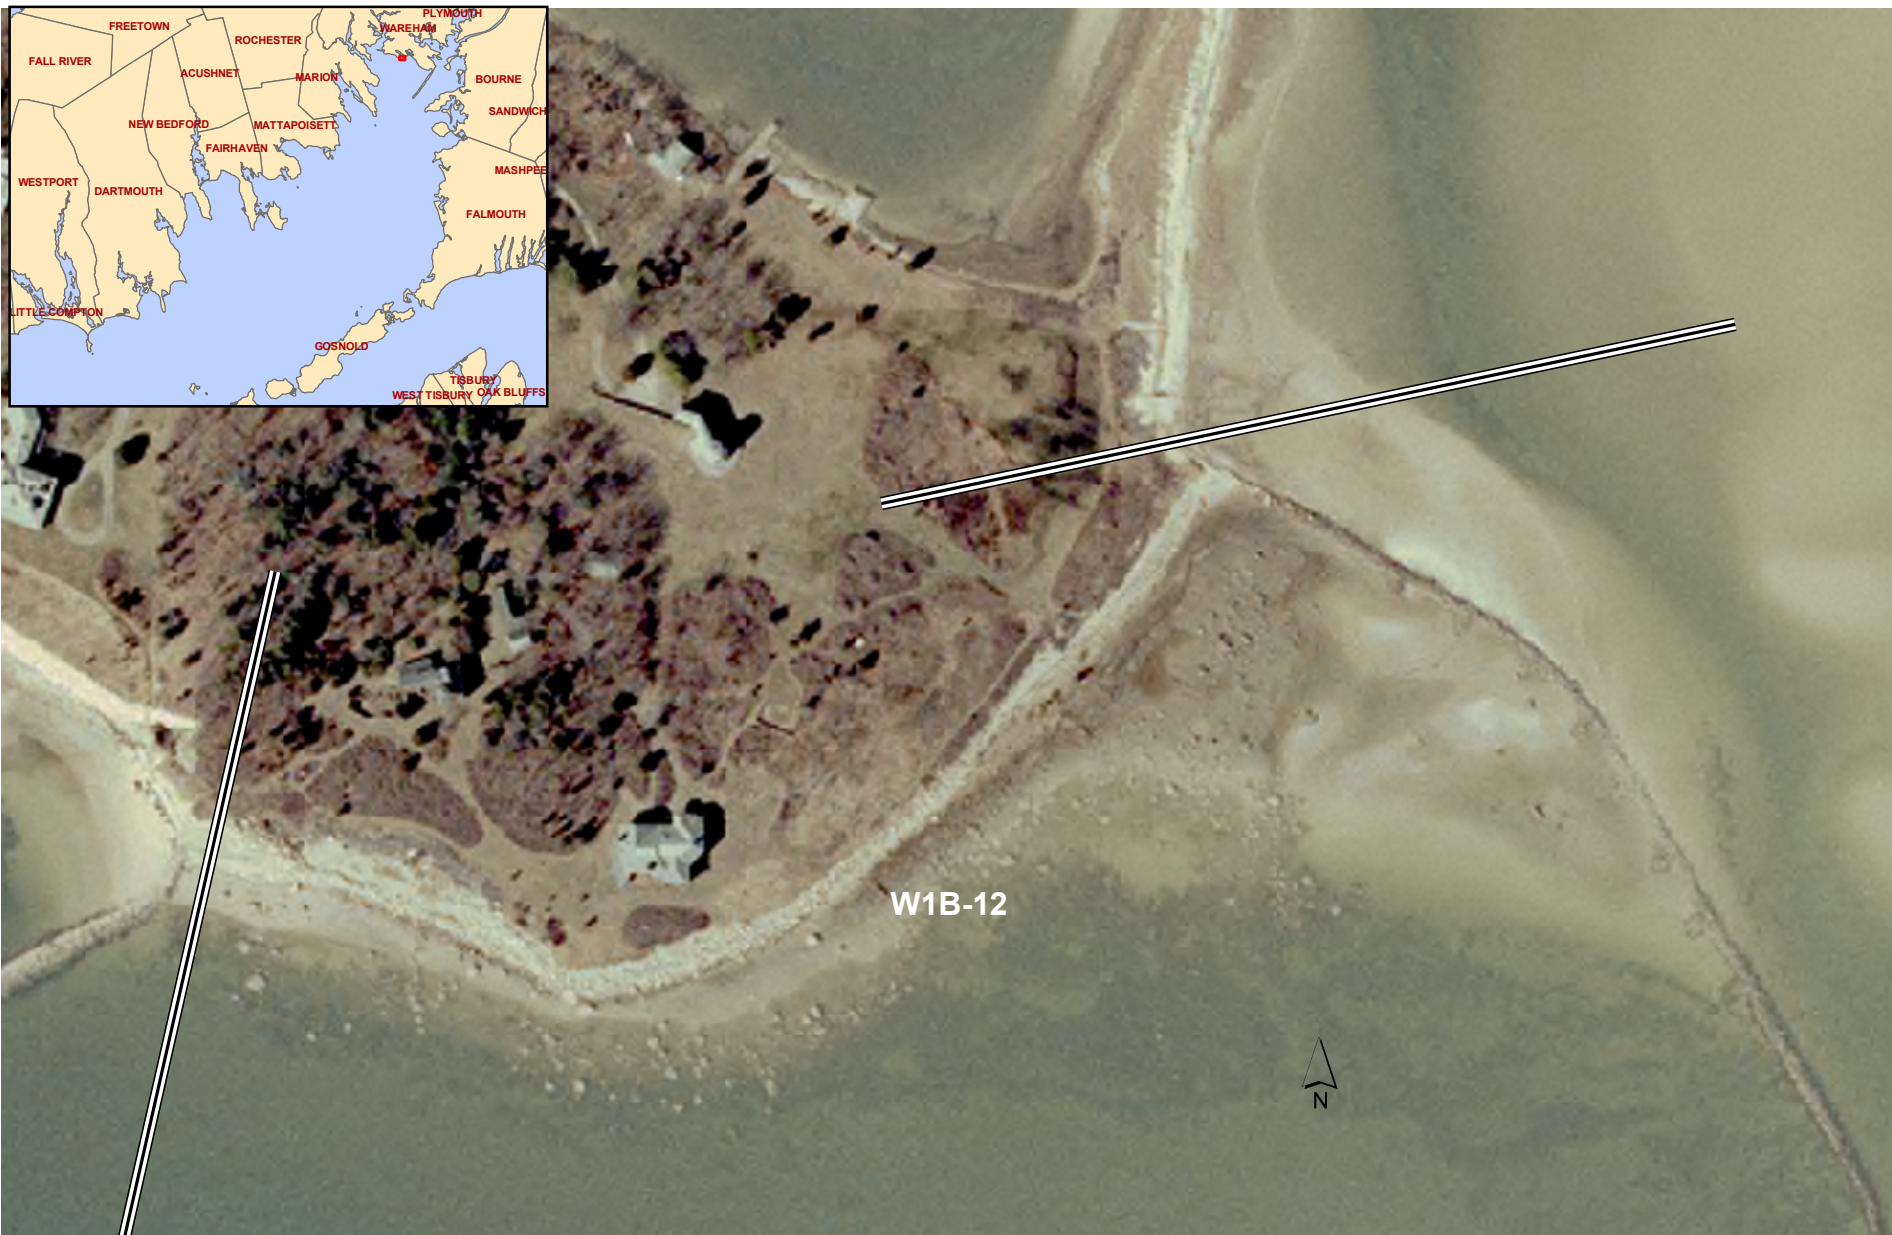
W1B-12

<b>E N T R I X</b>
<b>W1B-12</b> <b>Warren Point</b> <b>Bouchard B No. 120 Oil Spill</b> <b>Buzzards Bay, MA</b>

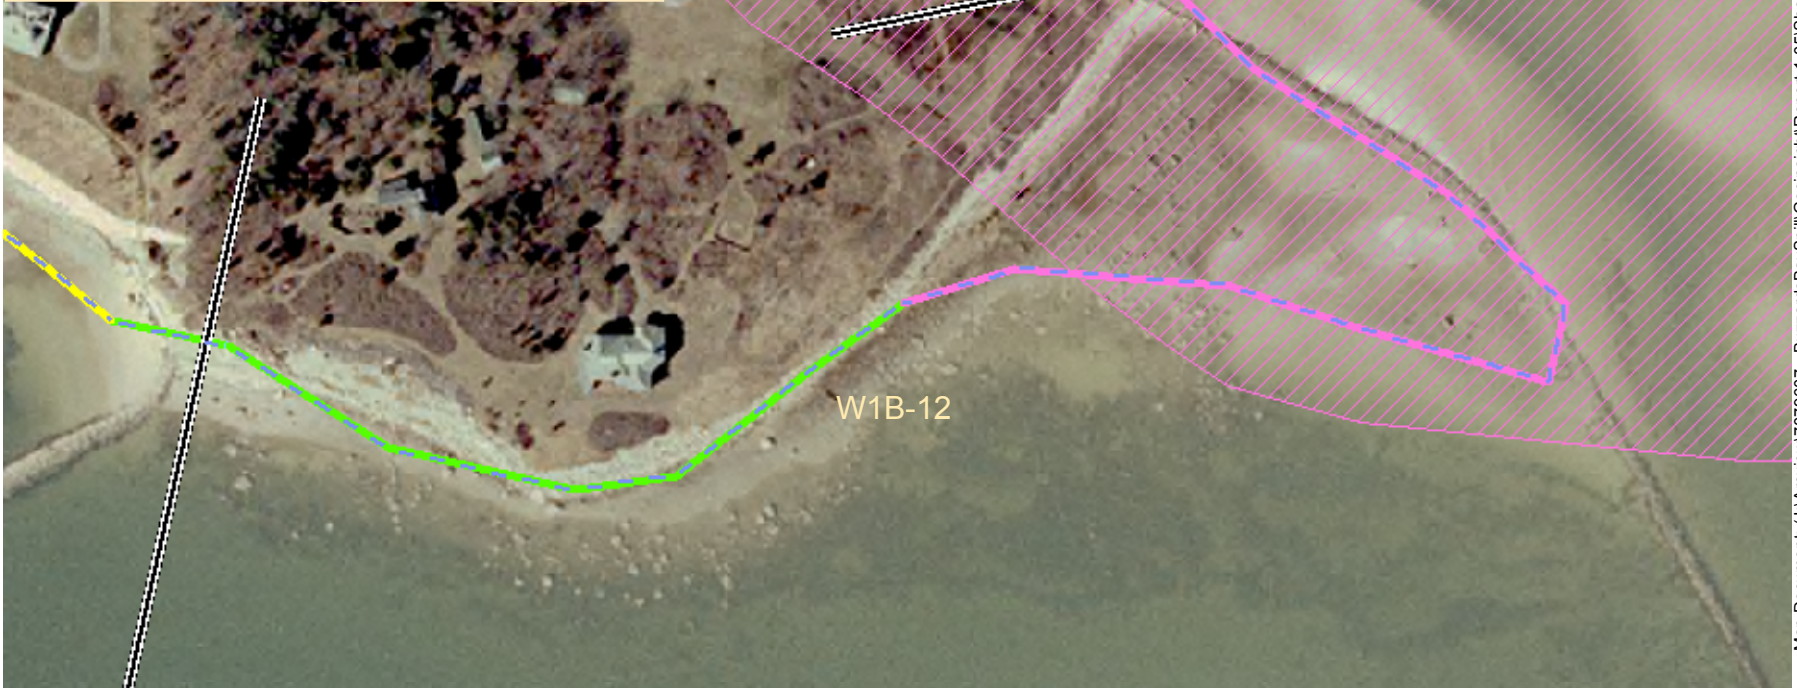
**W1B-12**  
**Warren Point, Wareham**  
**Comprehensive Activities**  
**Bouchard B No. 120 Oil Spill**  
**Buzzards Bay, MA**
