**BOUCHARD B120 RELEASE
SHORELINE SEGMENT SUMMARY**

GeoInsight Project Number 3871-002

SEGMENT IDENTIFICATION: **W1C-11**

SEGMENT NAME: **Sippican Harbor West**

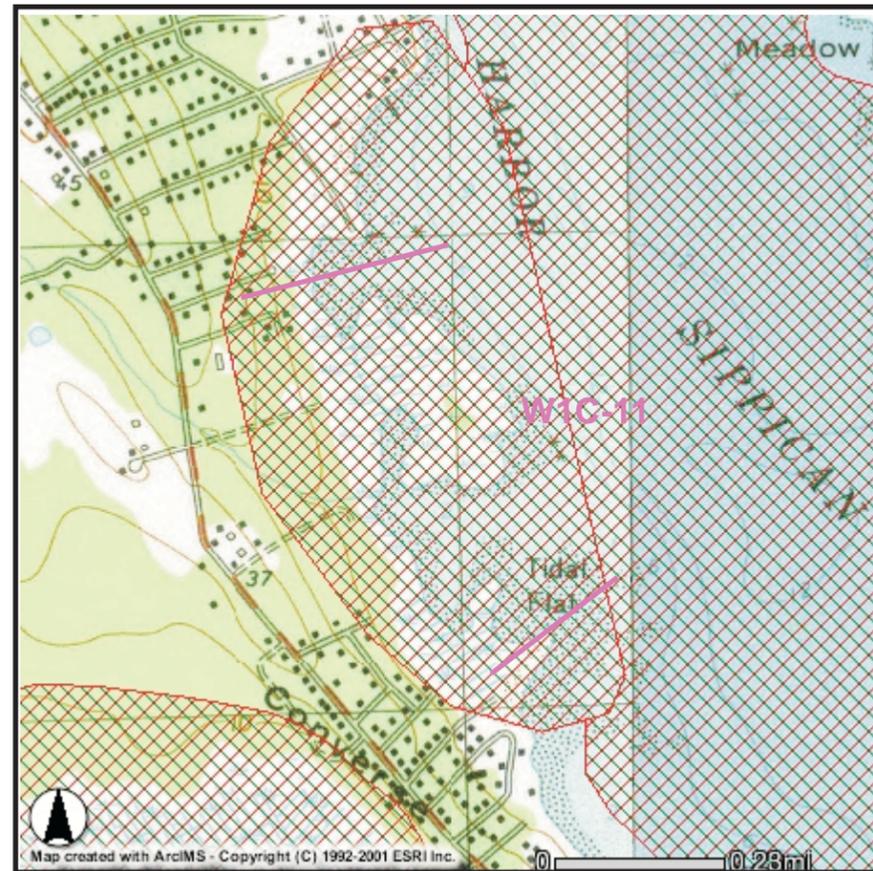
NATURAL HERITAGE AND ENDANGERED SPECIES MAP

Priority Habitats of Rare Species: At segment and adjacent to segment: Buzzards Bay aquatic environment.

Estimated Habitats of Rare Wildlife: At segment and adjacent to segment: Buzzards Bay aquatic environment.

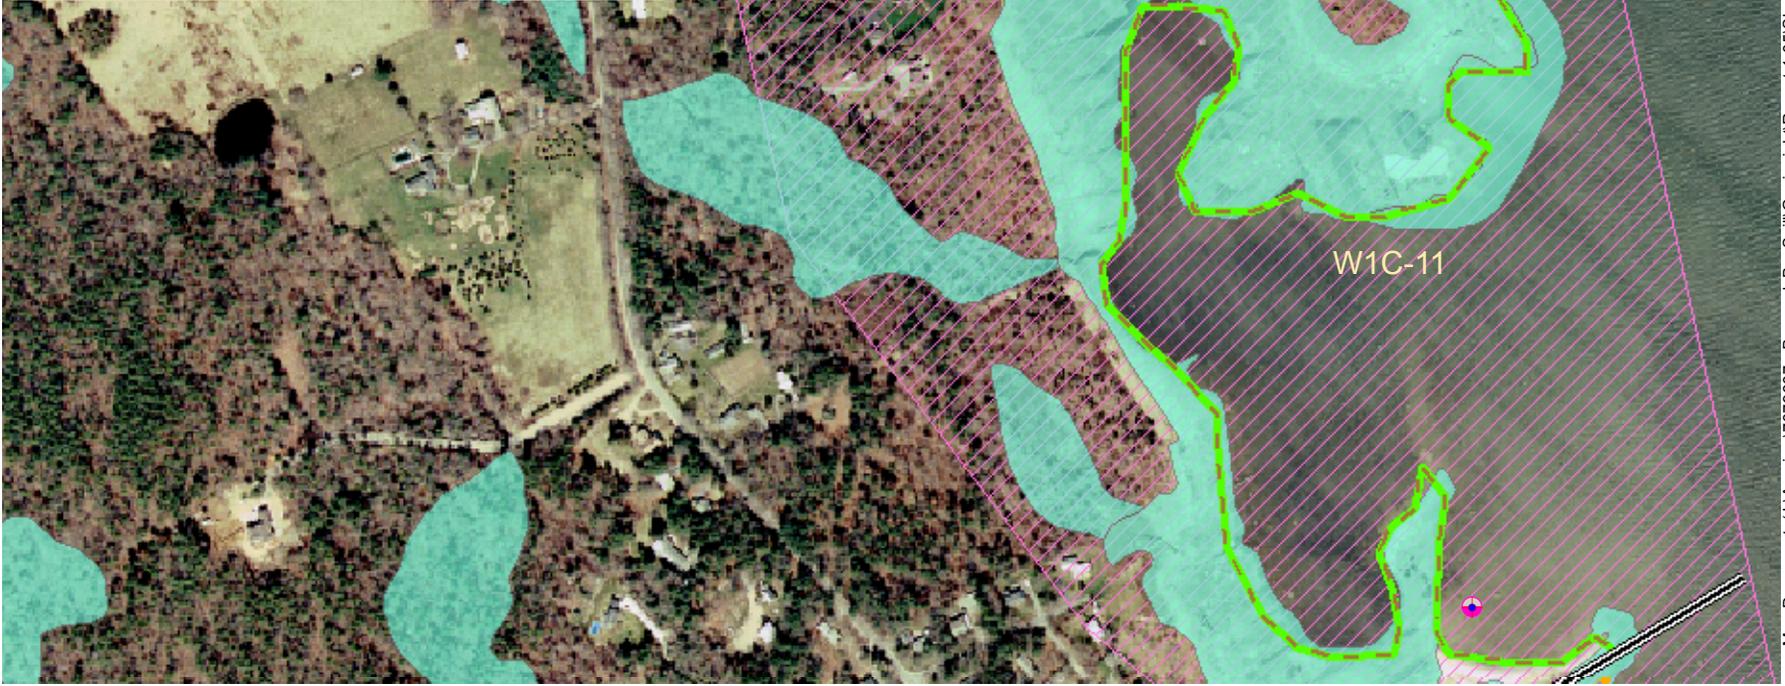
W1C-11
Sippican Harbor West, Marion
Comprehensive Activities
Bouchard B No. 120 Oil Spill
Buzzards Bay, MA

DATE	SUMMARY OF INFORMATION RECORDED BY INSPECTION TEAM
05/02/2003	Nine oil-coated areas, including tarballs and oiled wrack, were observed in the upper intertidal zone during high tide. A total of approximately 11% to 50% surface oil coverage was observed at portions of the segment.
05/20/2003	Shellfish tissue samples collected and analyzed.
