**BOUCHARD B120 RELEASE  
SHORELINE SEGMENT SUMMARY**

GeoInsight Project Number 3871-002

SEGMENT IDENTIFICATION: **W1C-12**

SEGMENT NAME: **Converse Point East**

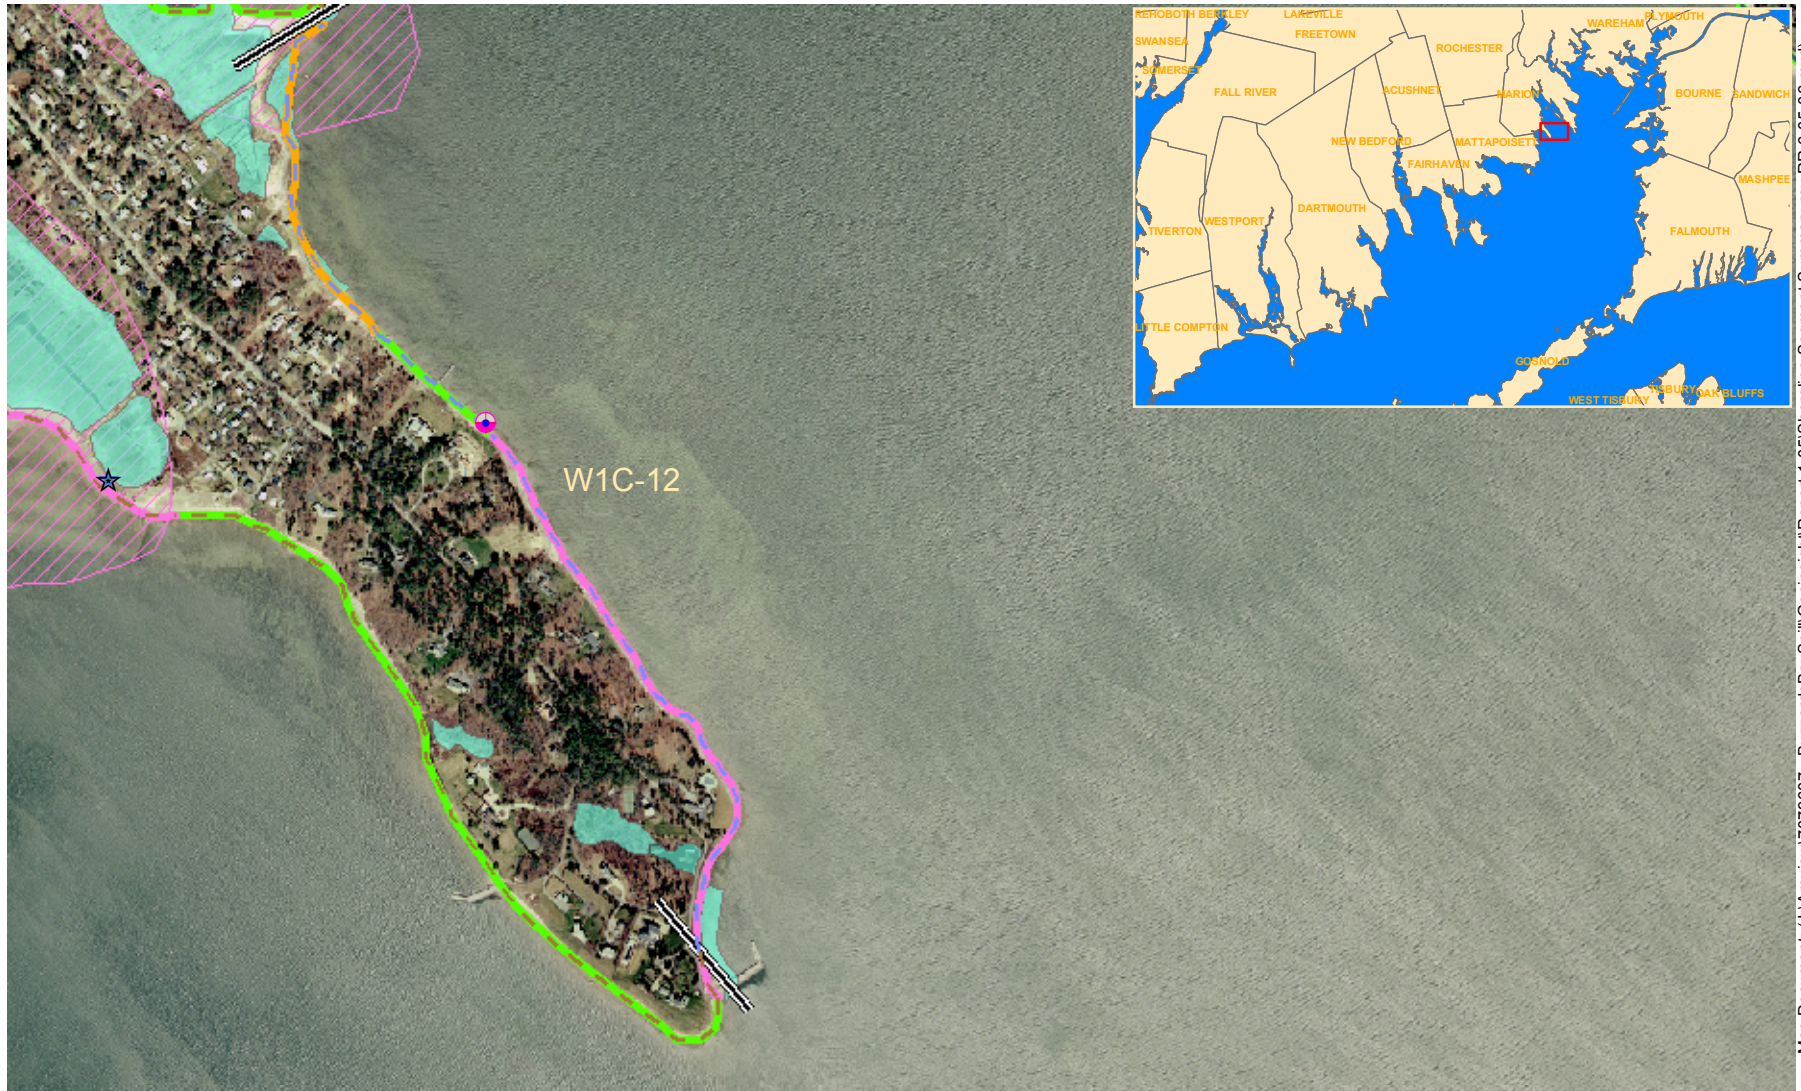
**W1C-12**  
**Converse Point East, Marion**  
**Comprehensive Activities**  
**Bouchard B No. 120 Oil Spill**  
**Buzzards Bay, MA**

**Trench Location**

- ★ Nearshore Subtidal Sediment Sampling Location 2004
- ★ Deep Subtidal Sediment Sampling Location 2004
- ✚ Subtidal Sediment Sampling Location 2003
- ▲ Qualitative Shellfish Surveys 2004
- ◆ Marsh Sampling Location 2004
- ◆ Marsh Core Sampling Location 2004
- ◆ Water Sampling Location 2004
- ◆ Water Sampling Location 2003
- ★ Intertidal Sediment Sampling Location 2003
- ★ Intertidal Sediment Sampling Location 2004

- NO DATA
- CLEAN
- VERY LIGHT
- LIGHT
- MEDIUM
- HEAVY

- Public-Private Sand Beach (1A/1B)
- Mixed Sand and Gravel (1C)
- Marsh (1F)
- Rocky Shoreline (1E)
- Riprap, Groin, Jetty (1D)
- Visual Inspection of Marsh Area
