**BOUCHARD B120 RELEASE
SHORELINE SEGMENT SUMMARY**

GeoInsight Project Number 3871-002

SEGMENT IDENTIFICATION: **W1E-05**

SEGMENT NAME: **Mattapoissett Harbor East**

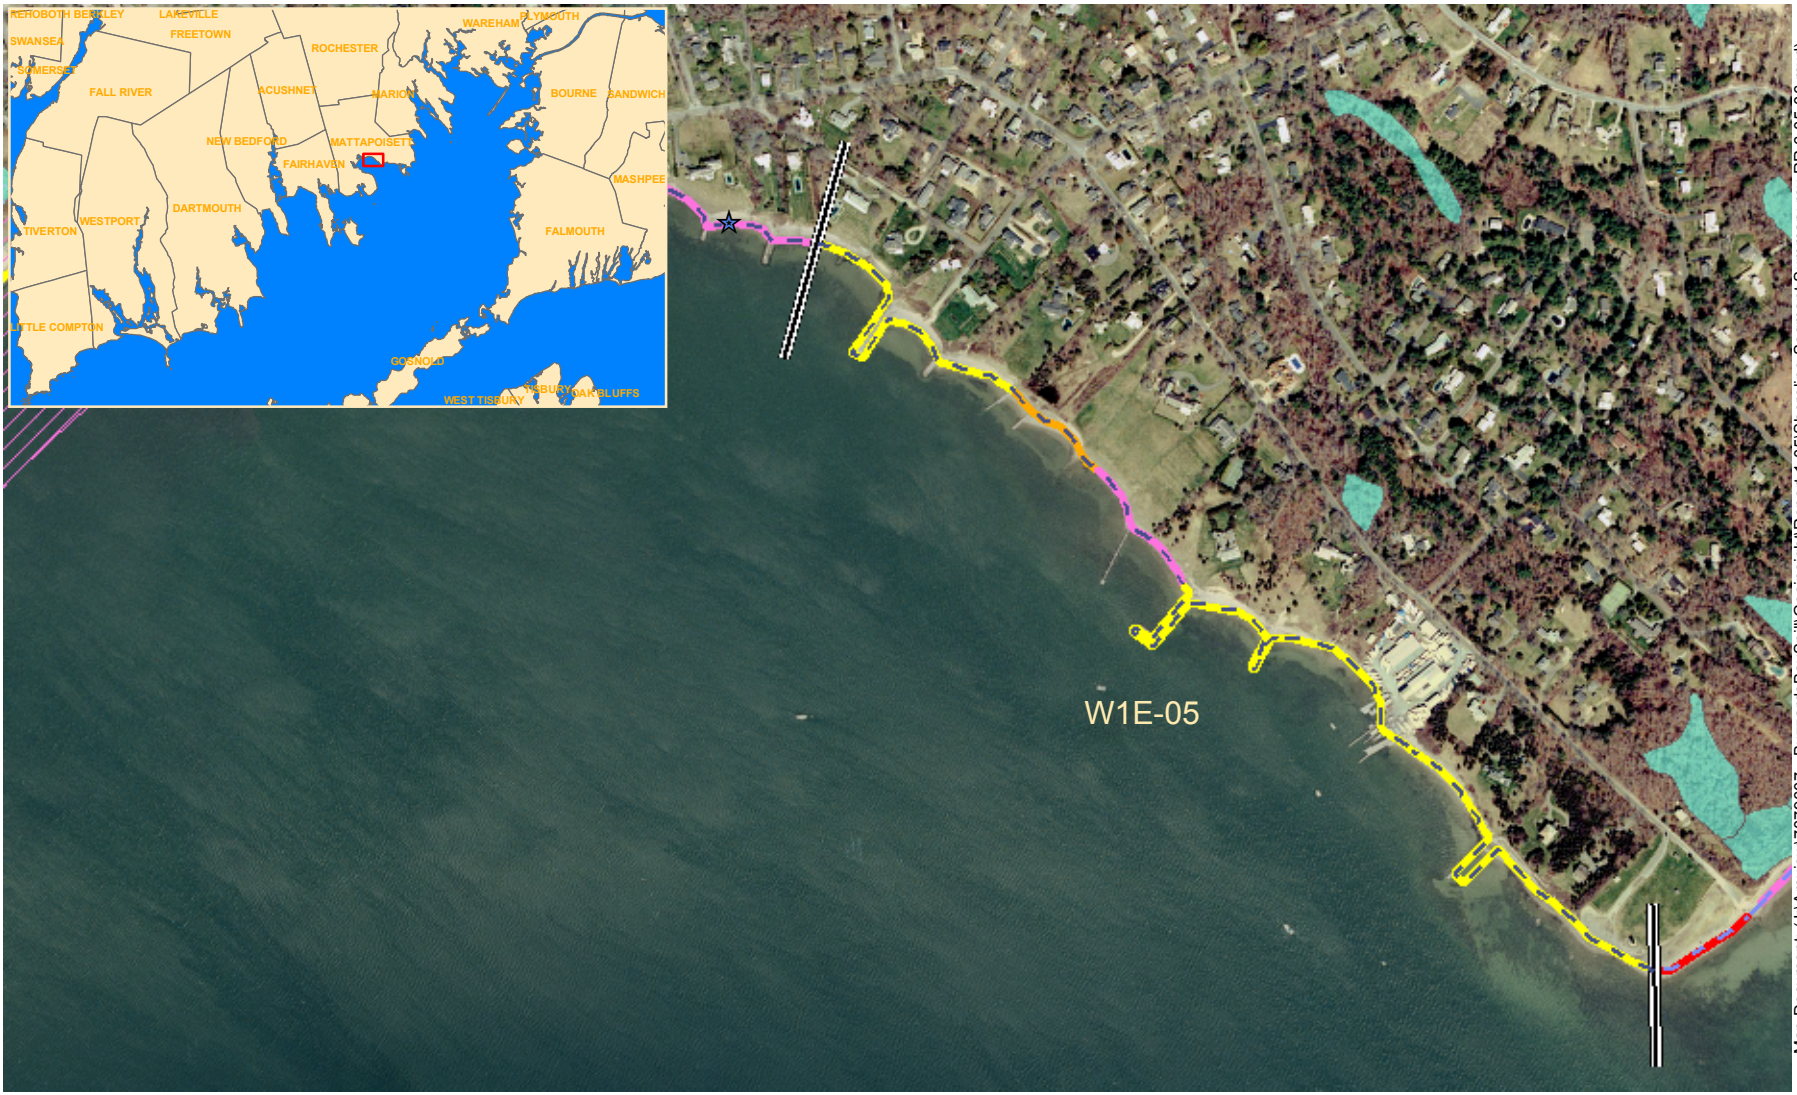
W1E-05
Mattapoisett Harbor East,
Mattapoisett
Comprehensive Activities
Bouchard B No. 120 Oil Spill
Buzzards Bay, MA

DATE	SUMMARY OF INFORMATION RECORDED BY INSPECTION TEAM
05/21/2003	Area of oil (approximately 50 meters long and 1 to 3 inches thick) observed. Tarballs and tar patties observed in the upper tidal zone. Cleanup crew was on-site during the inspection.

DATE	SUMMARY OF INFORMATION RECORDED BY INSPECTION TEAM
08/21/2003	Two areas of splatter observed on cobbles. Inspection team wiped splatter or removed small cobbles with splatter. Segment met IRAC criteria endpoints.
