Atlas of
Tidally Restricted Salt Marshes
in the Buzzards Bay Watershed
Massachusetts

Buzzards Bay Project National Estuary Program

June 2002

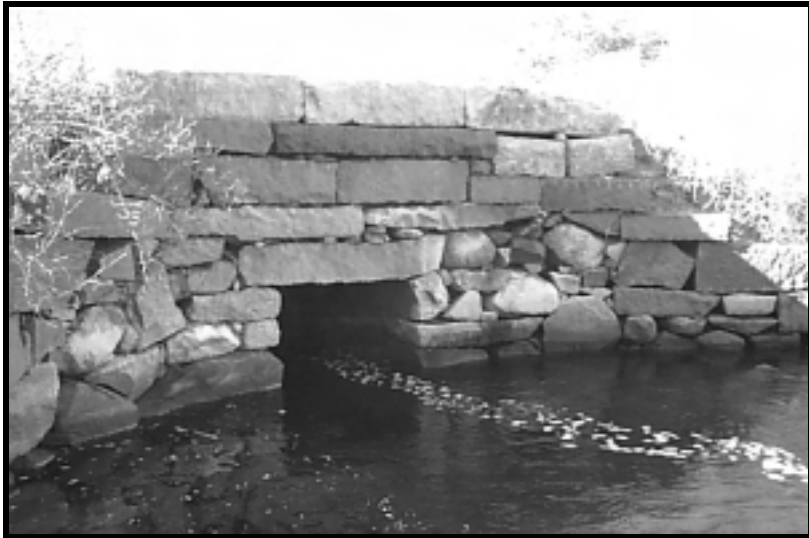
Figure 3. Tidal Restriction Site MT10 Old access to beach, Mattapoisett

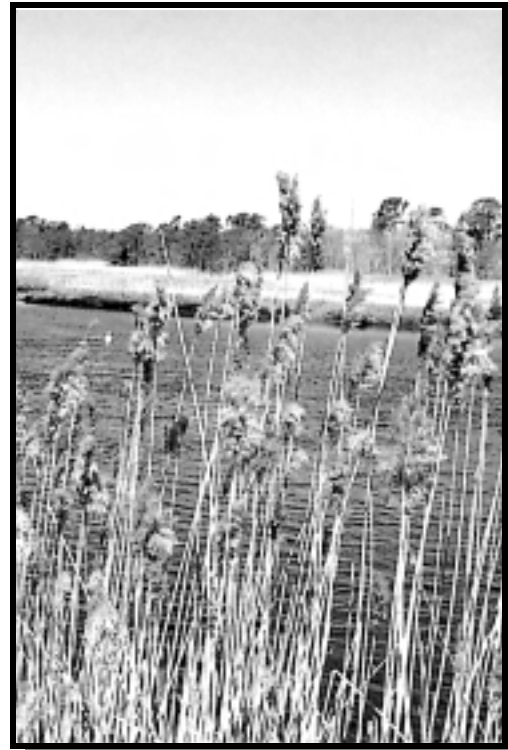
Figure 4. *Phragmites australis* stand in a salt marsh.

Culverts may be fitted with tide gates that could further restrict tidal flow or flapper valves which allow fresh water to leave the marsh but will not allow tidal flow to enter the marsh. Bridges may have similar effects if the openings are not wide enough to pass sufficient tidal water to maintain salt and brackish marshes further upstream. At some road crossings no culvert is provided and tidal flow is eliminated altogether. These hydrologic changes significantly alter the chemical integrity of the upstream salt marsh. The once strongly saline environment changes to one that is brackish or fresh water. This freshening of the salt marsh causes a major transformation in the vegetation as salt marsh grasses and rushes are displaced by common reed (Figure 4). Common reed often forms a monoculture, with plants growing up to, and in excess of, 12 feet. This decrease in plant diversity and the change in vegetative structure (from a low grassy meadow to a tall reedy thicket) causes a major shift in wildlife use as

typical salt marsh inhabitants are replaced by fewer species. Despite some use of the reeds by more common generalist species, it is not preferred by any species. This is in marked contrast to salt marsh vegetation which is preferred over other habitats by many wildlife species, including some of our rarer salt marsh specialists.

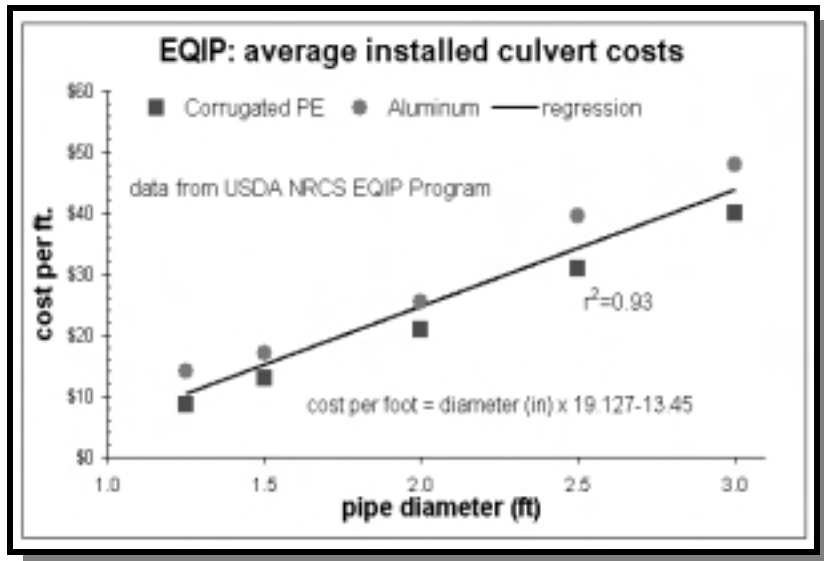
Figure 6. Simplified cost assumptions for culvert installation based on USDA-NRCS model for farm applications (i.e. not typically paved roads)

Simplified cost estimates for culvert replacement are shown in Figure 6. However, these estimates do not account for practical costs. For example, whether or not the culvert passed under a road, whether or not the road was paved, whether utilities must be moved, and other factors are important determinants of cost. Design and permitting costs must also be considered.

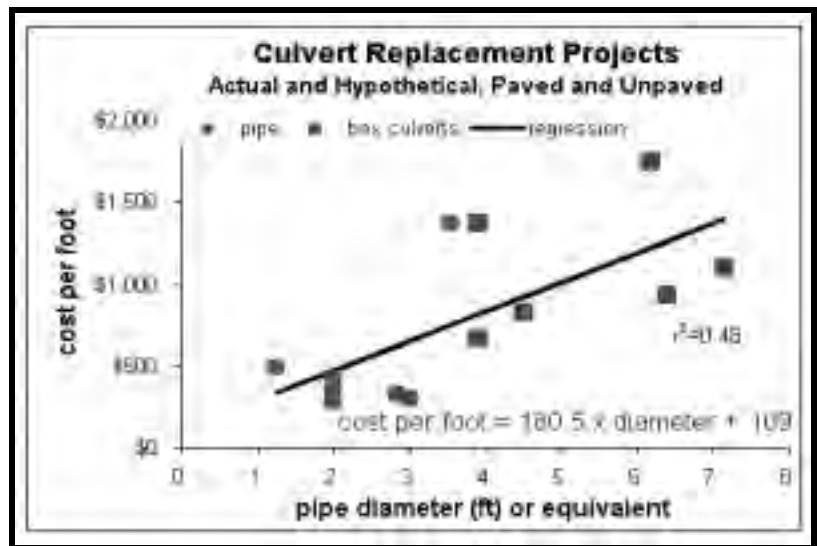
Figure 7. Actual cost of culvert replacement projects in Buzzards Bay including design, permitting, and road repaving costs. Five points represent theoretical variations of projects.

In Figure 7, we show a similar plot based on actual projects in Buzzards Bay. The plot includes eight actual projects and five hypothetical variations of two of the actual projects. For example, one of the projects involved the replacement of a dilapidated culvert with a new concrete 4-foot by 8-foot box culvert under a paved 25-foot wide rural road, with some of the replacement tasks being handled by a municipal DPW and some by a private contractor. The hypotheticals for this project were made by assuming the new culvert had dimensions of 4-feet by 8-feet and 4-feet by 10-feet, respectively, since that cost was well known and other project costs were held static. Similarly, another project represents the hypothetical estimates of the replacement of a 1-foot culvert with a 3-foot culvert on a coastal road in paved and unpaved conditions.

Although there is considerable variation in costs per foot for installation ($r^2 = 0.48$), it is apparent that real costs typically range from \$200 to \$1500 per linear foot, depending upon the diameter or cross section of the culvert, and the length of the culvert installed.
