Buzzards Bay

*National Estuary
Program*

December 21, 2005

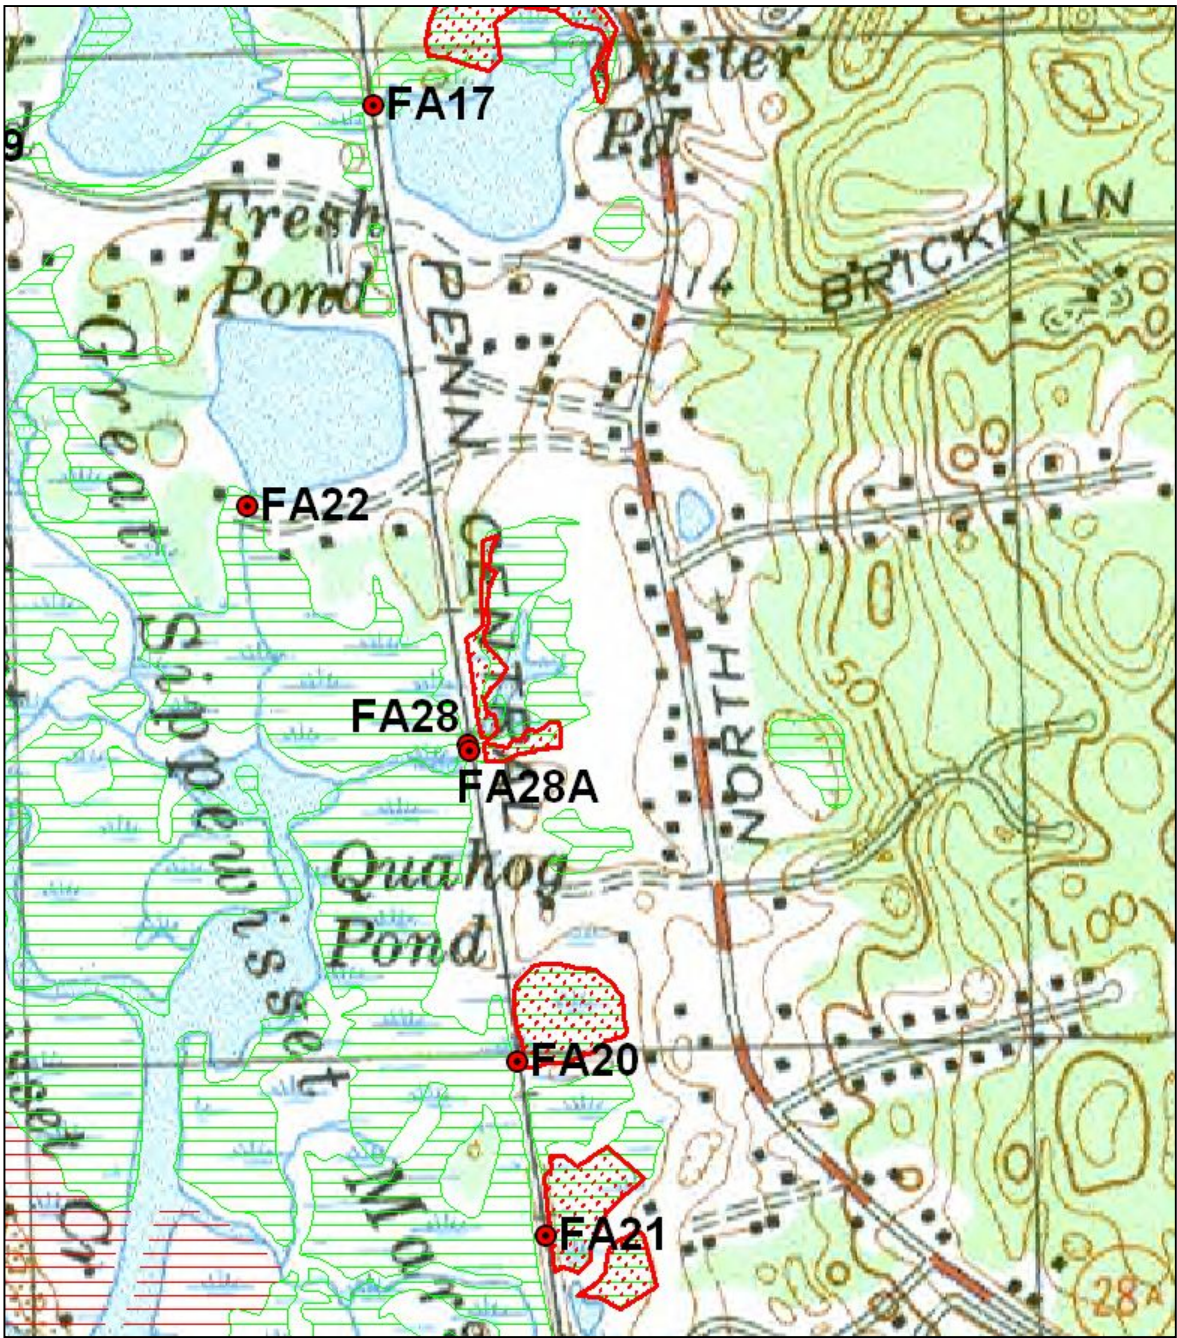
Fig. 1 USGS topographic map showing the tidal restrictions in West Falmouth along the rail line (red circles) with areas of adjoining wetland (principally salt marsh-green hatched areas) and wetlands dominated by Phragmites (red dotted areas).

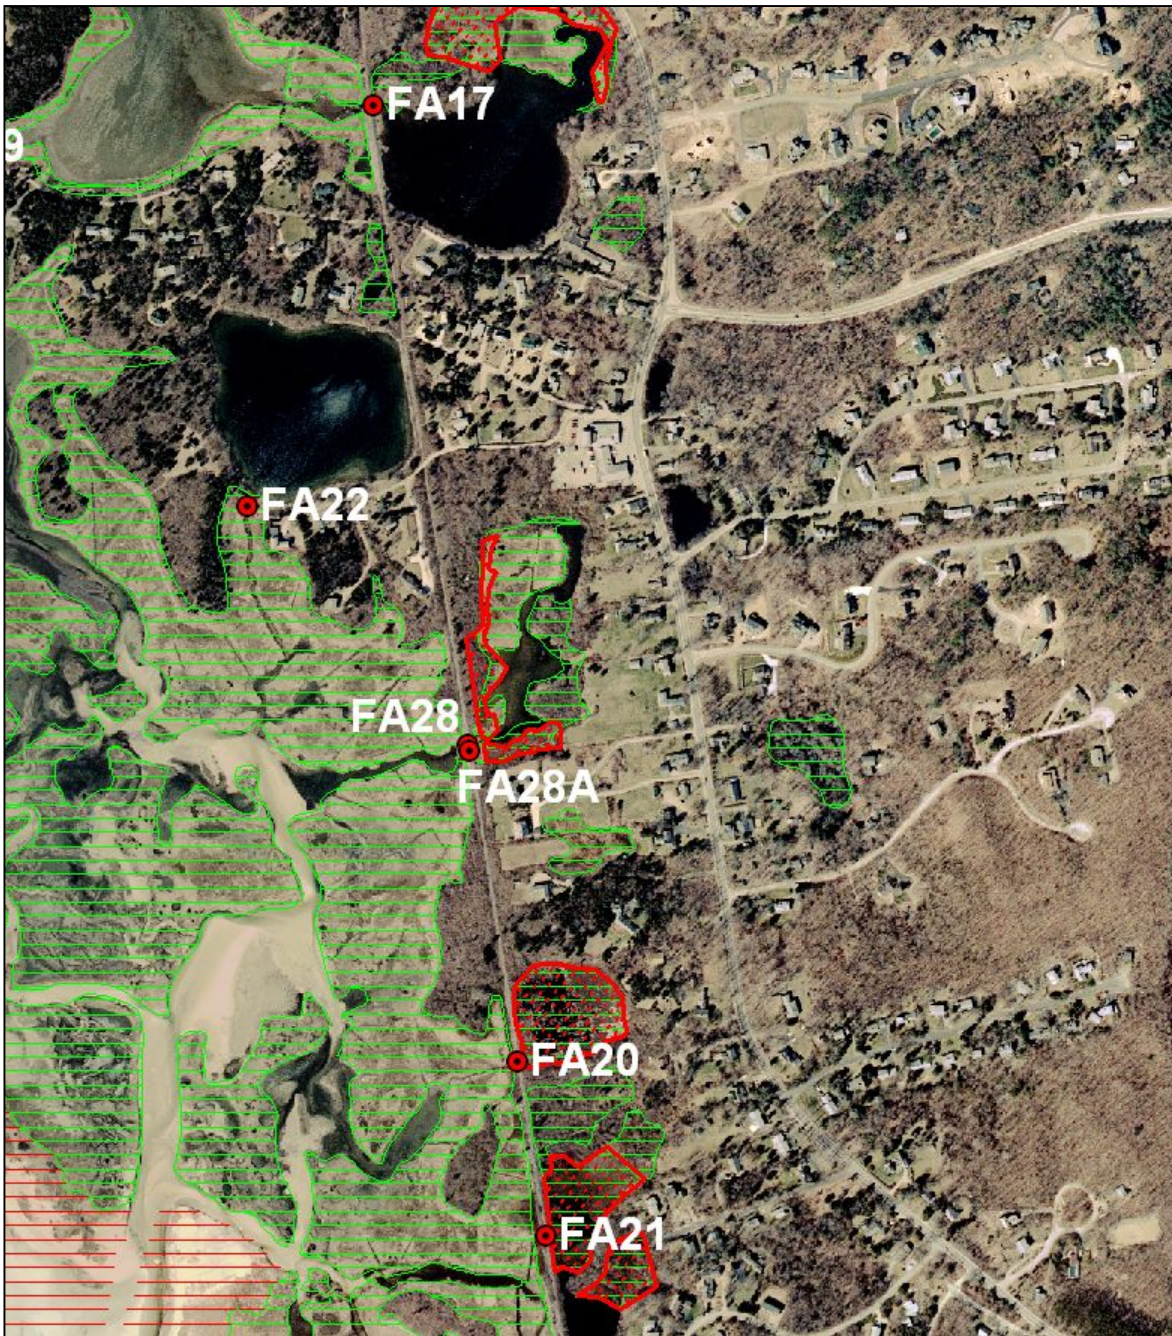
Fig. 2. A 2001 Orthographic aerial photograph map showing the tidal restrictions in West Falmouth along the rail line (red circles) with areas of adjoining wetland (principally salt marsh-green hatched areas) and wetlands dominated by Phragmites (red dotted areas).
