STUDY ON EEL POND IMPROVEMENTS

June 2005

Revised January 2006

Town of Mattapoisett
Board of Selectmen

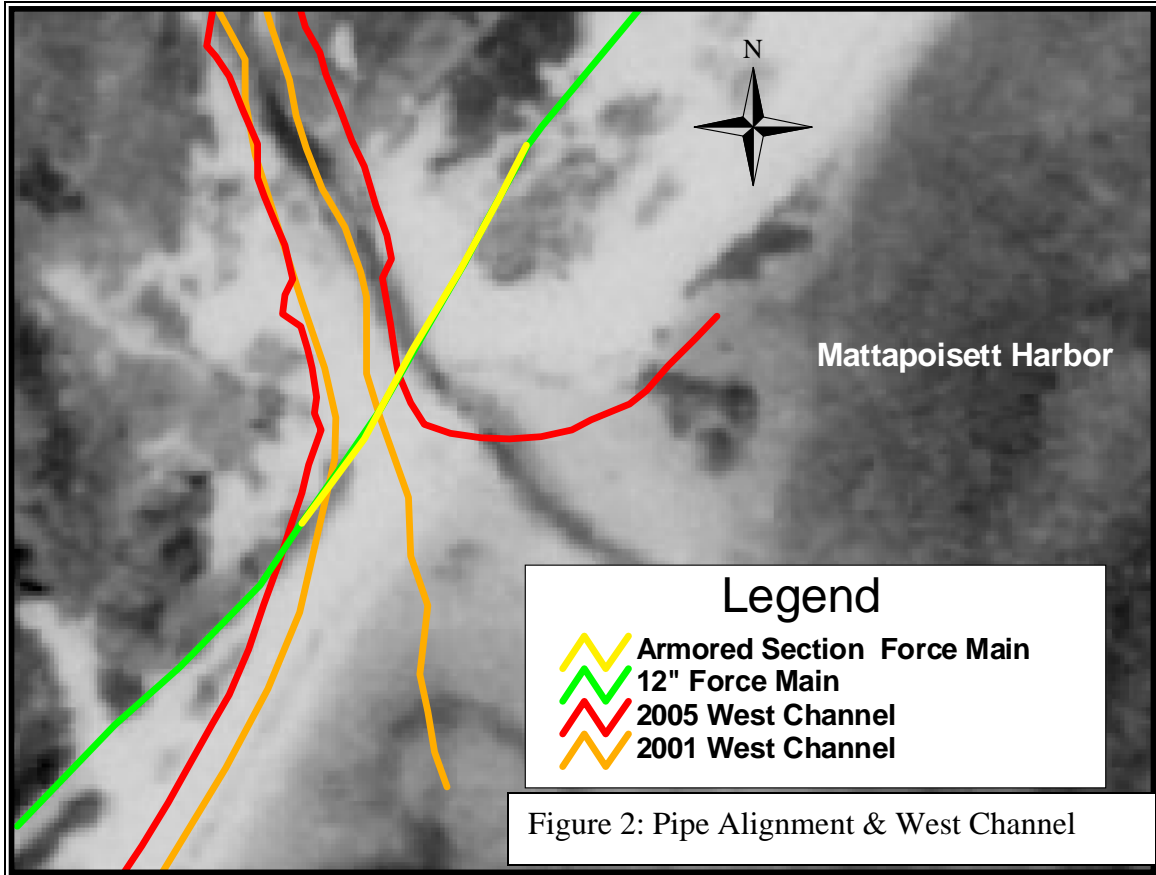
During the month of June 2005, the Town of Mattapoisett and New England Geophysical performed Ground Penetrating Radar (GPR) investigations of the pipe alignment shown in Figure 2. In conjunction with that investigation CLE provided survey services to locate the GPR soundings using RTK GPS, and referencing the location and elevation to NAD 83 and NGVD vertical datum. Using the information provided by New England Geophysical a plan and profile of the pipeline was mapped and added to the topographic plan prepared by CLE. In addition a profile of the pipeline was prepared and is included in Figure 3.

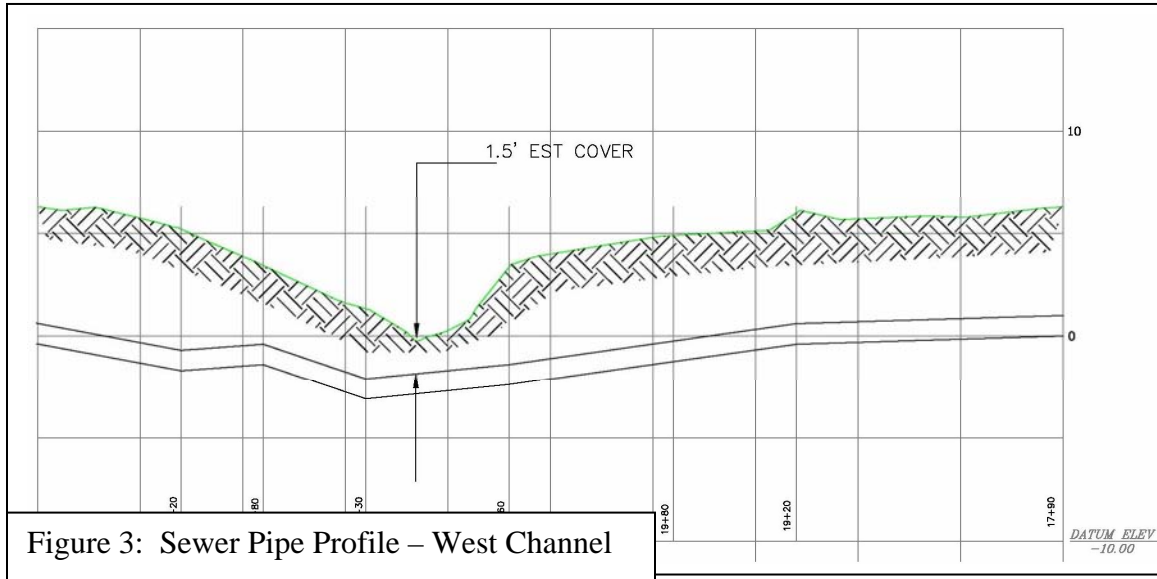
The surveyed profile of the pipeline was overlaid on the topographic data obtained by CLE, as it is shown above. It clearly shows that at the point where the pipe crosses the channel, the deepest part of the West Channel is only 1.5 feet above the top of the pipe barrel, and therefore only 12 inches away from the top of the concrete encasement. This is a source of significant concern over two issues:

- (1) The West Channel is known to be migrating to the West. If the channel continues its present migration where the pipe burial is much shallower, it may begin to expose the pipe. Further, while the exact location of the concrete encasement is not known, it is estimated that the present location of the West Channel is very near to the end of that encasement. Thus any further migration to the West could potentially expose bare unprotected pipe.

- (2) It is known that the flows out the Western Channel have increased as the Eastern Channel literally continues to choke itself off due to the structural restrictions. This means that the Eastern channel will be come less viable with respect to its ability to carry storm flows, such as the hurricane overtopping. This would, in-turn route more water toward the Western Channel, and in the event of a severe storm surge, overtopping flows could gouge the existing Western Channel even wider and deeper. Exposure of the pipe under such severe flows could cause it to rupture and begin spilling most of the untreated sewage into the Harbor.

One of the present contingency plans to avert this catastrophe would be to truck the sewage to Fairhaven using tankers, this would require at least 4 to 6 five thousand (5,000) gallon tank trucks running around the clock, and even at this rate trucking (considering potential hurricane related road closures and power failures) may not be able to keep up with peak flows. CLE therefore recommends that serious consideration be given to improving the East Channel to a condition where it can contain known storm flows, and closing the West Channel. Further, CLE recommends the portion of the sewer line that lies within the potential “wash-out” zone of the West Channel, be replaced with more suitable material for submarine crossings.

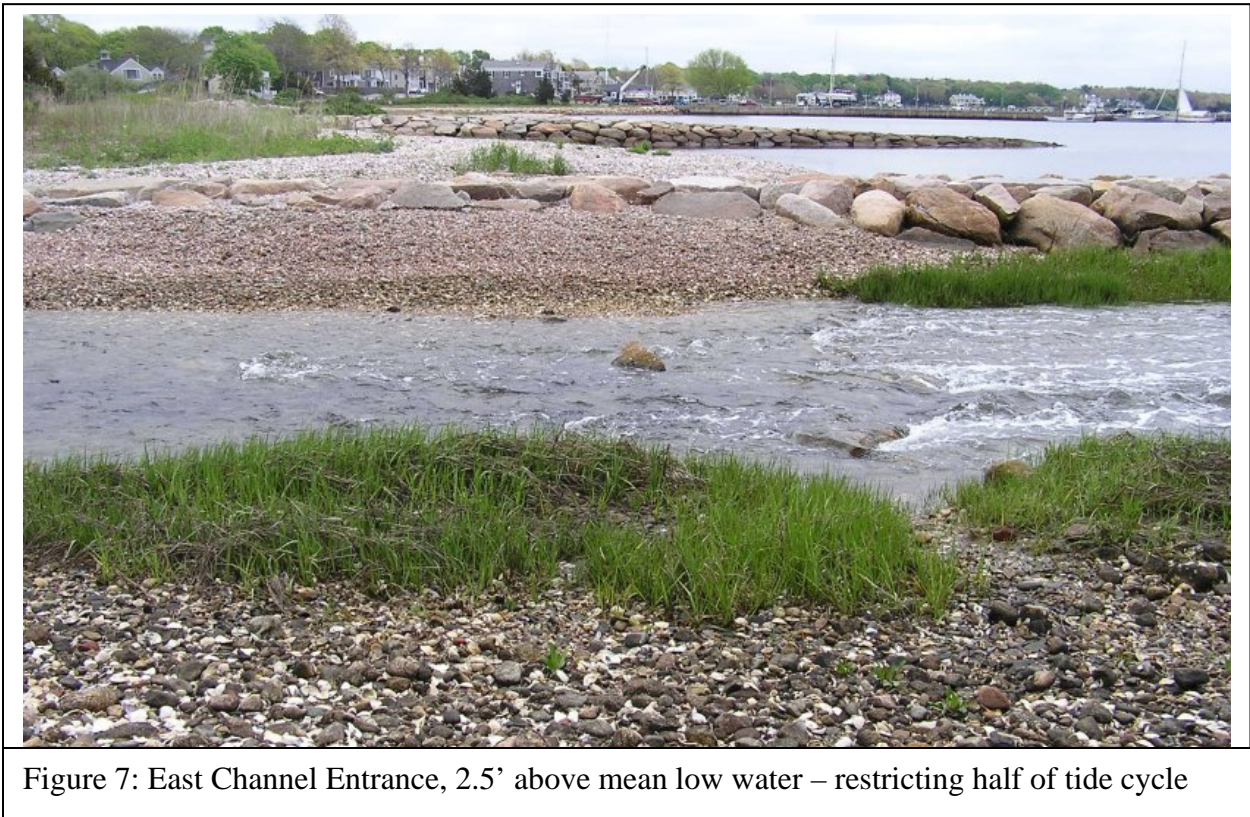
2. It can also be noted that at the present time approximately 85% of the present tidal flow occurs through the West Channel, with the remainder of 15% flowing through the East Channel. This imbalance occurs for a number of reasons; however, two conditions are the primary cause: one is a restriction caused by the Rail Road Culvert, which measures only 5.0 feet wide by 5.5 high, with an invert elevation of +1.3 MLW (0.0 NGVD) (See Figure 6). The second restriction occurs all along the East Channel before it empties into Mattapoisett Harbor. The restriction is caused by the shallow, almost braided condition of the east channel (in general), which culminates near the harbor jetties where an area of large gravel that runs the width of the channel that is at approximately elevation +2.5 MLW (+1.2 NGVD), (See Figure 7).

Figure 7: East Channel Entrance, 2.5' above mean low water – restricting half of tide cycle

- Another part of the study tasked to CLE was to determine what could be done to improve the water flow in and out of Eel Pond (flushing). Three methods of improving flow to and from Eel Pond were investigated; the first was to improve the East Channel by dredging. A number of channel sizes and widths were analyzed, the most effective channel was determined to be one approximately 30 feet wide at the base, with a depth of -2.7 MLW (-4.0 NGVD), the channel would have 3:1 sideslopes to meet the existing grade lines. Cross sections of the proposed channel are included in the Appendix section. Generally speaking the proposed channel fits within the “top of bank” lines that bound the existing channel; however, there are two places where the channel is narrow, and it is bounded by salt marsh on one or both sides. These locations occur adjacent to the existing jetty (See Figure 7) and between the small ponds designated as 1 & 2 in this report (See Figure 10).

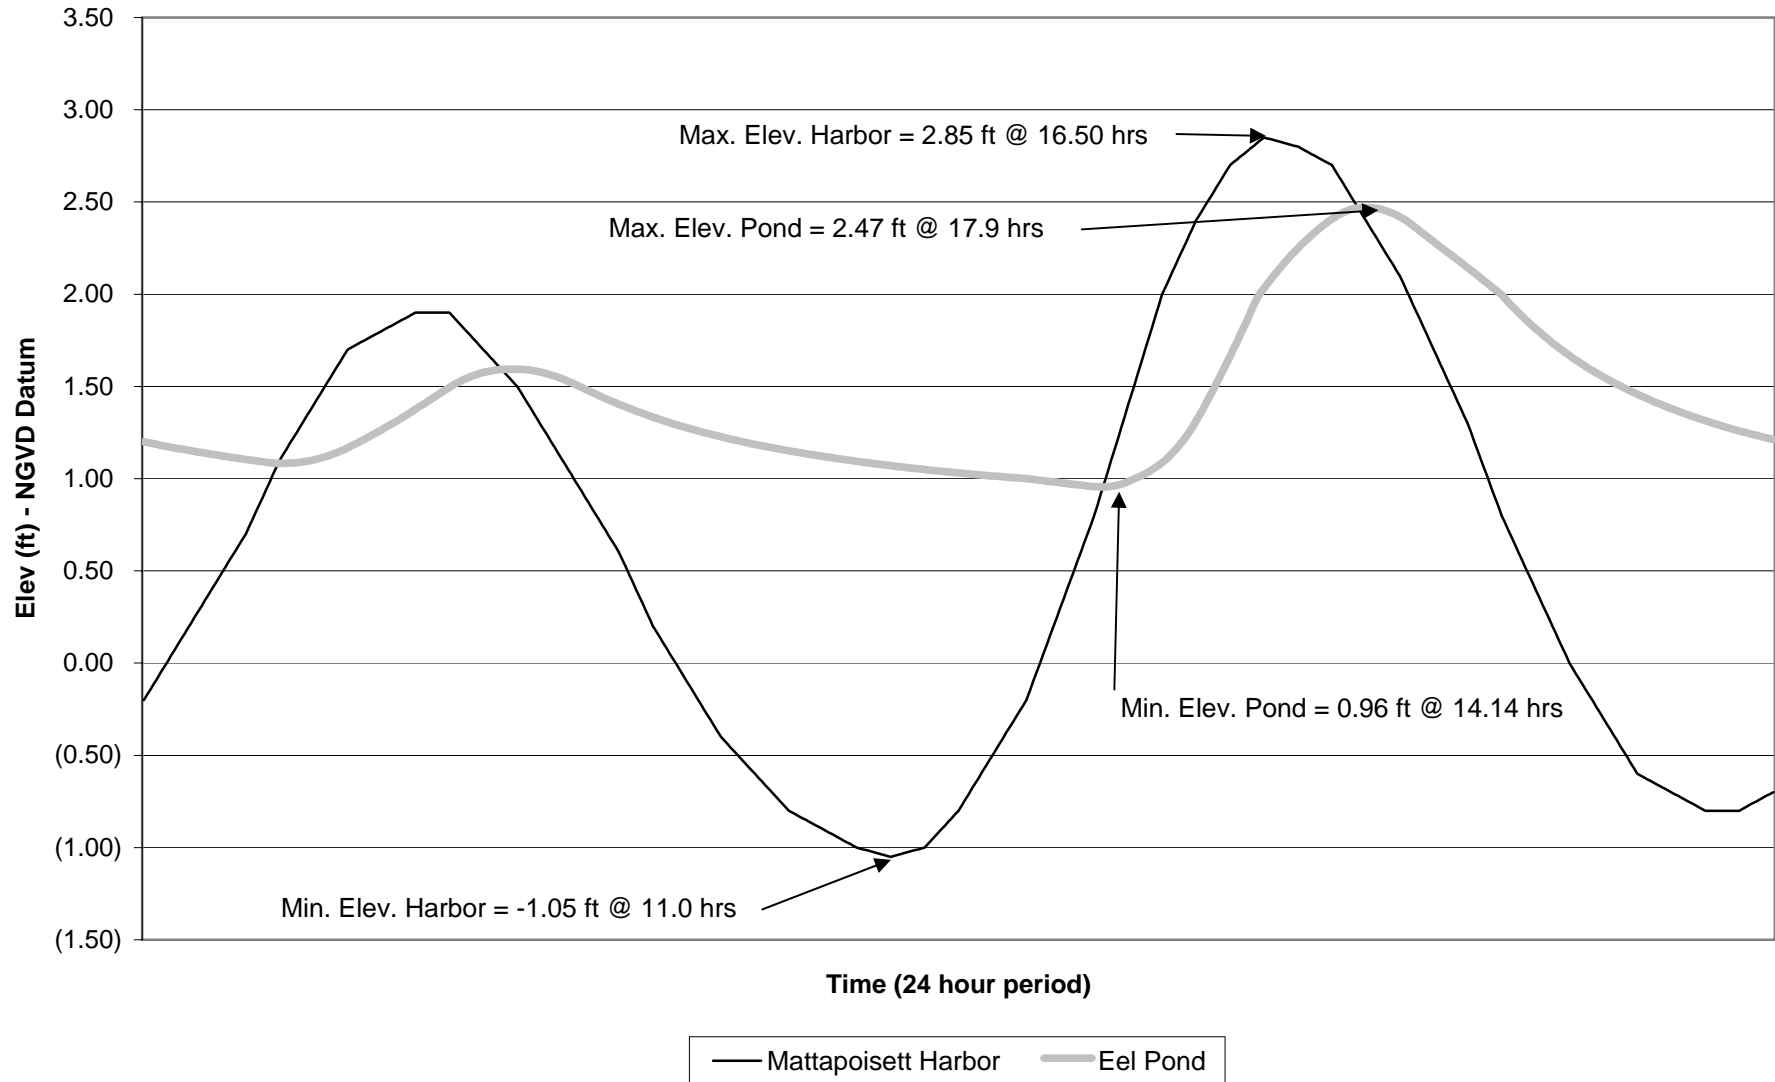
Exhibit 1

3. An example of the typical tidal restriction is shown in Exhibit 1, which represents the comparison of a Mean tidal curve for Mattapoisett Harbor versus that of the same tidal cycle in Eel Pond. Note that because the high tide in Eel Pond lags the harbor by over an hour, the high tide in Eel Pond is approximately 0.4 feet lower, because the flow restrictions do not allow the volume of water needed to fill Eel Pond to pass through the channels. Additionally note that the low tide in Eel Pond is about +2.3 MLW (+1.0 NGVD). This is because the restrictions at the entrance to the harbor act as a dam, and will not let all of the water out. As a result of this long-term restriction, Eel Pond has acted as a detention pond, and essentially trapped much of any silt-laden run-off from upland sources. Eventually the pond filled with mud to the approximate level of the tidal restrictions. Figure 9, shows the present profile of Eel Pond, and the East and West channels, Figure 8 shows the route used to take the profiles.
