Atlas of
Tidally Restricted Salt Marshes
in the Buzzards Bay Watershed
Massachusetts

June 2002

Buzzards Bay Project National Estuary Program

Study Purpose

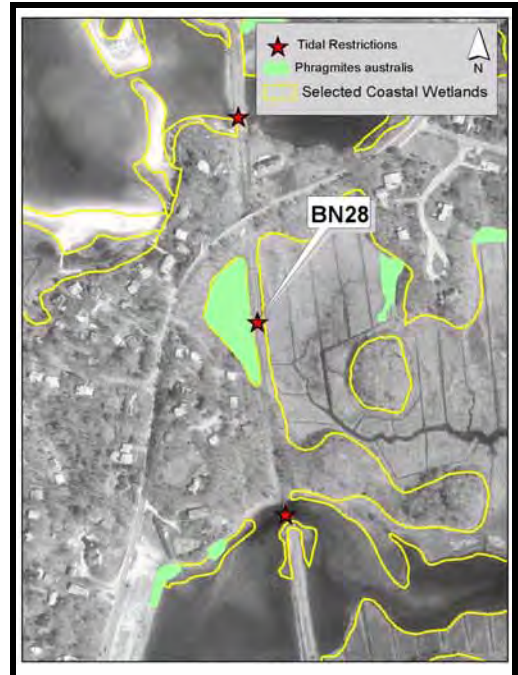
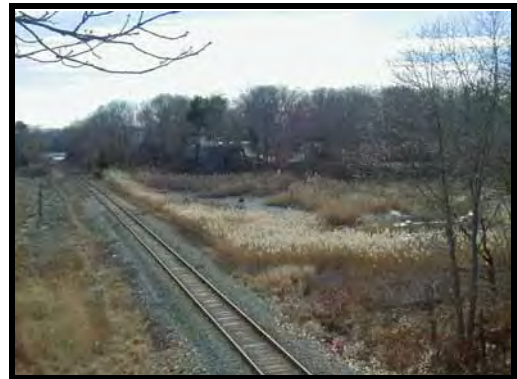
View of railroad tracks

Culvert condition: no culvert – dike
Restriction width: 60 feet
Proposed culvert length: 72 feet
Acres of wetlands affected: 1.0 acres
Acres of *Phragmites* present: 1.0 acres

A culvert could be installed under the tracks to allow tidal flow to the wetland to the West. The low elevation of the tracks relative to the salt marsh make this an affordable railroad bed project.

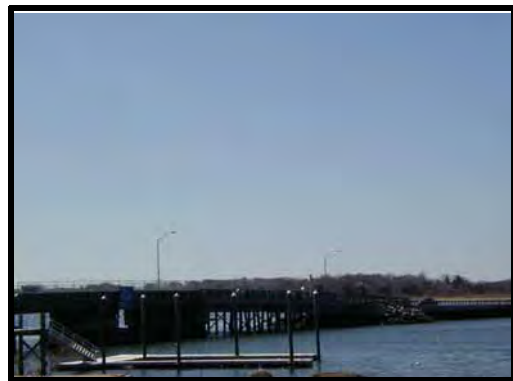
Looking south

Bridge Street is on a long (1800 foot) causeway connecting Padanaram Village with South Dartmouth (see map on page 78). This very old road has severely restricted tidal flows into upper Apponagansett Bay. The lower section of the road abutments are constructed with cut granite blocks.

Bridge condition: good

This bridge was recently rebuilt. It might be more cost effective to install new culverts under selected areas of Bridge Street rather than to expand the opening of the bridge or deepen the channel.

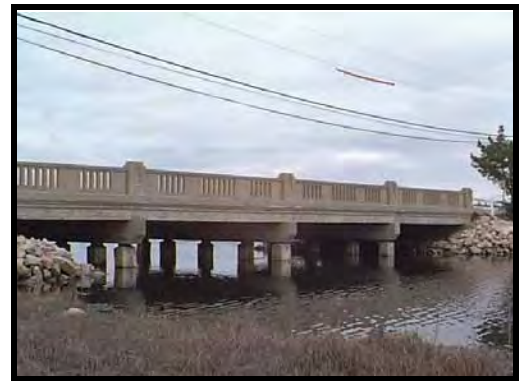
View of bridge

Bridge condition: good

This bridge was originally built in 1938, and it has recently been rebuilt. Deepening of the channel or adding additional culverts may improve flushing upstream.

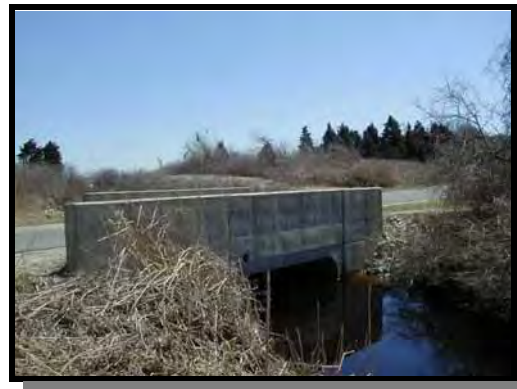
Culvert under road

Culvert condition: fair

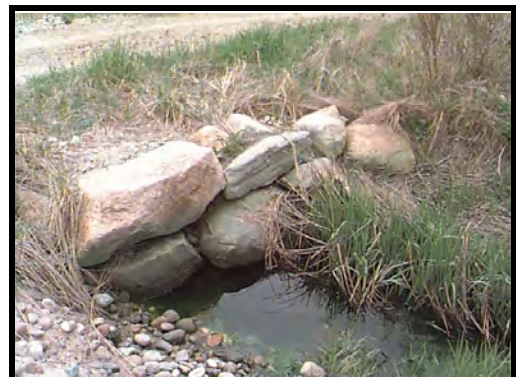
South side of culvert

Culvert condition: poor
Road width: 12 feet
Culvert length: 14.4 feet
Acres of wetlands affected: 6.3 acres
Acres of *Phragmites* present: 2.2 acres

The Buzzards Bay Project has initiated discussions with the Massachusetts Audubon Society and the Town of Dartmouth concerning the replacement of the undersized culvert with two 24" culverts.

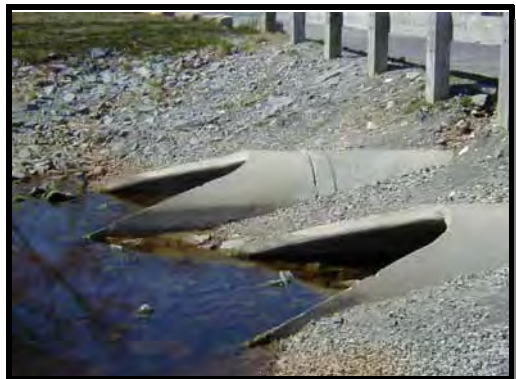
South end of culverts

Culvert condition: excellent
Road width: 40 feet
Culvert length: 48 feet
Acres of wetlands affected: 9.3 acres
Acres of *Phragmites* present: 5.3 acres

Buzzards Bay Project staff members have made arrangements with the Department of Environmental Management’s park supervisor to remove the stones in the culvert. While removal of the obstructing stones within the existing culverts may improve flushing, a new culvert may be needed. The road edge at the culverts is crumbling due to the loss of the stabilizing rip rap.

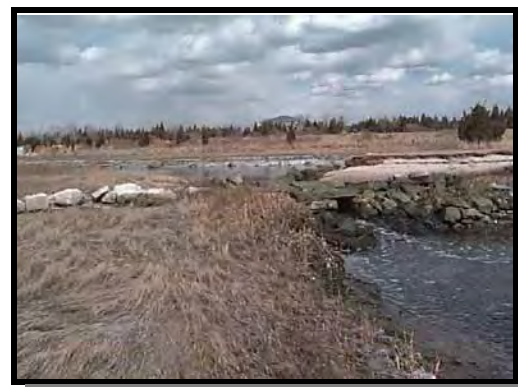
Upstream view

Culvert condition: poor

The replacement of the existing stone path with a footbridge would increase the tidal flow yet still allow pedestrian access to the property.

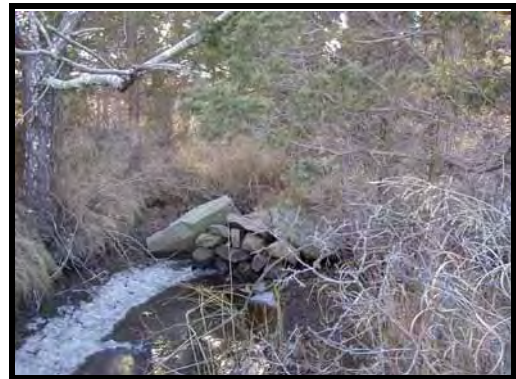
Downstream view

Culvert condition: poor

Since this road is no longer used, the removal of the old road and culvert would be fairly simple.

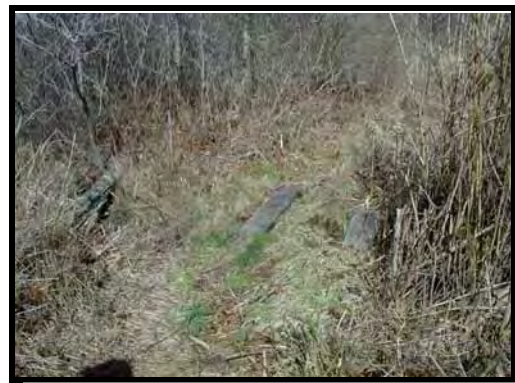
View of path

Culvert condition: no culvert - breached dike
Path width: 4 feet
Proposed culvert length: 6 feet
Acres of wetlands affected: 2.3 acres
Acres of *Phragmites* present: 2.3 acres

A culvert needs to be installed at this site. This would be an excellent AmeriCorp project. All materials could be brought in by hand. All work could be performed with hand tools.

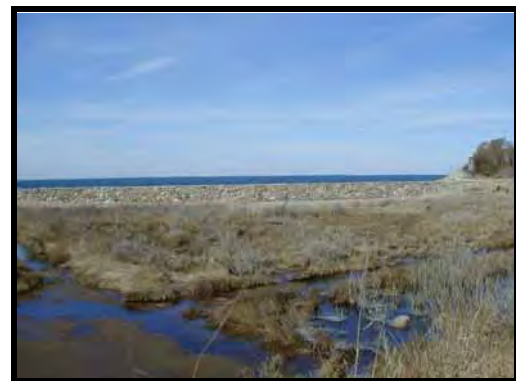
View from behind wall

FA02 is a seawall located east of Gardiner Road (see map on page 101). The seawall is on a barrier beach designed to prevent tidal and storm flows from entering the salt marsh and low lying areas north of Eel Pond in Woods Hole. The seawall has been recently repaired. Most of the marsh has been transformed into *Phragmites* except for the portion “reclaimed” as a ball field and now owned by the Town of Falmouth.

Culvert condition: culvert not visible
Stone wall width: 3 feet
Estimated culvert length: 24 feet
Acres of wetlands affected: 14.8 acres
Acres of *Phragmites* present: 14.8 acres

Due to the low lying areas, this site should be investigated to determine if a self regulating tide gate is needed. The impacted marsh is the same area affected by FA03, FA04, FA05, FA06, FA40, and FA41. A study that looks at all restrictions affecting this marsh system is recommended.

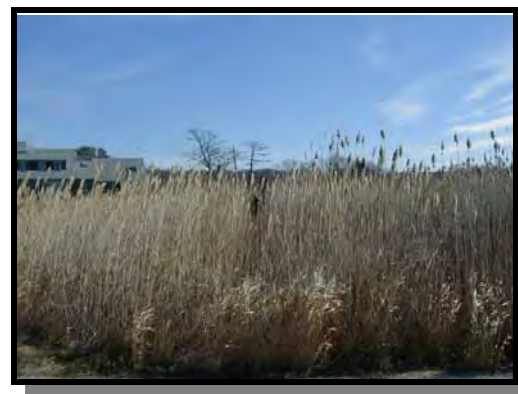
Restriction site FA05

There is a lot of *Phragmites* on the upstream side of this culvert. The culvert has filled in on the east side with soil and is not visible, as it is covered by rocks. A larger culvert is required. The impacted marsh is the same area affected by FA02, FA03, FA04, FA06, FA40, and FA41. A study that looks at all restrictions affecting this marsh system is recommended.

Upstream view

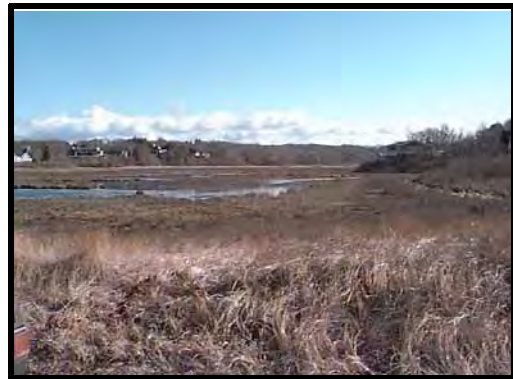
This is a barrier beach road with no culverts. The pond that formed on the blocked side may have created specialized habitat which may now deserve protection. This freshwater/brackish habitat should be studied before the installation of a culvert is considered.

View of marsh

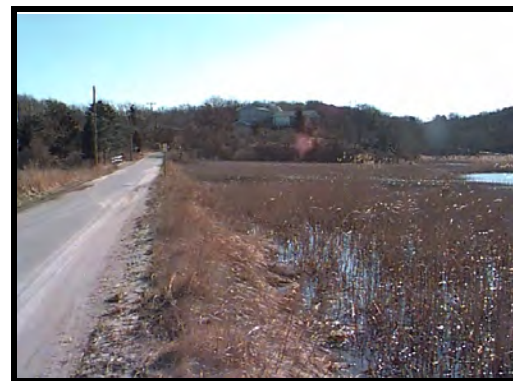
FA10 is a beach access road near Little Sippiwisset Marsh that was installed with no culvert (see map on page 99). The lack of a culvert has prevented tidal flows from the north and has caused ponding of water on the south side of the road.

View of road

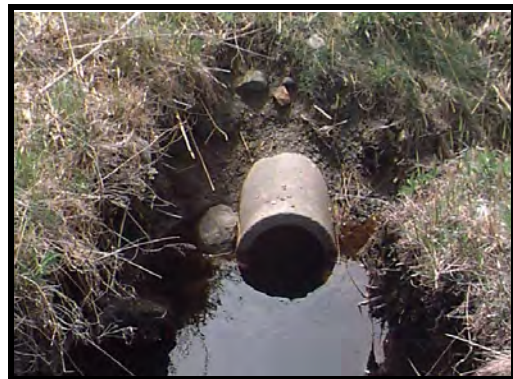
This site has generated interest among several state agencies. The ditch through the upland to FH18 should also be reshaped to handle an increased flow when the culvert is replaced with a larger one.

Upstream view

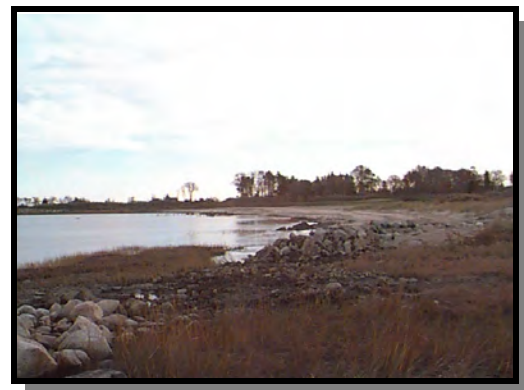
Most of the *Phragmites* has died back since the restriction was partially removed in 1998. This site should be investigated further to determine if other improvements to flushing can be achieved.

Section of wall that was removed

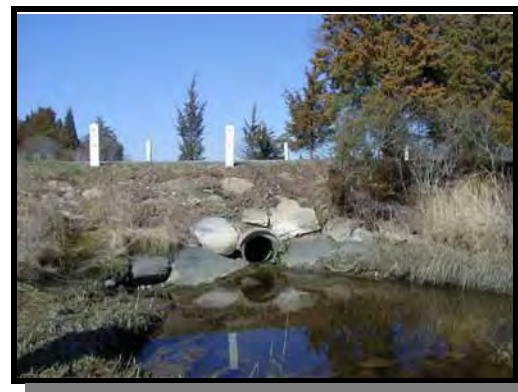
MT04 has been selected as a GROWetlands site. The Massachusetts Wetland Restoration Program has engaged an engineering firm to study this marsh and the three restrictions: MT03, MT04 & MT05.

View of south side of Mattapoisett Neck Road

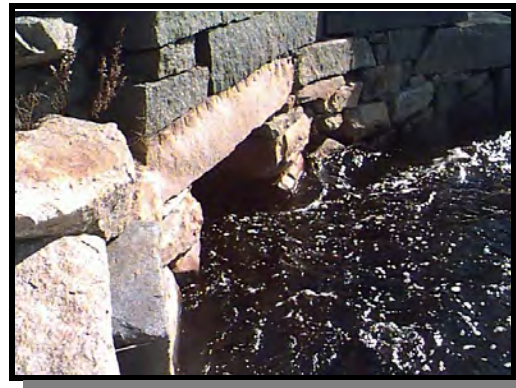
Restriction site MT09

The culvert is submerged and Eel Pond has developed a breach in the barrier beach west of this site. The breach may provide adequate flushing to the pond. Further study of this issue is warranted prior to planning a secondary culvert.

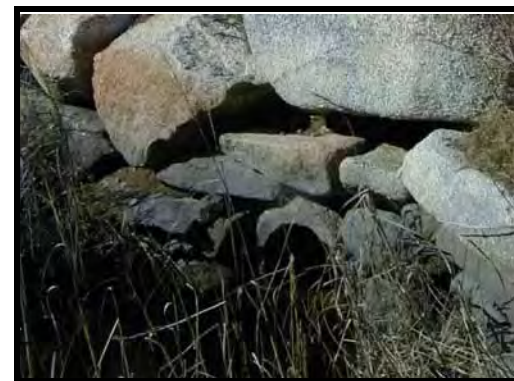
Due to the lack of paving and utilities and the shallow culvert depth, this culvert would be easy to replace. There has been somewhat of a breach in the barrier beach to the south at MT17, which allows tidal waters to the same wetland.

Upstream end of culvert

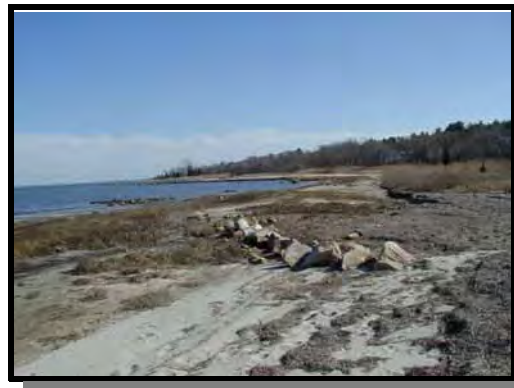
The rock wall has sunk and is clearly over washed. While the removal of this wall would provide only a marginal increase in tidal flooding, the project would be easy to complete.

Stone wall on beach, looking south

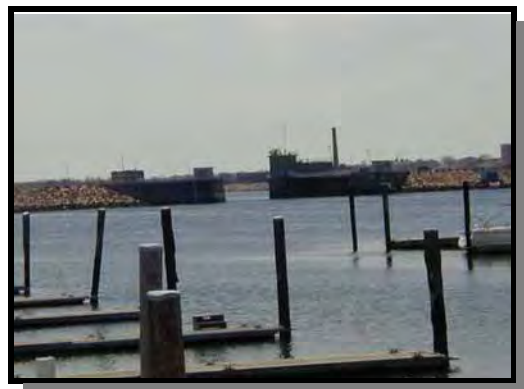
The New Bedford Harbor Trustees Council is investigating the possibility of increasing tidal flow to New Bedford Harbor. Rather than altering the hurricane barrier entrance, installation of a large culvert west of the entrance is being considered.

Opening in hurricane dike from the Fairhaven Shipyard & Marina

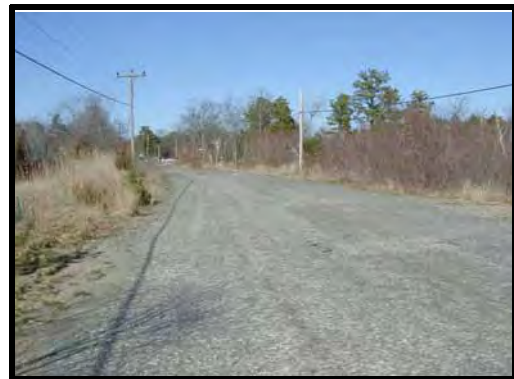
This project must be remediated in conjunction with WH29. Although there are no properties accessed by this section of road, the road contains water mains and active electric/telephone poles precluding road removal. The marsh to the south was flooded for several days by salt water after Hurricane Bob in 1991. All freshwater vegetation in the marsh was killed as a result of that flooding.

Old section of Route 6

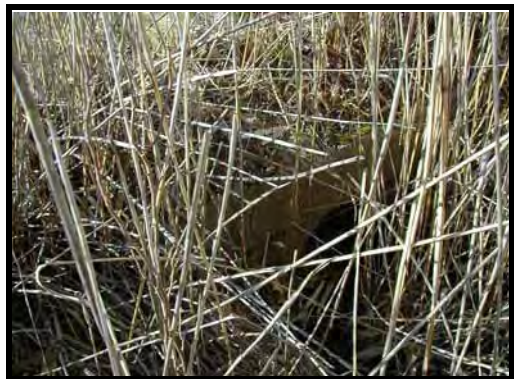
Phragmites at end of pipe

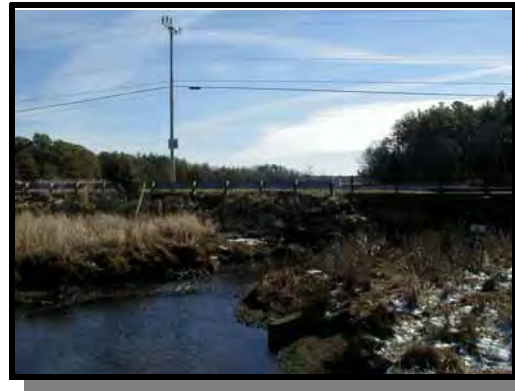
Improvements to flushing under this old road, should be done in conjunction with improvements at WH41. The removal of this old road remnant would be fairly easy to accomplish as there is ready access for heavy equipment. Due to the site topography it would not be necessary to remove the material off-site. Wetland Protection Act permits must be issued by both Wareham and Plymouth.

Downstream view from WH40, looking at WH41

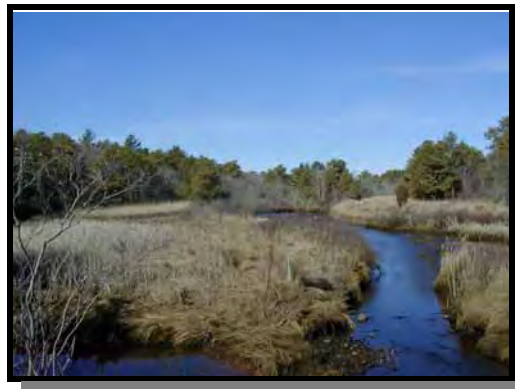
Upstream view, above WH40

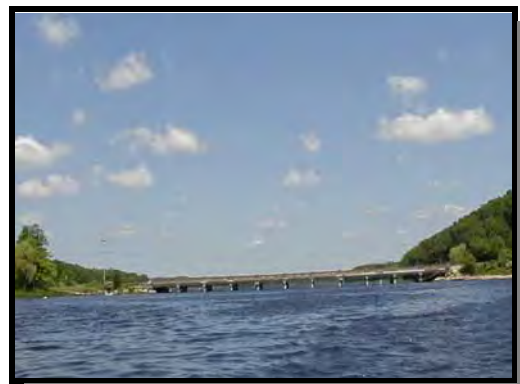
This tidal restriction is caused by fill material deposited under Hix Bridge, which impedes tidal flow and creates a damming effect (see map on page 141). Large granite blocks were toppled in the river as a result of the destruction of the old Hix Bridge by the Hurricane of '38 and from the demolition of the bridge in 1939.

The Town of Westport is planning to rebuild this bridge. The U.S. Army Corps of Engineers is conducting a tidal flushing study to determine the benefits of increased tidal flushing. There may be problems associated with the removal of the granite blocks. A detailed report on this site is available on the Buzzards Bay Project's website, www.buzzardsbay.org.

View of Hix Bridge, looking North

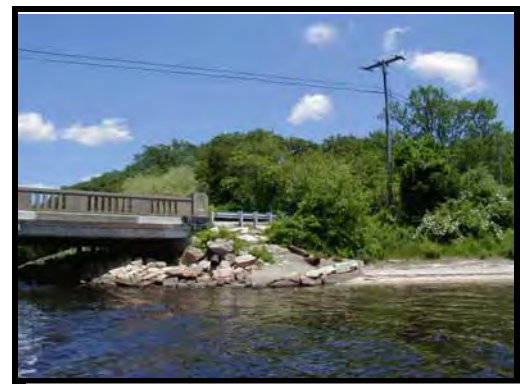
Close up view

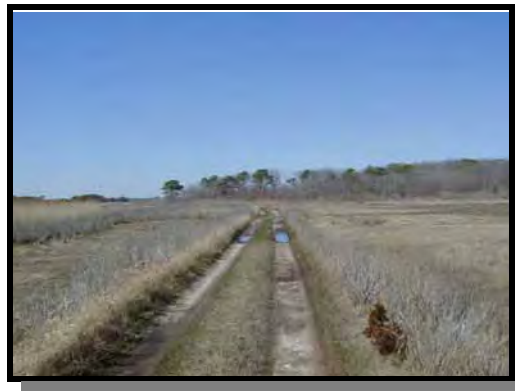
The addition of new culverts at the site may require new mosquito ditching. Any new culverts would be fairly easy to place. If the driveway is improved by an increase of fill, new ditching may not be required.

View of driveway
