ATLAS OF

TIDALLY RESTRICTED SALT MARSHES

IN THE
BUZZARDS BAY WATERSHED
MASSACHUSETTS

JANUARY 2001
DRAFT FINAL

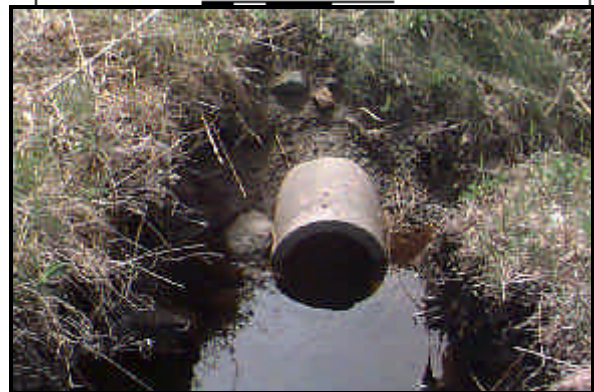
Culvert under Fir Street, upstream side

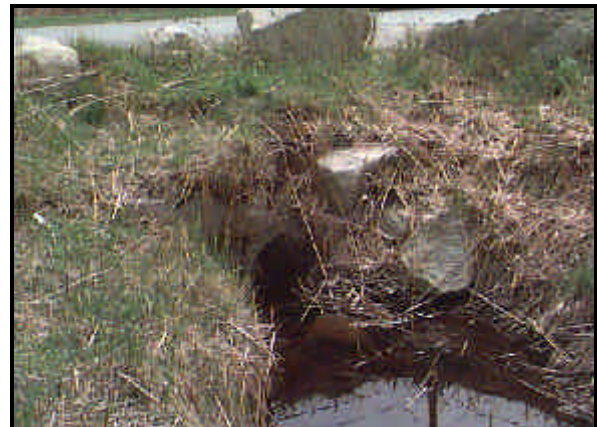
Culvert under Fir Street, downstream side

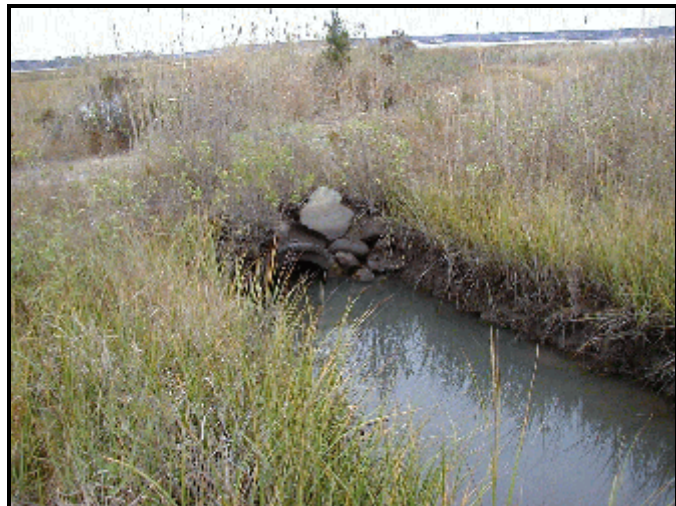
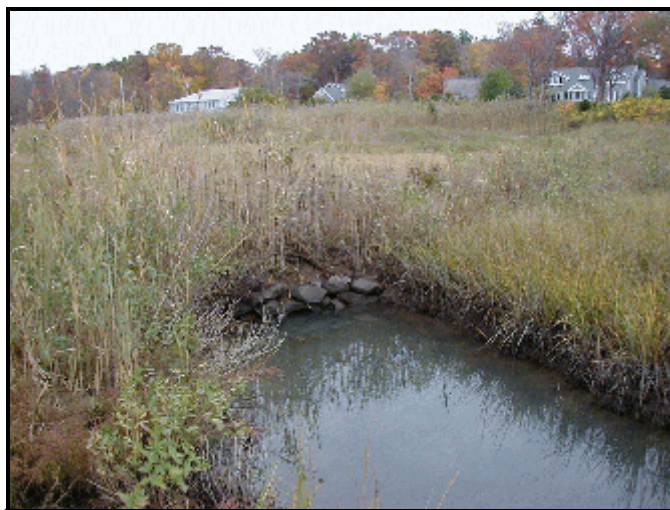
Tidal Restriction Site WH17

This site, like a number of bridge restrictions included in this report, became high priorities because of the large area of potential wetland habitat area affected. Whether expansion of the restriction, or dredging of the channel would be beneficial to salt marsh habitat will require further study. Improved flushing may be relevant to water quality above the bridge because the municipal treatment plant discharges 1000 meters upstream of this site.

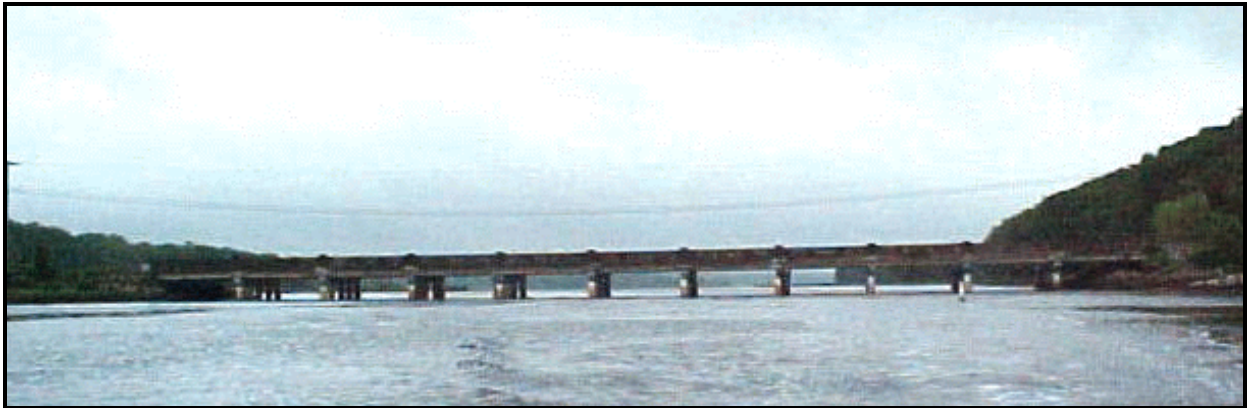
Tidal Restriction Site BN05

The stream above this bridge remains tidal. Widening or deepening of the bridge could improve habitat marginally. Because of costs and small wetlands areas affected, this work could only be justified during a future planned bridge replacement.

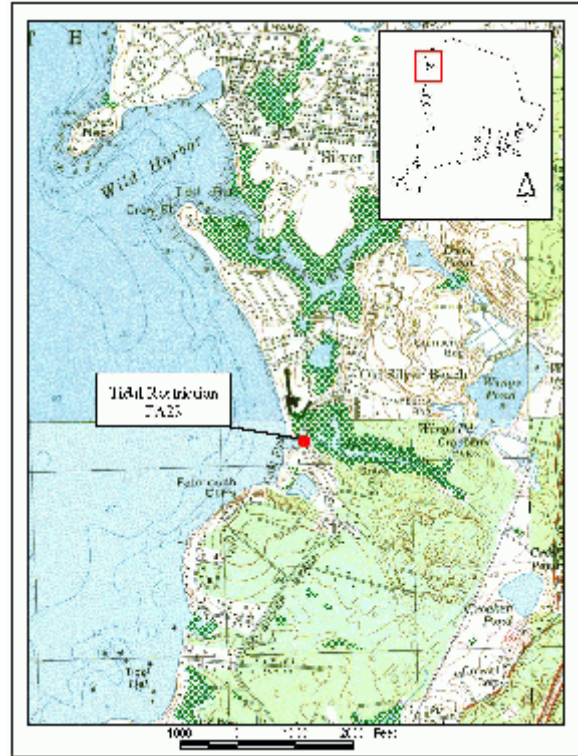
The bridge and foot bridge was recently reconstructed as a single bridge over the channel. Given this recent reconstruction, the only potential restoration at this site is channel dredging. The channel is very long and shallow, but it is unclear if dredging the channel under the road and to Old Silver Beach would result any benefit to this wetland system. This site is included in this report to acknowledge further study could be considered at this site.

New Bridge at Old Silver Beach (FA23).

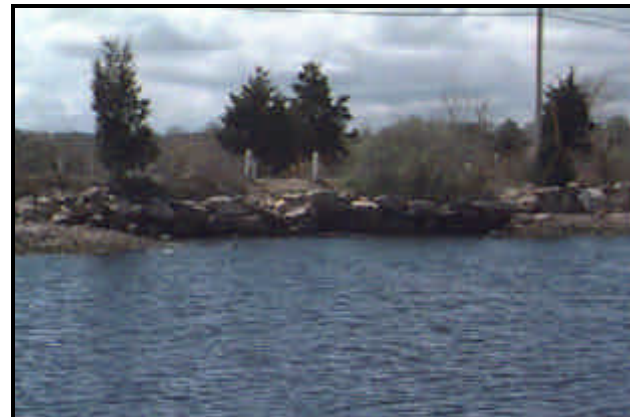
Downstream side of tidal restriction MT03

Replacement of the circular culvert with a large box culvert may be an effective cost effective solution for this site.

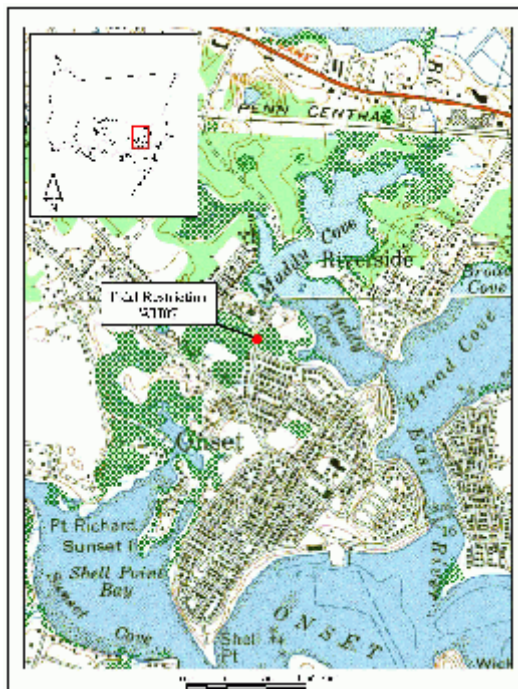
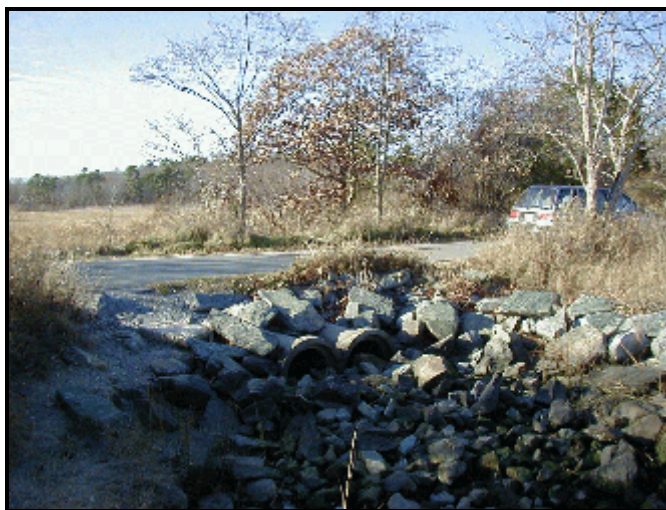
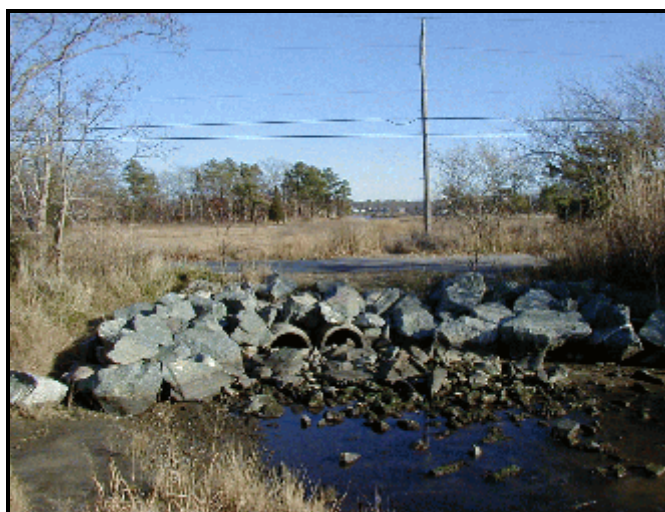
- Culvert condition - concrete culvert
- Restriction width - 2 feet
- Restriction length - 24 feet
- Channel width - 2 feet
- Acres of wetlands affected - 12.2
- Acres of *Phragmites* - 1.6

Removal of debris, and possibly installation of a box culvert may be the solution for this site.

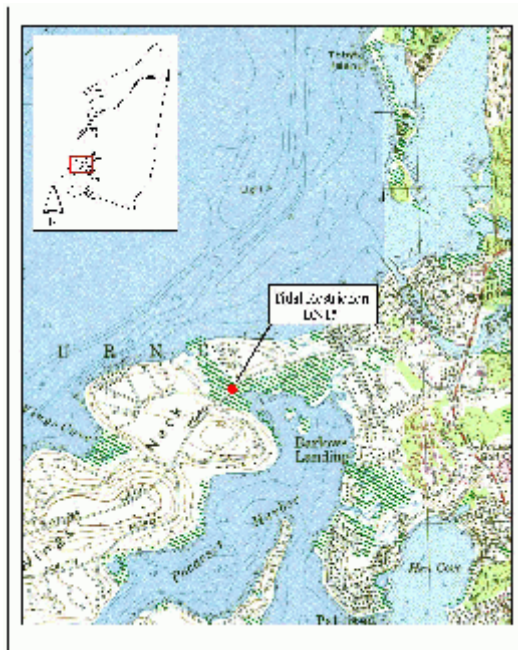
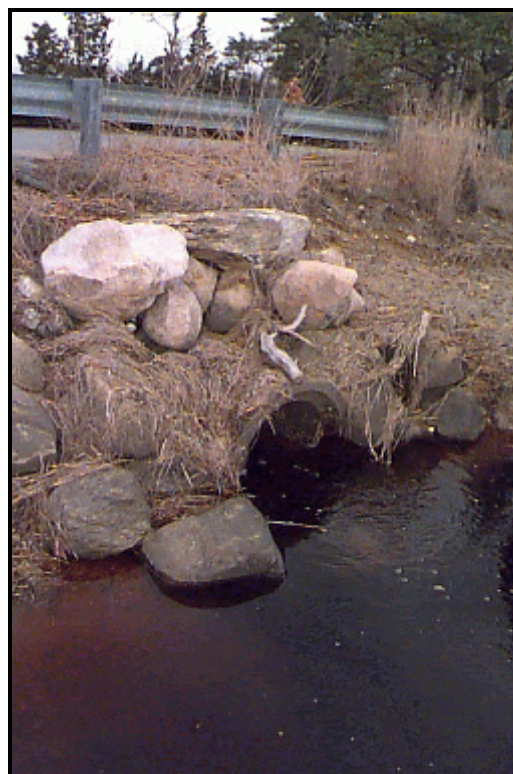
Tidal Restriction Site BN15

- Culvert condition - concrete culvert
- Restriction width - 2.5 feet
- Restriction length - 26.4 feet
- Channel width - 4 feet
- Acres of wetlands affected - 8.2
- Acres of *Phragmites* - 1.3

Several agencies have reviewed this site and it is under consideration as a remediation project. The town of Bourne has prepared grant applications for the remediation of this site.

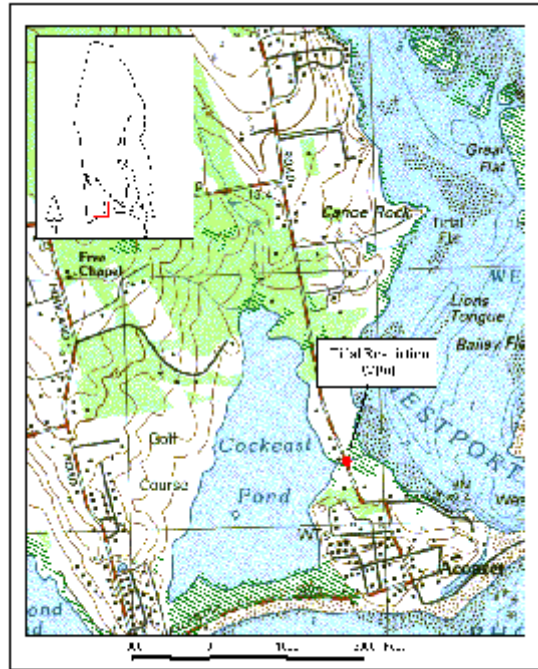
Tidal Restriction Site WP01

Restriction WP01 is a culvert under River Road at the edge of Cockeast Pond. The existing culvert has rusted through on bottom side. Historically this pond was fresh until the last culvert replacement after hurricane Carol in 1956. There is not sufficient salt water to establish *Spartina*. Species growing around the edge of the pond are *Phragmites* and narrow-leaved cattail, *Typha angustifolia*. The restriction is on town property. The restricted wetlands are privately owned and listed as habitat for rare & endangered species by the Natural Heritage & Endangered Species Program. The culvert is part of an anadromous fish run.

Restriction WP01 consists of a circular, 24 “ corrugated metal culvert under River Road. The road is 30 feet wide and paved.

- Culvert condition - poor
- Restriction width - 2 feet
- Restriction length - 36 feet
- Channel width - 4 feet
- Acres of wetlands affected - 5.0
- Acres of *Phragmites* - 0.0

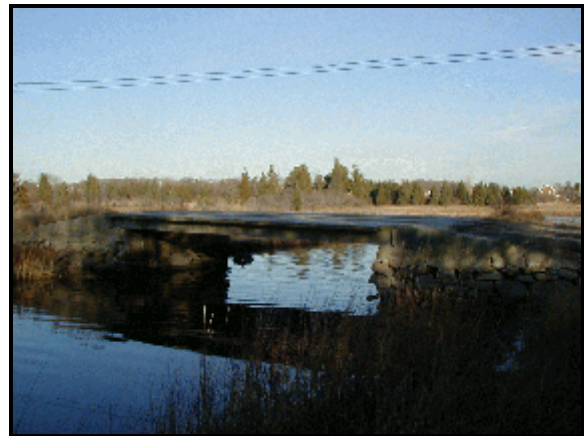
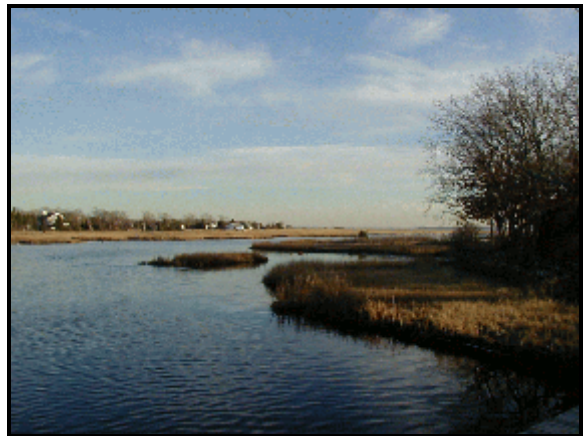
- Bridge condition - fair
- Restriction width - 35 feet
- Restriction length - 12 feet
- Channel width - 20 feet
- Acres of wetlands affected - 19.3
- Acres of Phragmites - 4.2

This site, like a number of bridge restrictions included in this report, became high priorities because of the large area of potential wetland habitat area affected. Whether expansion of the restriction, or dredging of the channel would be beneficial to salt marsh habitat will require further study. The cost of remediating this site is probably less than projected because this road receives little traffic.

Downstream view from site FH03.

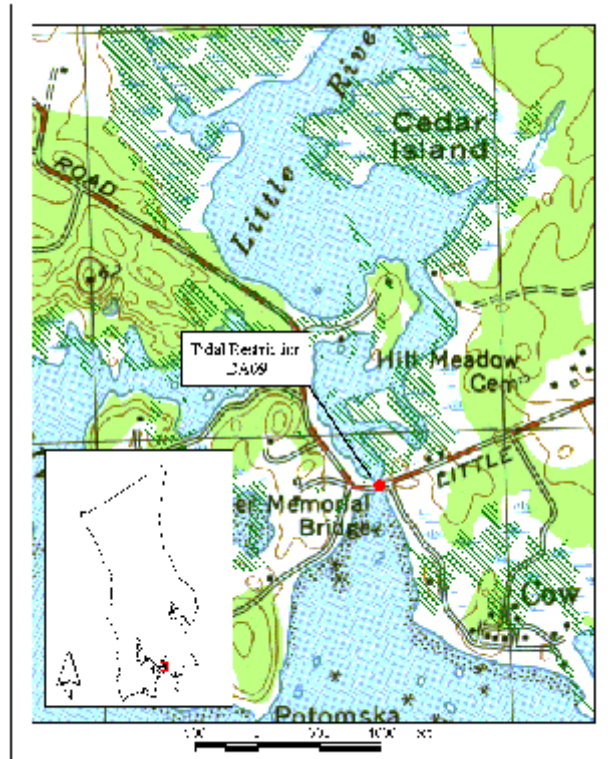
Tidal Restriction DA09 is the Little River Bridge. Located at the mouth of Little River, this bridge has cracks and spalling in many areas. The restriction is town property, while the restricted wetlands along Little River are privately owned. The wetland areas are categorized by the Natural Heritage & Endangered Species Program as rare & endangered species habitat.

This restriction consists of the Little River Bridge on Potomska Road in South Dartmouth. The road is 25 feet wide and paved. There is no culvert.

- Bridge condition - Poor
- Restriction width - 60 feet
- Restriction length - 30 feet
- Channel width - 120 feet
- Acres of wetlands affected - 164.7
- Acres of Phragmites - 0.0

This site, like a number of bridge restrictions included in this report, became high priorities because of the large area of potential wetland habitat area affected. Whether expansion of the restriction, or dredging of the channel would be beneficial to salt marsh habitat will require further study.
