**ENVIRONMENTAL ASSESSMENT OF  
POLYCHLORINATED BIPHENYLS (PCBs)  
NEAR NEW BEDFORD, MASSACHUSETTS  
MUNICIPAL LANDFILL**

May 1978

Final Task Report  
Research Request No. 4  
Contract No. 68-01-3248

ENVIRONMENTAL SCIENCE AND ENGINEERING, INC.  
P. O. Box 13454, University Station  
Gainesville, Florida 32604

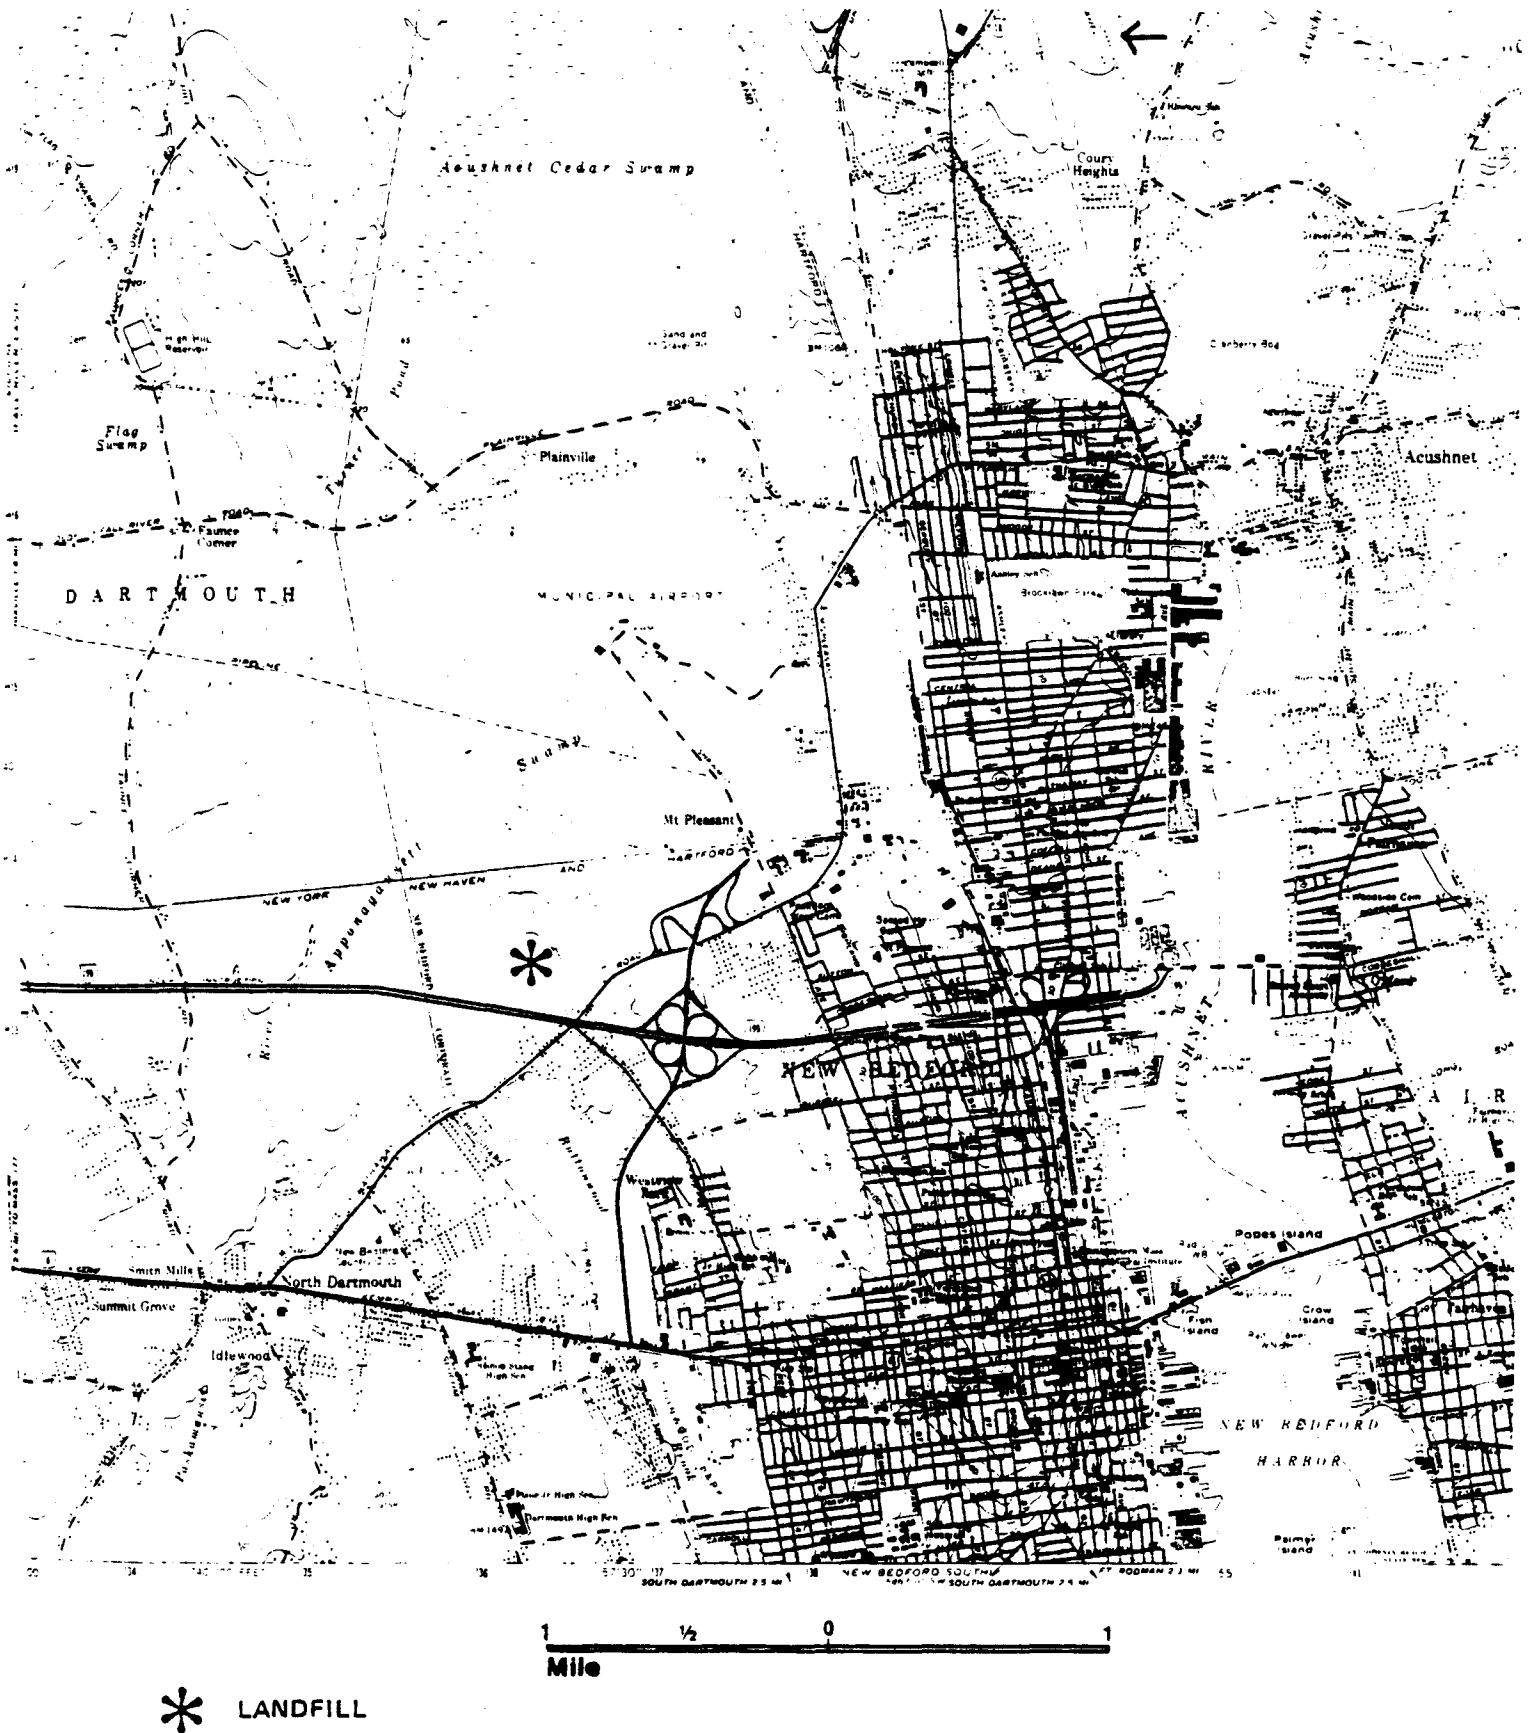
FIGURE 1

# NEW BEDFORD MUNICIPAL LANDFILL AND SURROUNDINGS

The landfill is located one-half mile from the Paskamanset River near the southern end of a large glacial lake deposit that extends from the Apponagansett Swamp to the northern limit of the Acushnet Cedar Swamp. Figure 1 shows the location of the landfill near the New Bedford Airport and Interstate 195.

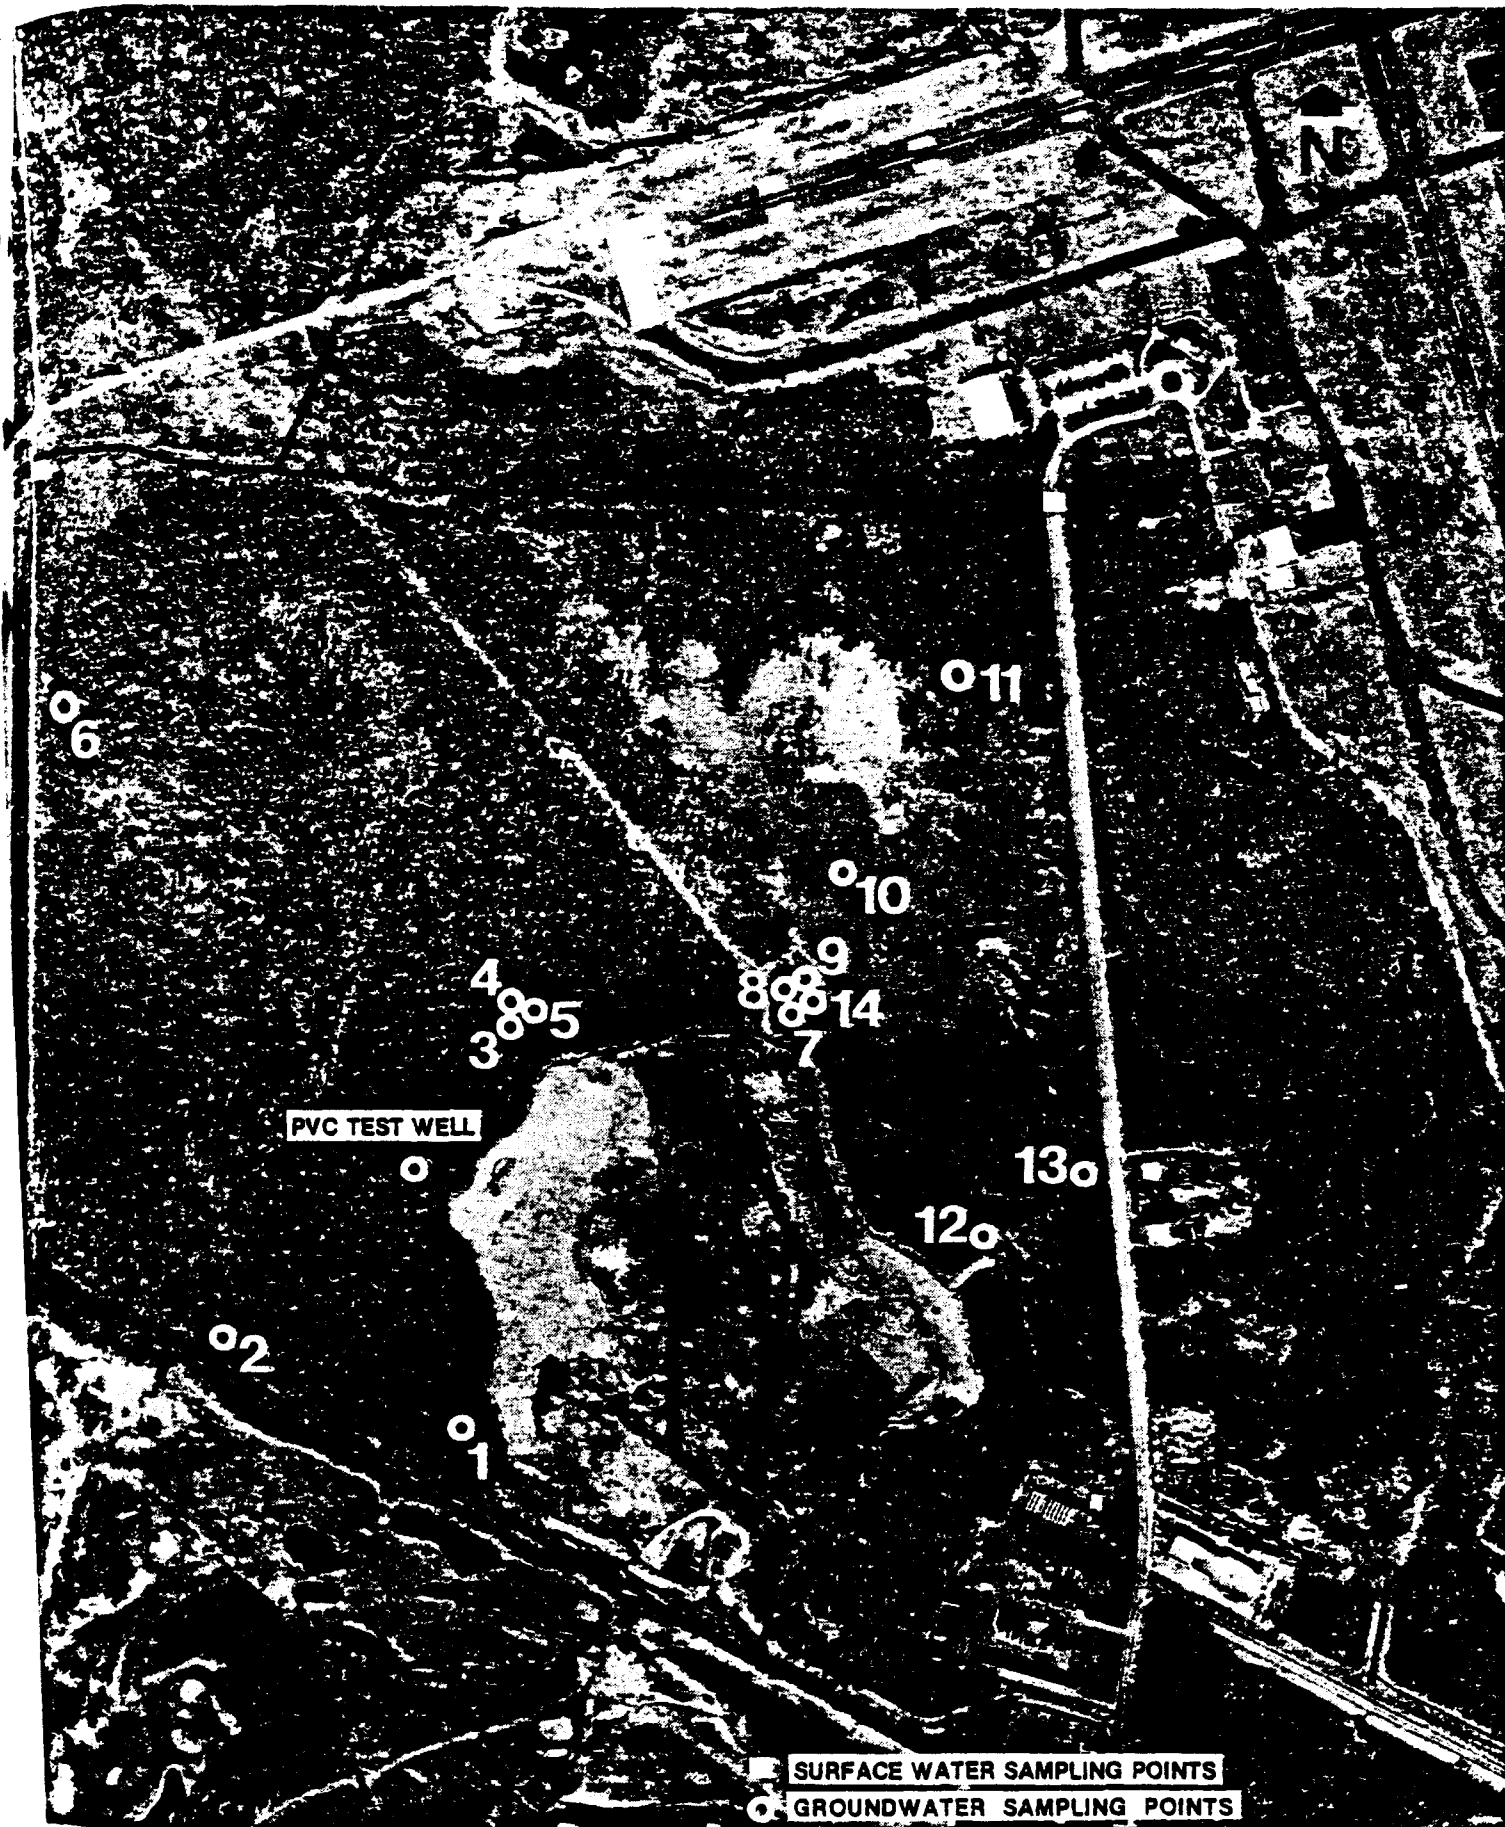
FIGURE 3

Fourteen well points were hand-driven to various depths around the edge of the landfill at the locations shown in Figure 3, which is an aerial photograph of the landfill. Conductivity readings were taken at each of these sites. Well depth and conductivity are listed in Table 1. The conductivity studies show that at locations where two or more points were driven to different depths, the wells with the shallowest depth have the highest conductivities. This indicates that the leachate plume is shallow. Wells 3, 4, and 5 were grouped together and show this trend. Wells 7, 8, and 9 also show this same trend.

GROUNDWATER SAMPLING POINTS

All shallow groundwater samples taken along the periphery of the landfill were analyzed for PCB. In addition, samples collected from Well A and Well B of the Dartmouth Municipal Water Works and the sample taken from a private artesian well (23 Tolland Path) were analyzed for PCB. These analytical results are reported in Table 5. Figure 3 shows the location of the shallow groundwater samples.

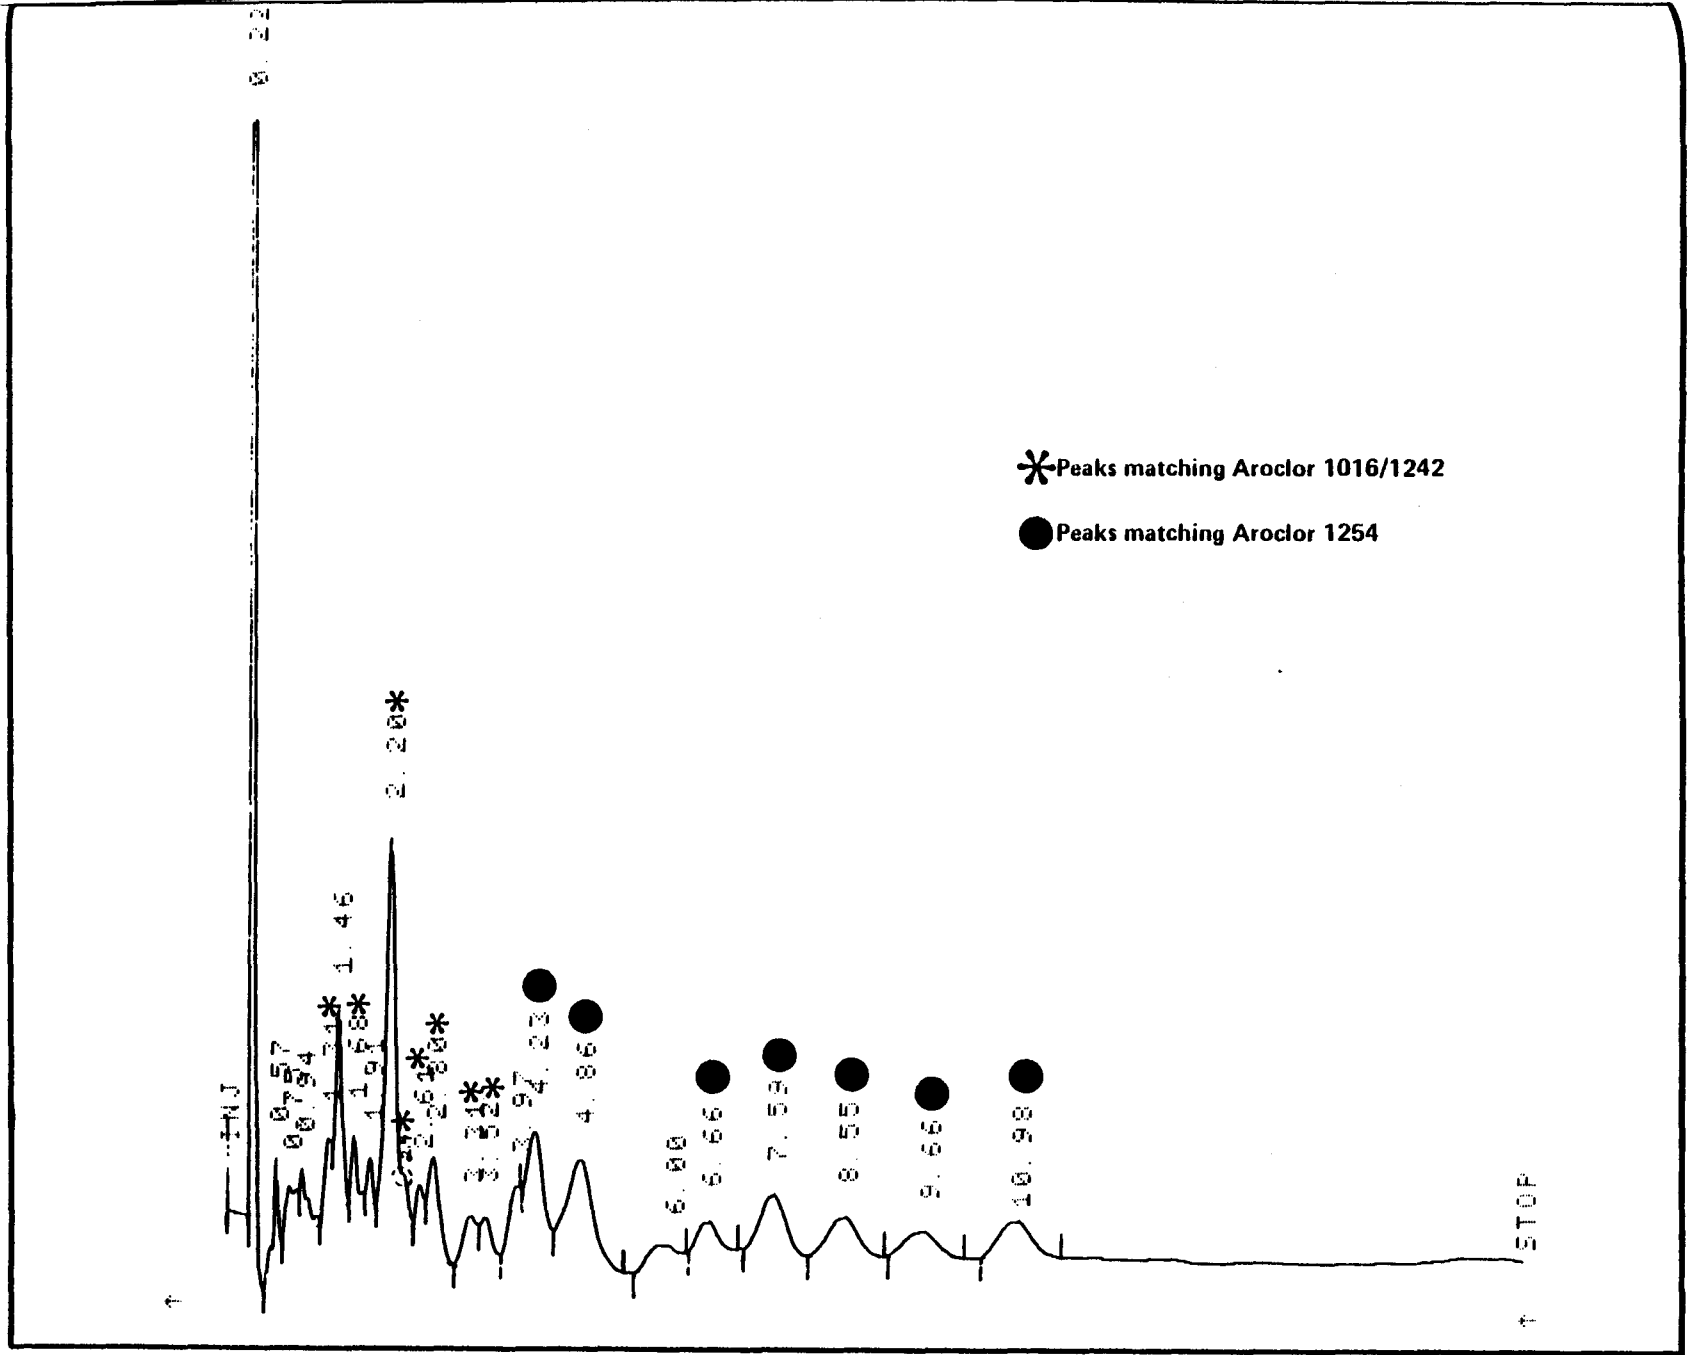
FIGURE 7

Figure 7 is a chromatogram of the water sample taken from Test Well 9. Figure 8 shows chromatograms of Aroclor 1016/1242, and Figure 9 a chromatogram of Aroclor 1254. It can be seen that the well water sample (Figure 7) contains all the major peaks of Aroclor 1254, except the two latest eluting, and many earlier peaks matching Aroclors 1016 and 1242. It is not possible when Aroclor 1254 is present to definitively identify the earlier pattern as either Aroclor 1016 or 1242, since the elution patterns for these two Aroclors differ only with respect to the last few eluting peaks which coincide with Aroclor 1254 peaks.

CHROMATOGRAM OF SHALLOW GROUNDWATER  
 SAMPLE FROM TEST WELL NO. 9
