Atlas of
Stormwater Discharges
in the Buzzards Bay Watershed

Atlas of Stormwater Discharges in the Buzzards Bay Watershed

Buzzards Bay Project National Estuary Program
Massachusetts Office of Coastal Zone Management
2870 Cranberry Highway
East Wareham, Massachusetts 02538
(508) 291-3625
www.buzzardsbay.org

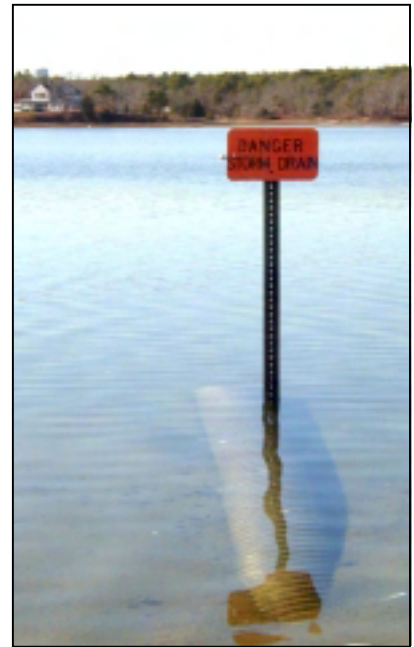
Figure 1. A submerged stormdrain in Wareham.

Similar to most coastal areas, stormdrain discharge pipes dot the coast of Buzzards Bay. Some discharges, like the one in Figure 1, are easy to find because they are marked or highly visible; others are hidden from view or forgotten. Some discharges are via pipes; others are merely “roadcuts.” The *Atlas of Stormwater Discharges in the Buzzards Bay Watershed* attempts to document all known stormwater discharges and contributing catchbasins along the shores of the eight municipalities shown in Figure 2¹. The stormwater discharges included in this study were limited to stormdrain pipes and major roadcuts. A roadcut is defined as any cut in a berm, curb, or bank that discharges stormwater runoff from a paved surface directly to a wetland, waterbody, or upland area.

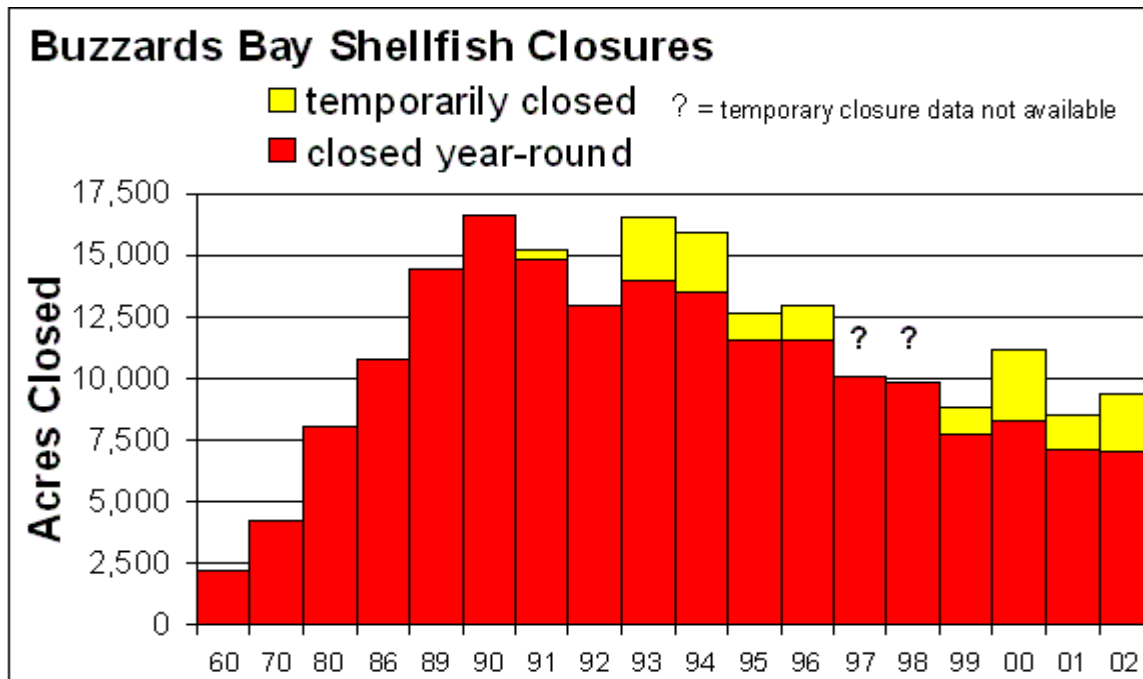
Figure 5. Number of acres of permanently and temporarily closed (rainfall or seasonal conditional) shellfish beds in Buzzards Bay on or about July 1. Note: Closed year round = “prohibited” + “restricted” + “management” closures. Whether the conditional beds were open or closed on July 1 depended on recent rainfall and other conditions.

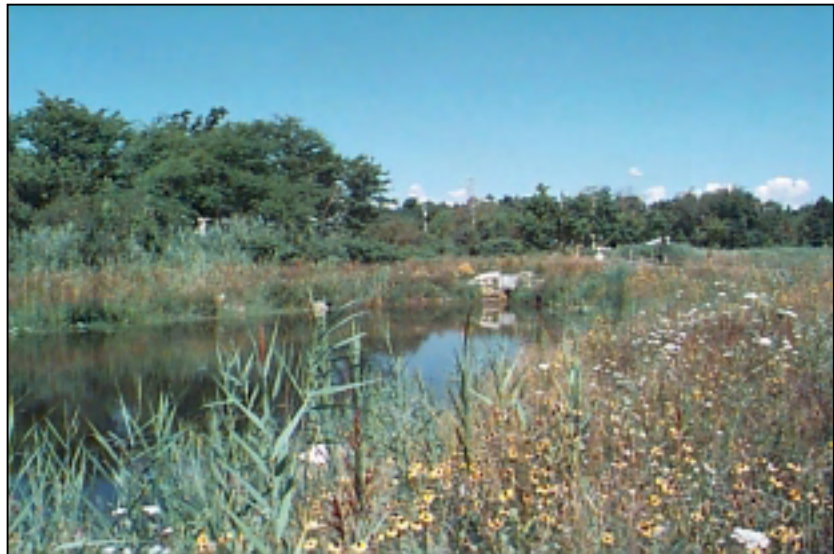
Figure 7. Settling basin and constructed wetland at Spragues Cove, Marion, MA.

- Wet basins, ponds, and constructed wetlands (Figure 7) detain runoff and allow for settling of pollutants associated with sediments and reduction of nutrients through biological processes.
- Municipal maintenance practices remove potential pollutants from streets and storm sewers, and include street and catchbasin cleaning.

In areas that have already been developed, options for remediation of stormwater discharges are usually limited. Site conditions, land availability, and purchase cost of such land becomes an issue when large, end of the pipe solutions are proposed. If land is available, however, the Buzzards Bay Project encourages municipalities to construct “above-the-ground” remediation structures, such as infiltration basins and wetland systems. An example of this type of solution is a constructed wetland system that was installed in the Town of Marion to treat stormwater from a downtown residential area (Figure 7). In this particular case, the town owned a large parcel of land at the end of the pipe. Since no other land in the watershed was available, and site conditions within the watershed (poorly drained soils and high water table) limited design options, the constructed wetland was selected as the management practice.

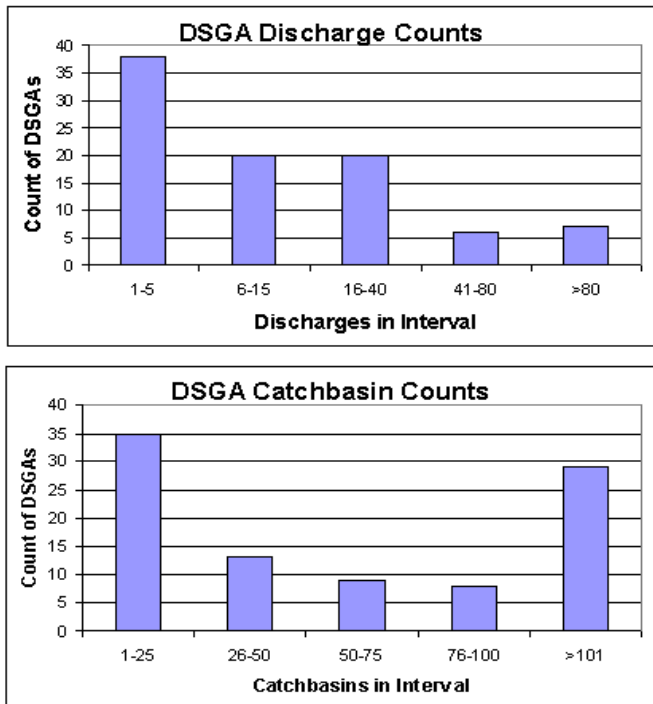
Figure 17. Frequency histograms of counts of discharges (top) and catchbasins (bottom) in each DSGA.

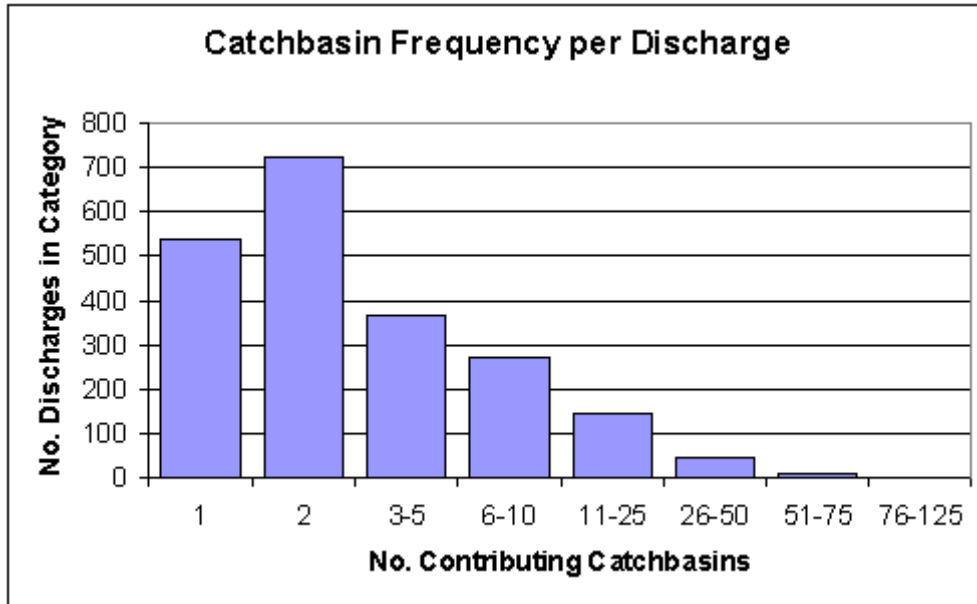
Figure 20. Frequency histogram of number of catchbasins per stormwater discharge pipe for all known and mapped connections.

Based on data for 4 of 8 towns, the average number of catchbasins connected to a drainage pipe in the study was 8.1, with a median of 2.0. Many drainage pipes had 20 or more catchbasins attached. The actual number varied widely, and a frequency histogram summarizing the catchbasin data set is shown in Figure 20.
