Appendix 4: Fall River Potential Restoration Sites

Selected Inventory of Potential Wetland Restoration Sites in the Buzzards Bay Watershed – Phase I

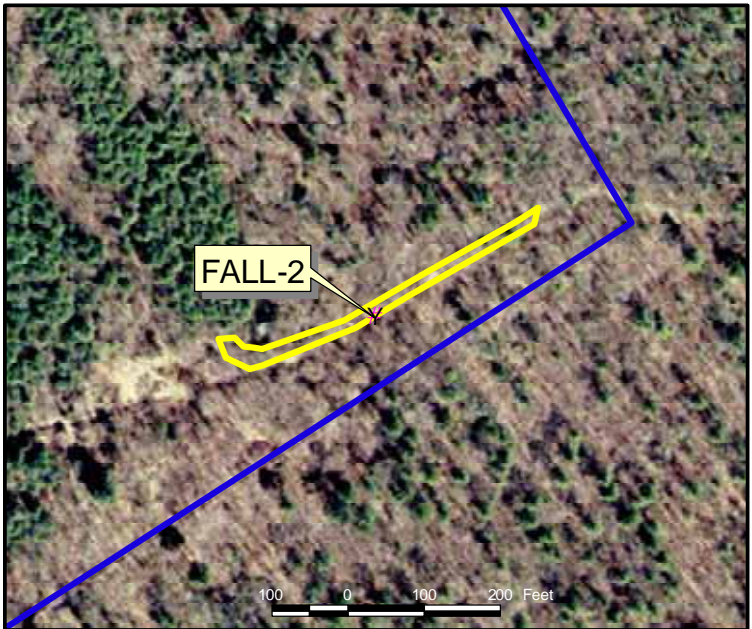
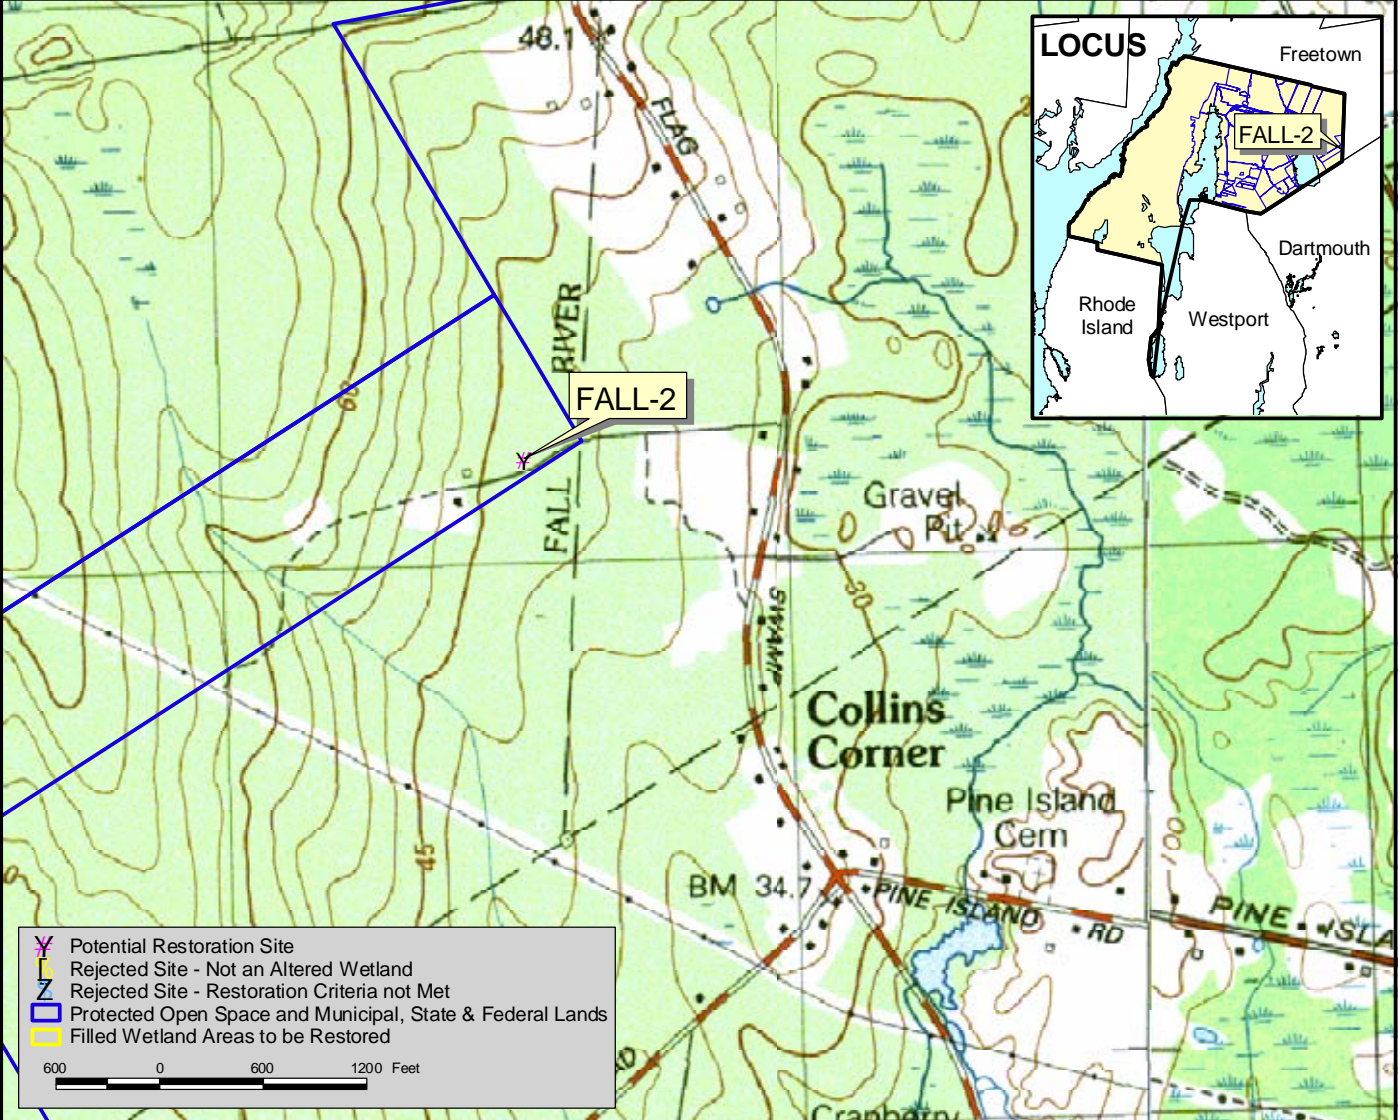
Town: Fall River **Site:** FALL - 2

Disturbance Type: Fill
Disturbed Area: 7,720, square feet
Owner: City of Fall River, Water Department
Assessors' Lot Number: W-50-3
Cubic Yards of Fill to be Removed: 572

Comments: This freshwater site is an old road that provides foot access to Water Department property. The road width is much wider than that required for foot traffic. Foot traffic may not even be desired at this location. There is good access to this site for construction purposes.

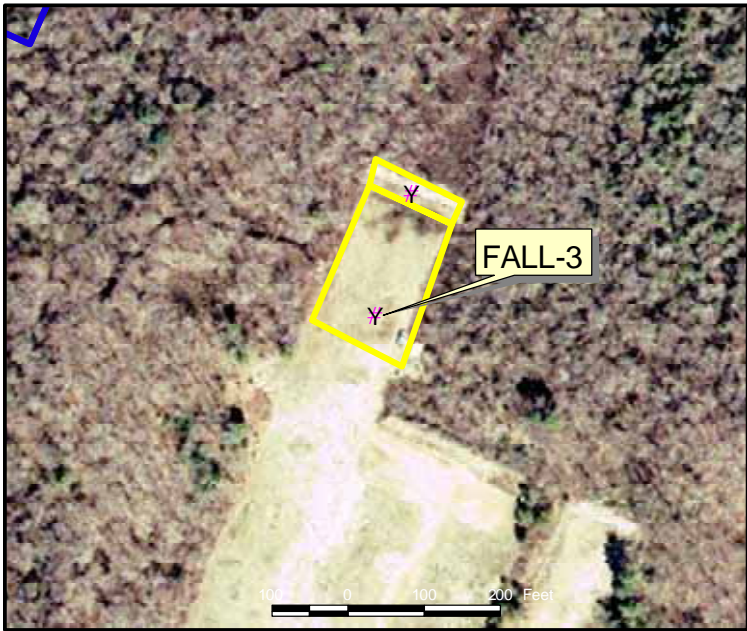
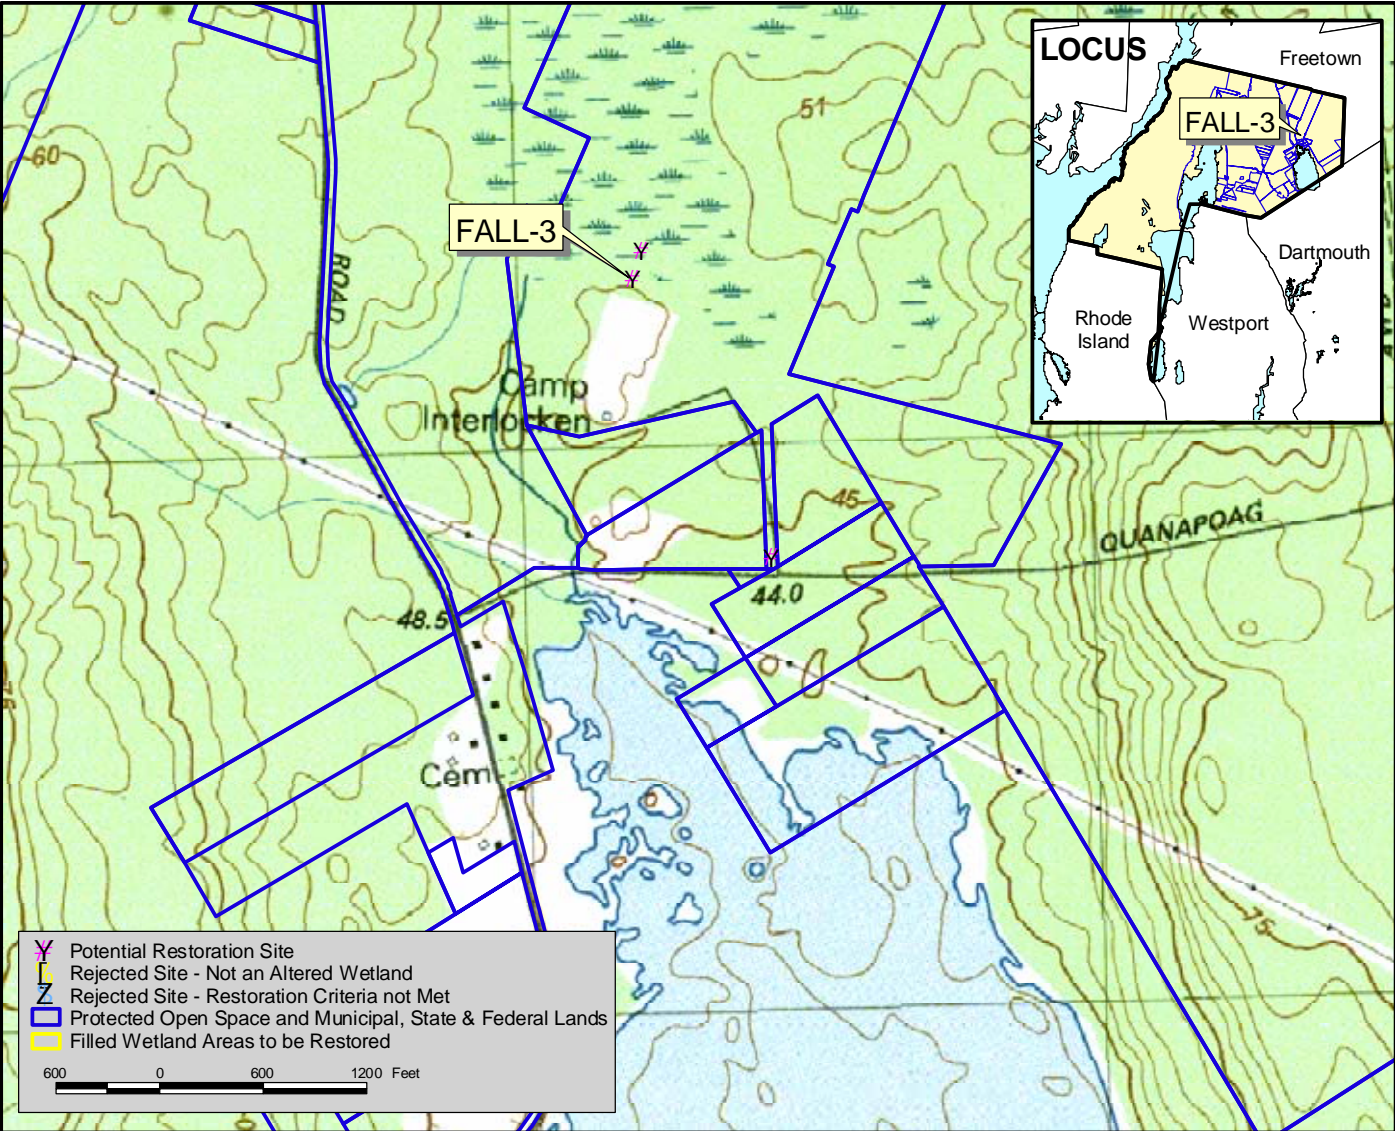
Town: Fall River **Site:** FALL - 3

Disturbance Type: Cropping, mowed
Disturbed Area: 24,559 square feet
Owner: City of Fall River, Water Department
Assessors' Lot Number: CO
Cubic Yards of Fill to be Removed: 0

Comments: This freshwater site is an active shooting range operated as the Copicut Rifle Range. It is difficult under current conditions to accurately scope the magnitude of restoration potential at the site.

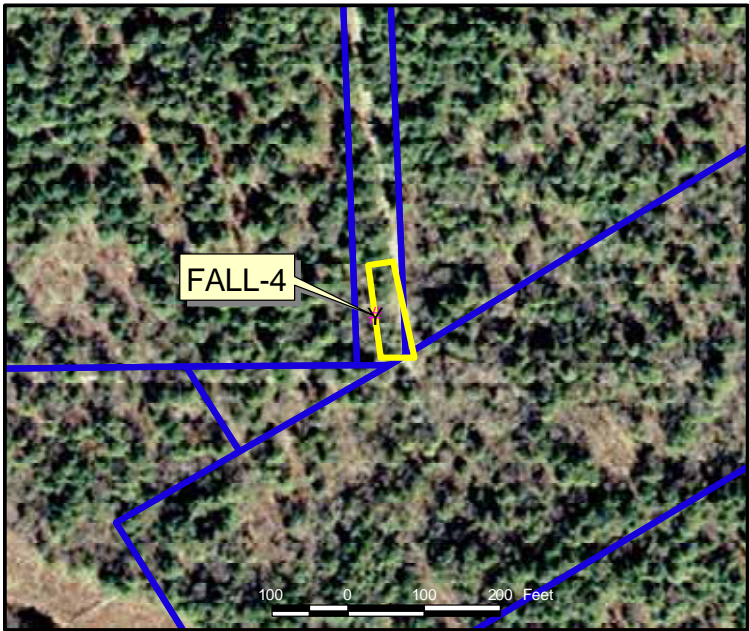
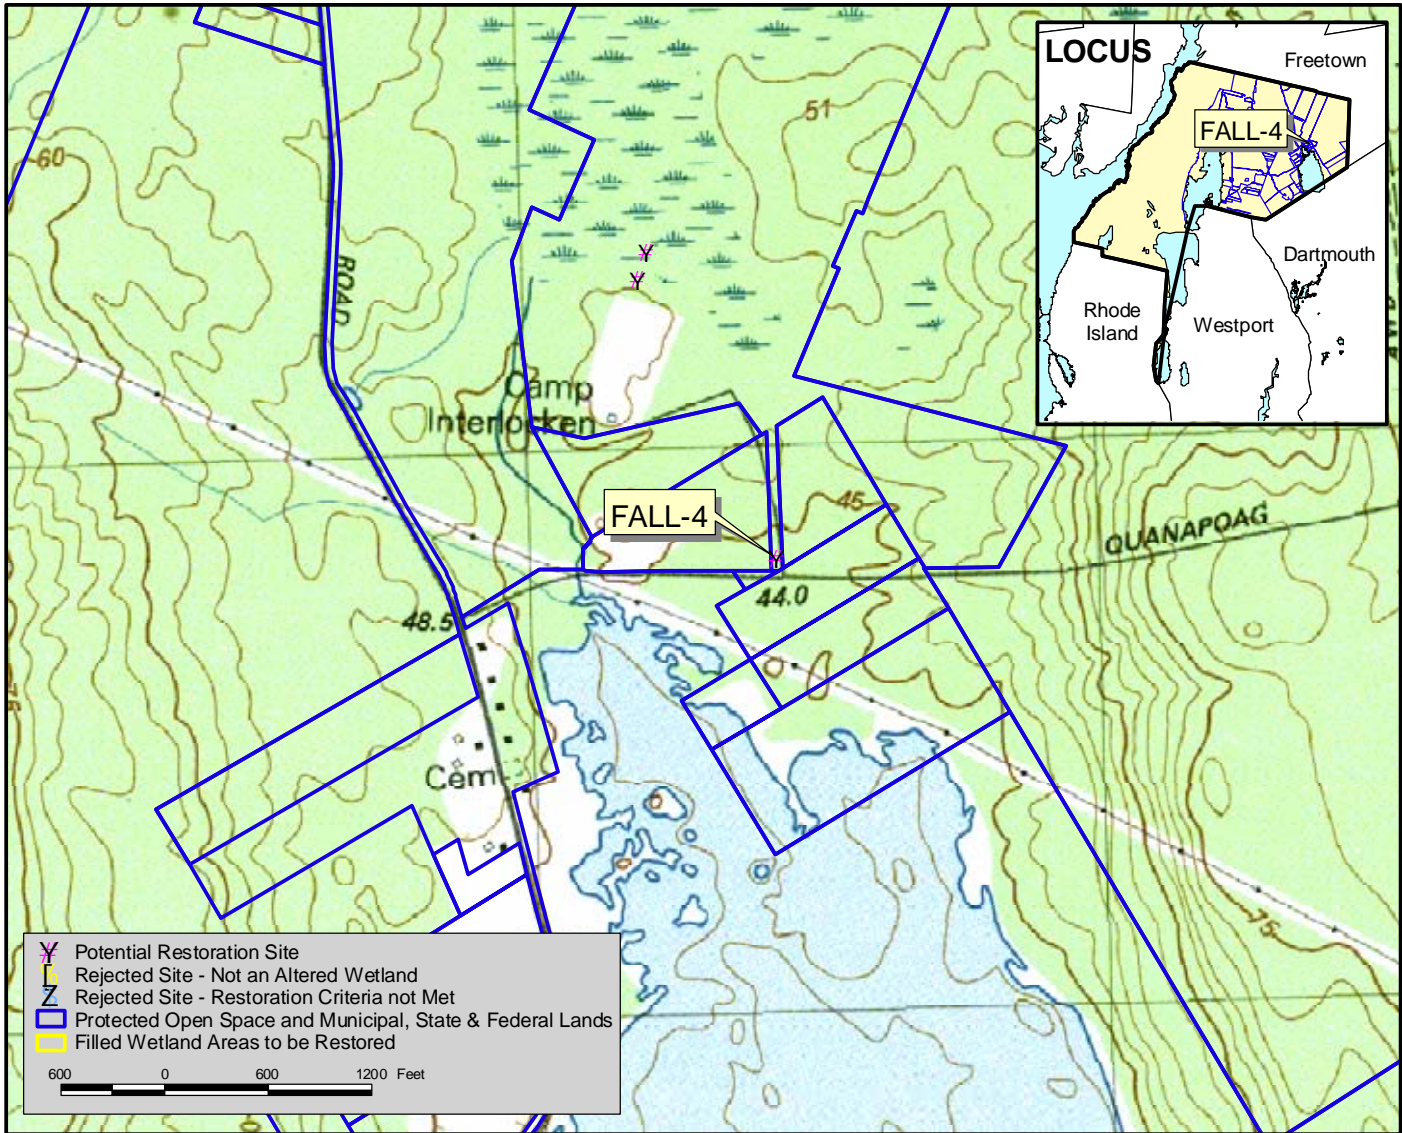
Town: Fall River **Site:** FALL - 4

Disturbance Type: Fill
Disturbed Area: 10,946 square feet
Owner: City of Fall River, Water Department
Assessors' Lot Number: None
Cubic Yards of Fill to be Removed: 811

Comments: This freshwater site is part of an access road for the Copicut Rifle range. An alternative access location would be needed to remove the fill at this site.

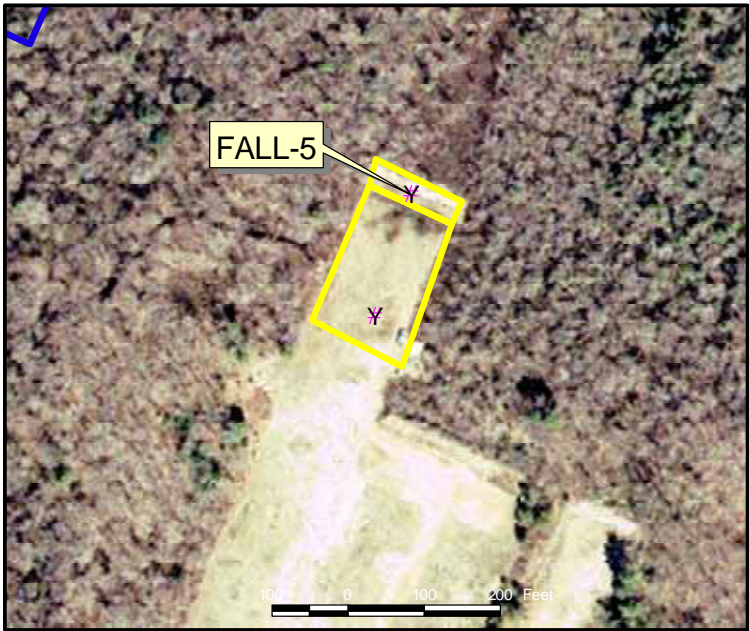
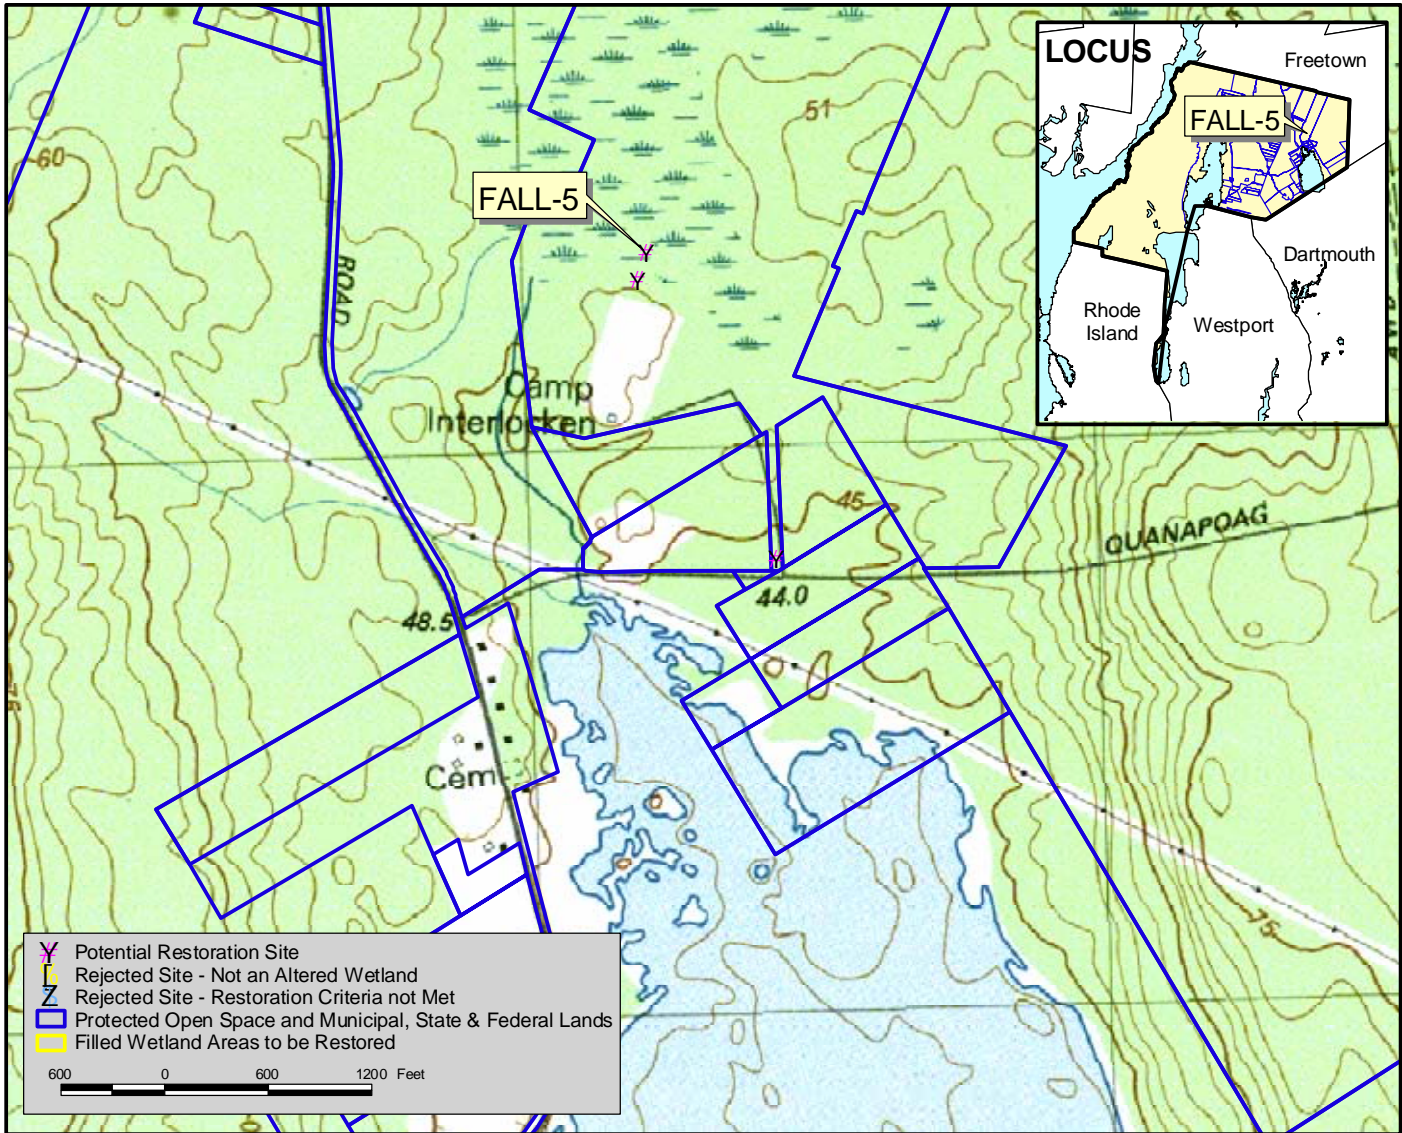
Town: Fall River **Site:** FALL - 5

Disturbance Type: Fill
Disturbed Area: 4,129 square feet
Owner: City of Fall River, Water Department
Assessors' Lot Number: CO
Cubic Yards of Fill to be Removed: 918

Comments: This freshwater site is an active shooting range operated as the Copicut Rifle Range. It is difficult under current conditions to accurately scope the magnitude of restoration potential at the site. FALL - 5 is a target backdrop that could be replaced with a wood structure.
